Inspection Photos

Location Name: Sitzman 1 Tank Battery Spill ID: 454307, API: 05-123-11421

Complaint #200445872 Inspection Date: 05/15/2018

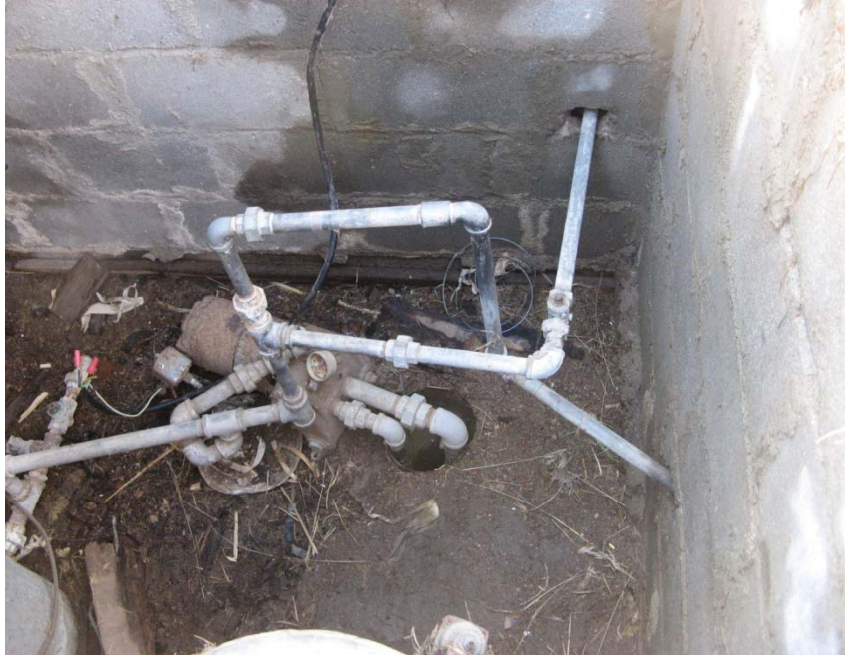
Photo 1 – View of domestic water well vault/sump for water well permit no. 276778. Well casing is open hole in sump. Motor has seized and a sample was not collected.

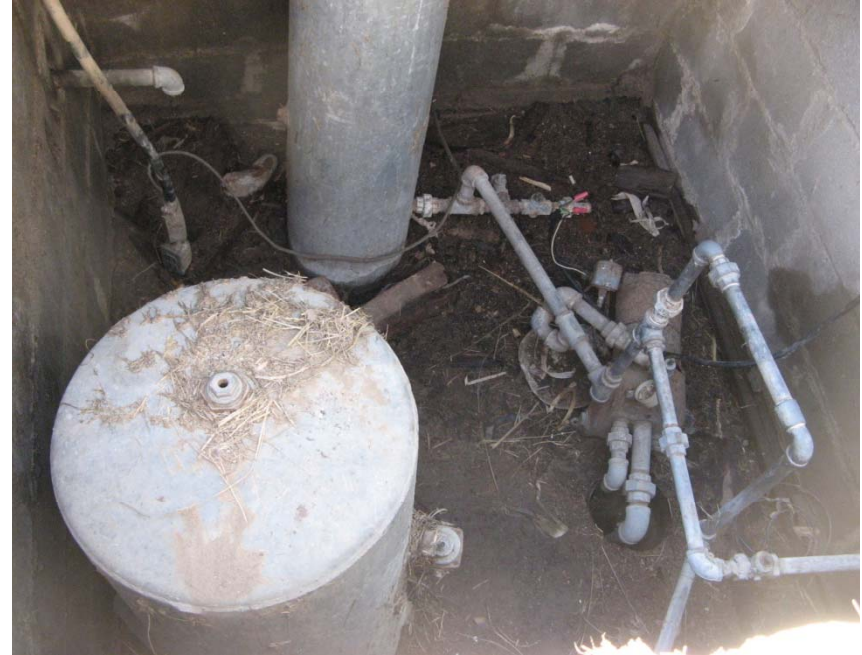
Photo 2 – Second view of domestic water well vault/sump for well permit no. 276778 showing pressure tanks.

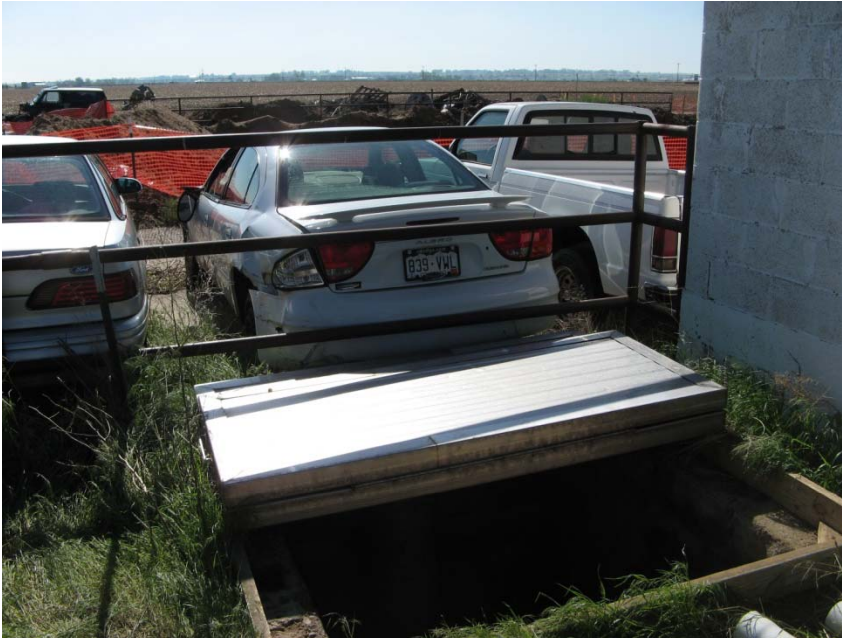
Photo 3 – Surface view of water well vault/sump location for water well permit no. 276778, looking east toward excavation for remediation at Sitzman #1 tank battery.

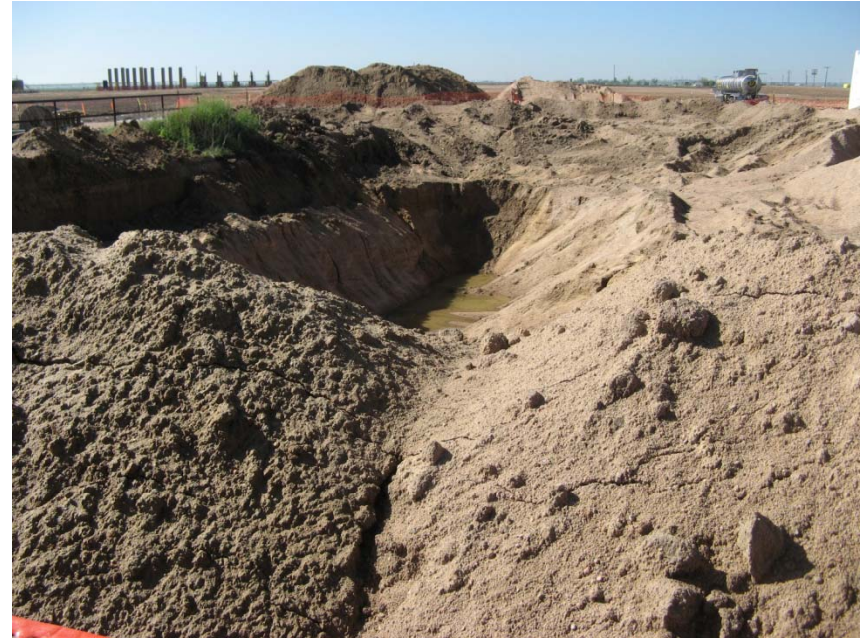
Photo 4 – View from north end of excavation at former Sitzman 1 tank battery, looking south. Excavation is approximately 80 feet east of water well permit no. 276778.

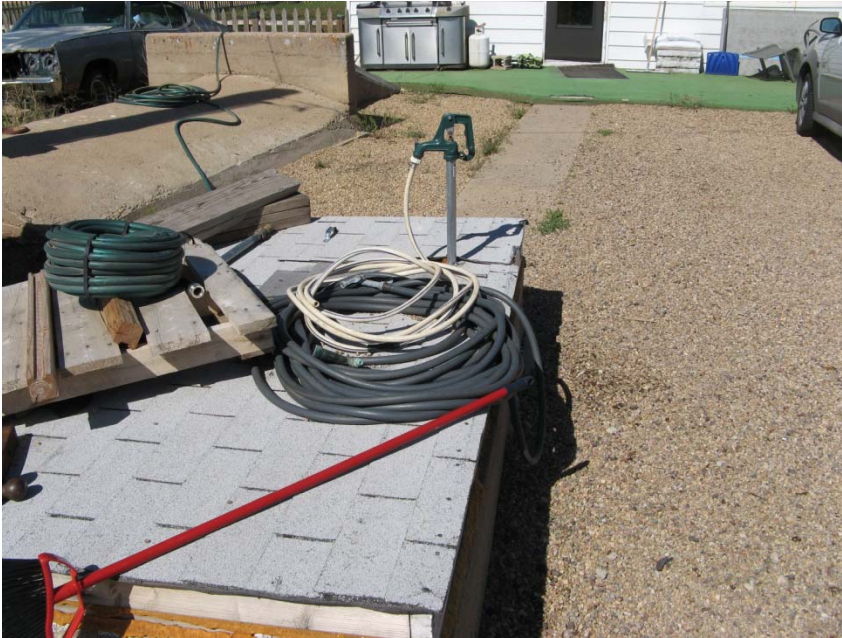
Photo 5 – View of hydrant at well vault/sump for domestic water well permit no. 202929A which supplies the residence. Water sample collected from hydrant in photo.

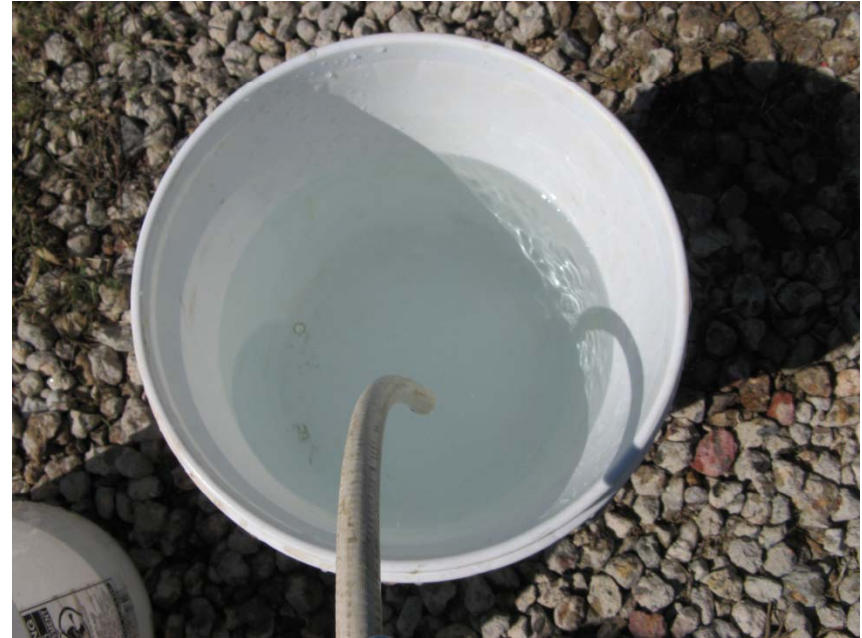
Photo 6 – Purge water from water well no. 202929A just prior to sample collection.
