Final Reclamation Inspection

Operator: MAGPIE OPERATING, INC- # 52530

API: 05-069-06159

Inspection Photos
Location Name: PROCTOR-SKAER #1-A
API: 05-069-06159

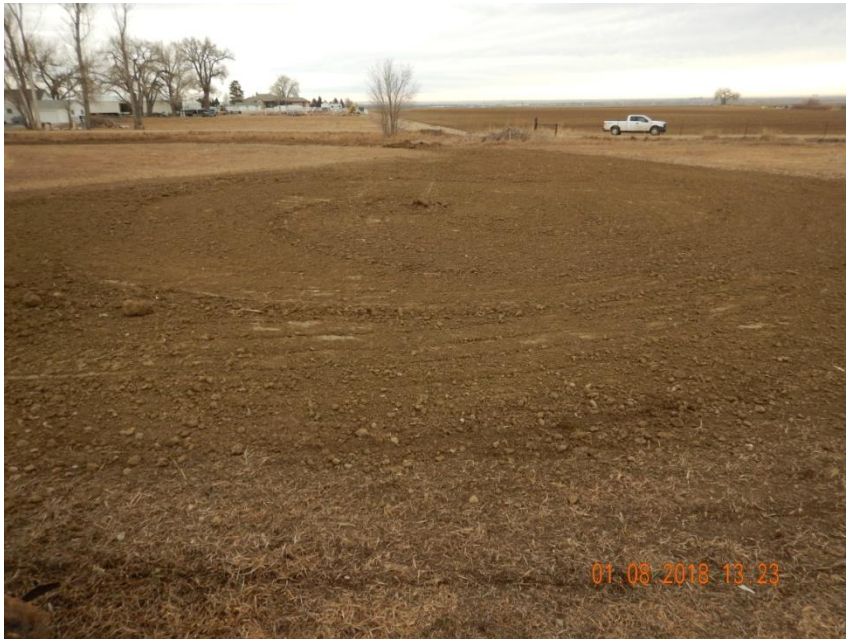
Photo 1. Photo taken on January 8, 2018 from the well location, facing North. Operator is IN-PROCESS of reclamation activities regarding the previous corrective action inspection. A follow-up inspection will occur at a future date to ensure compliance with Rule 1004 standards.

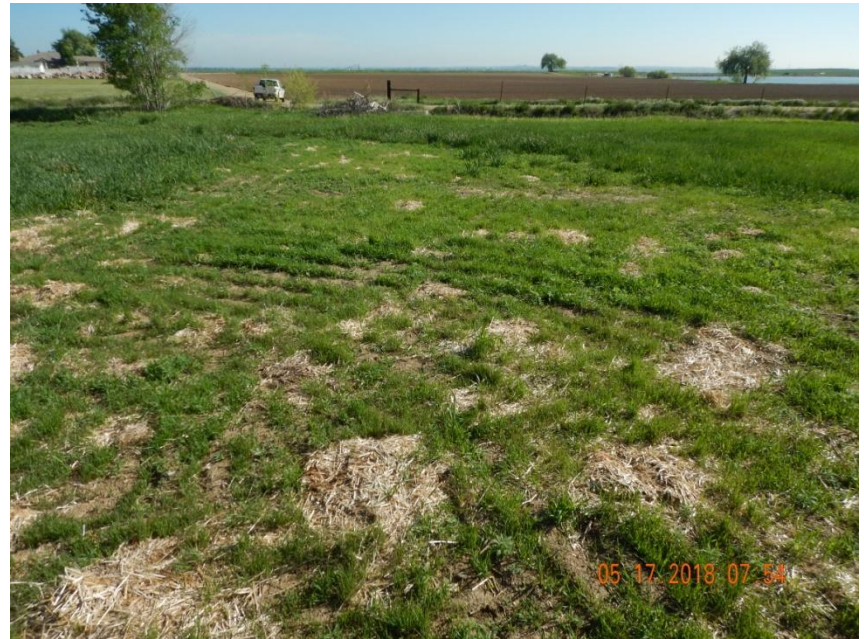
Photo 2. Photo taken on May 17, 2018 from the well location, facing North. Germination evident throughout the entire well location. A follow-up inspection will occur at a future date to ensure compliance with Rule 1004 standards.
