# Final Reclamation Inspection

Operator: EXTRACTION OIL & GAS INC - #10459

API: 05-069-06215

Inspection Photos  
Location Name: SKAER FARM #2  
API: 05-069-06215

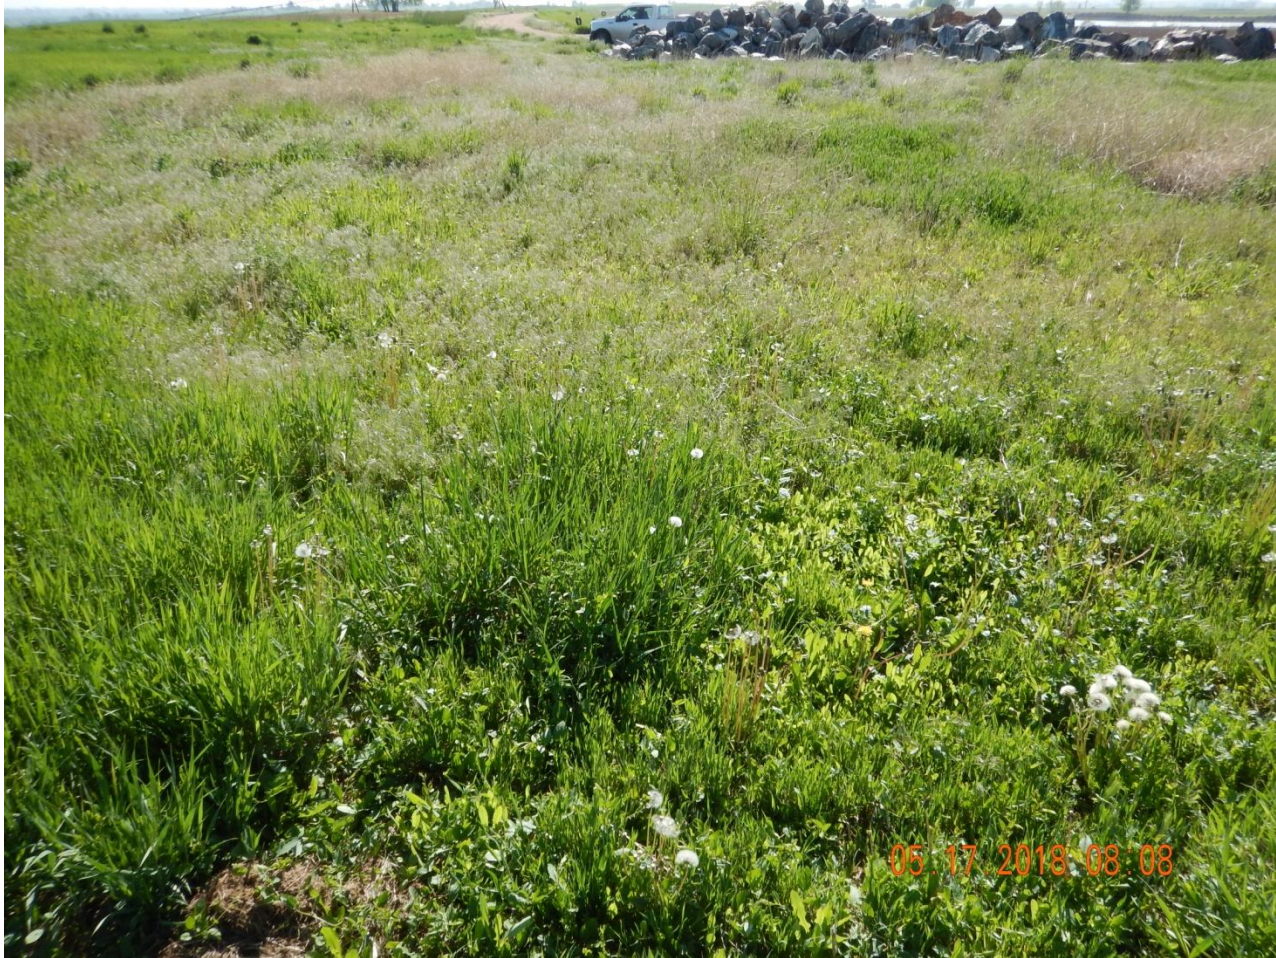
**Photo 1.** Photo taken from the approximate well location, facing East. Desirable vegetation was observed within the well location but several annual, weedy vegetation and noxious weeds were observed. At a minimum, Operator shall control noxious weeds and may need to perform additional reclamation activities.

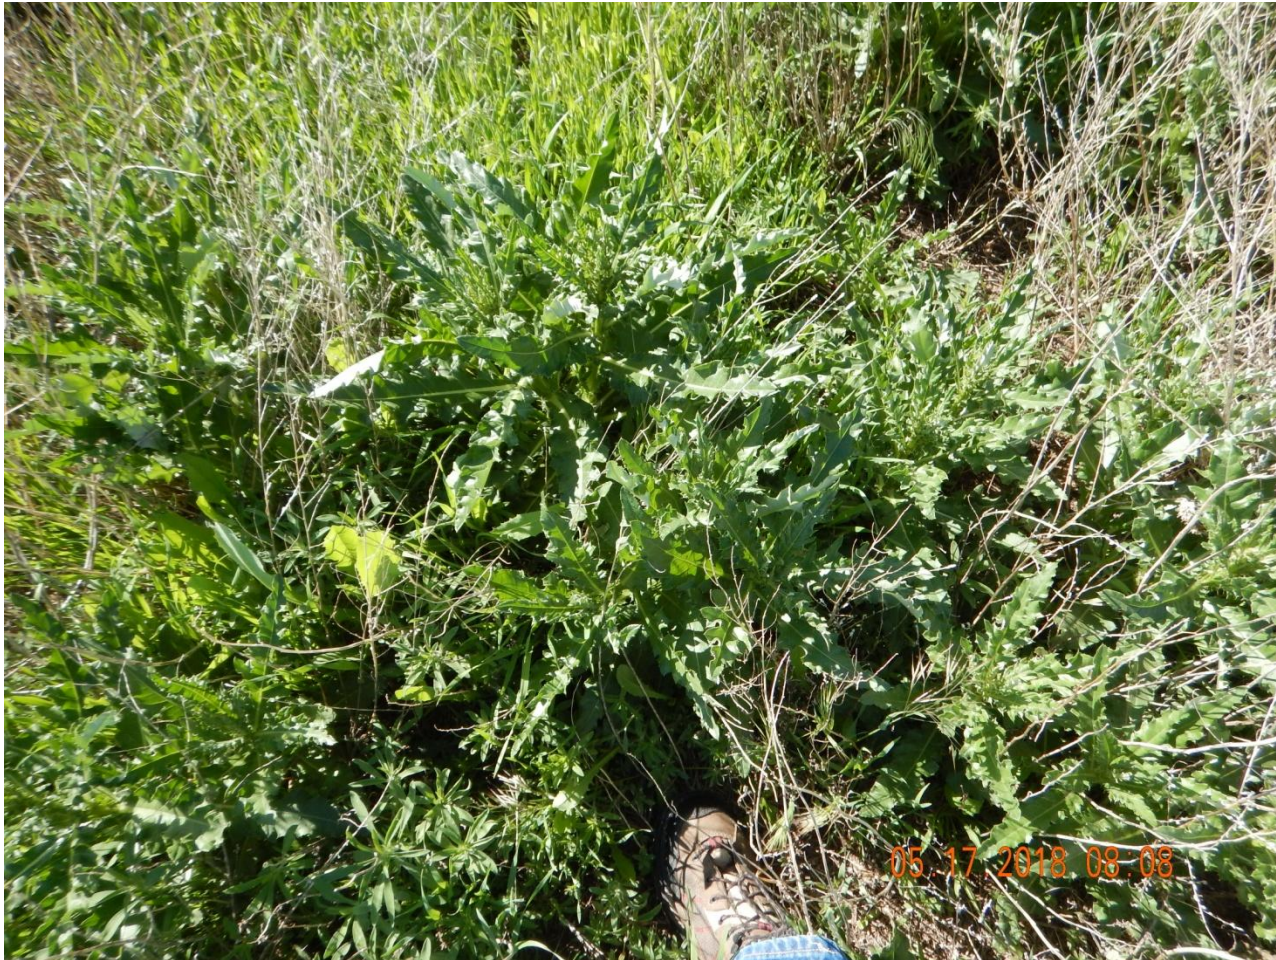
**Photo 2.** Photo taken from the well location, illustrating Canada thistle, List B CO Noxious weed. Operator shall control noxious weeds prior to seed set.

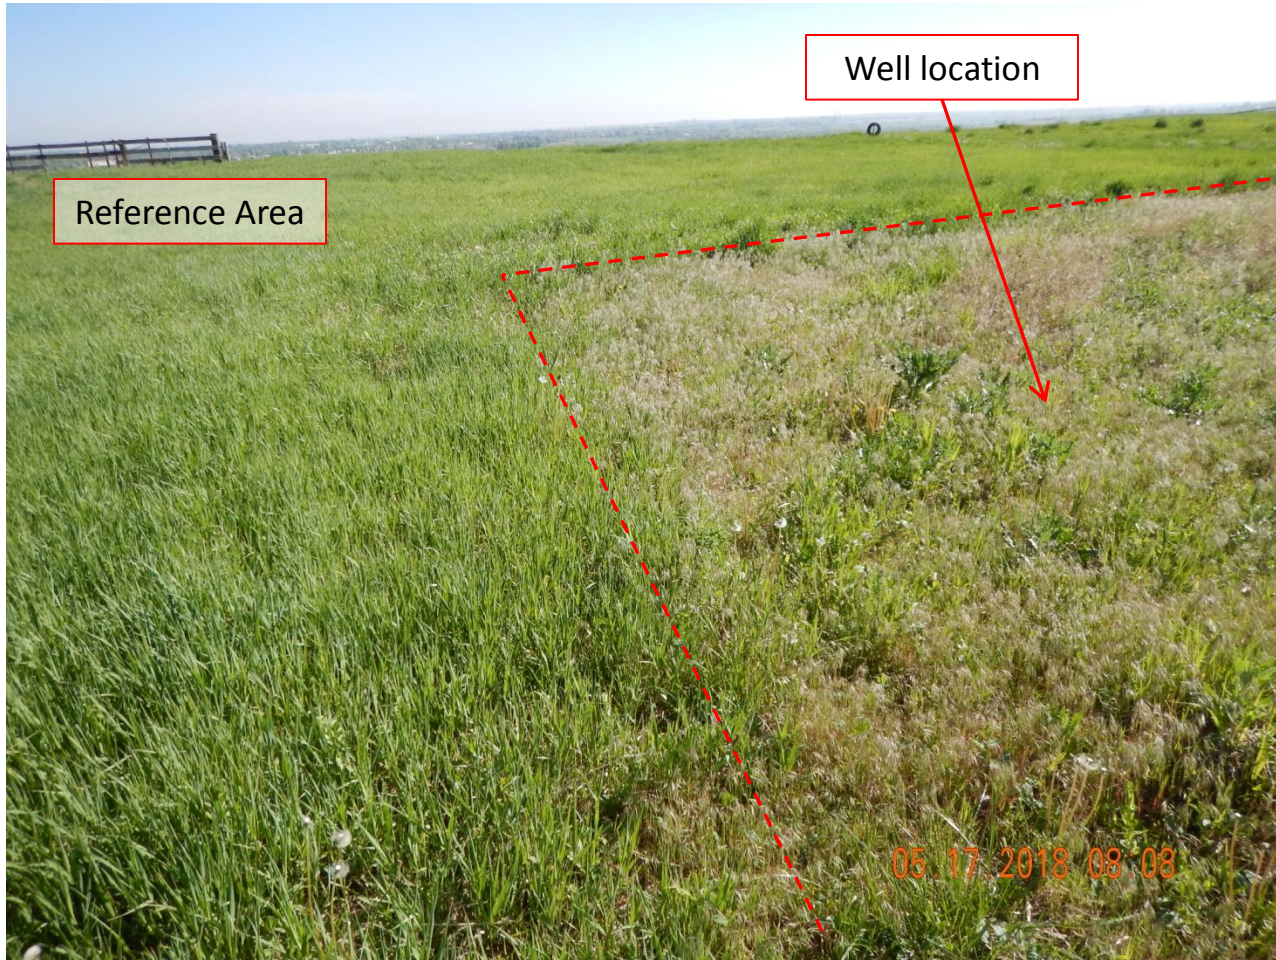
**Photo 3.** Photo taken from the western well location, facing North. Well location is not reflective of reference area vegetative conditions. At a minimum, Operator shall control noxious weeds and may need to perform additional reclamation activities.

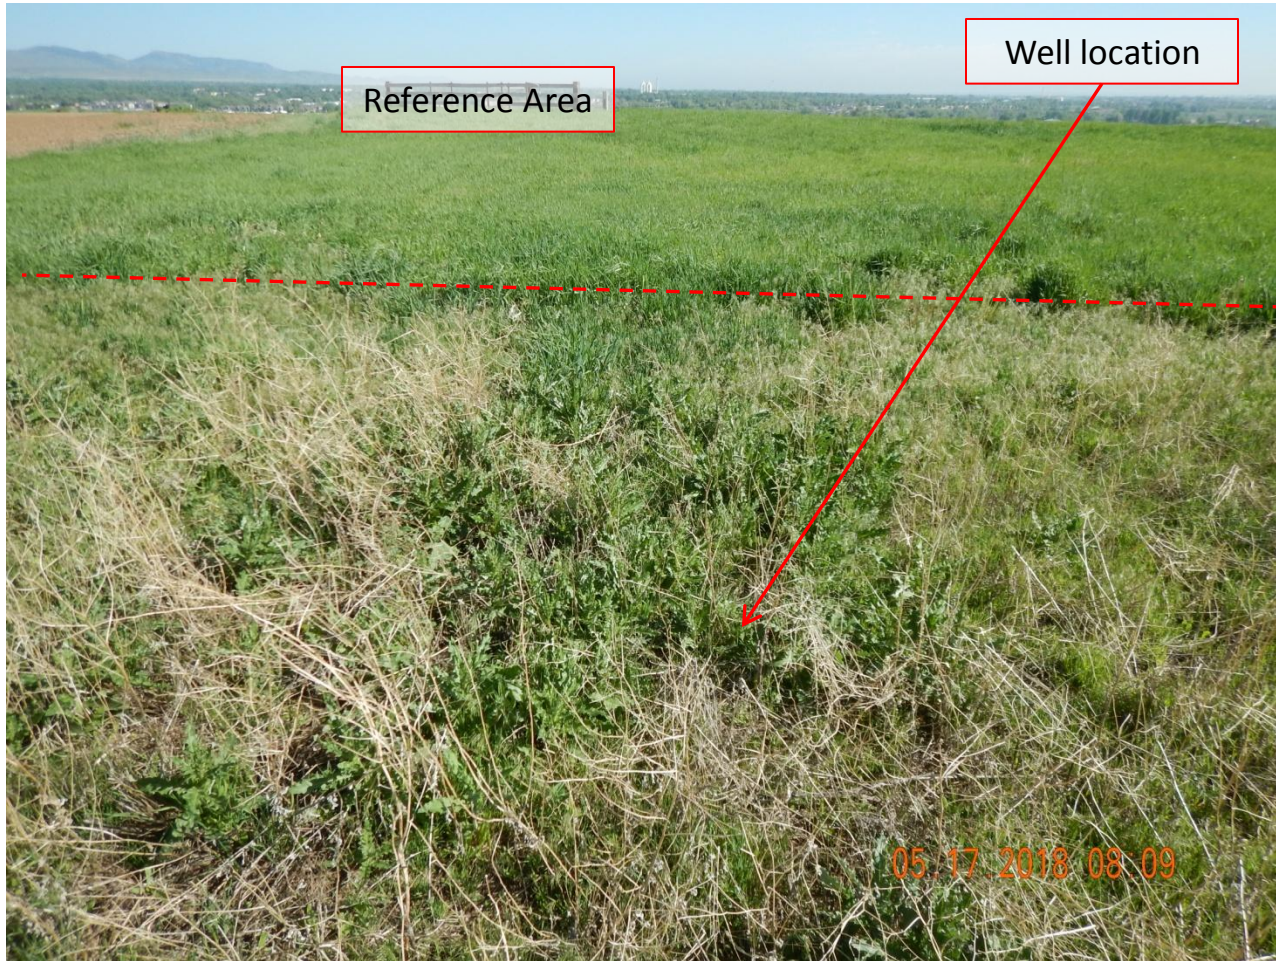
**Photo 4.** Photo taken from the northern well location, facing North. See comments under Photo 3.
