Interim Reclamation Inspection

May 21, 2018

Operator: KERR MCGEE OIL & GAS ONSHORE LP - #47120

API: 05-123-25854

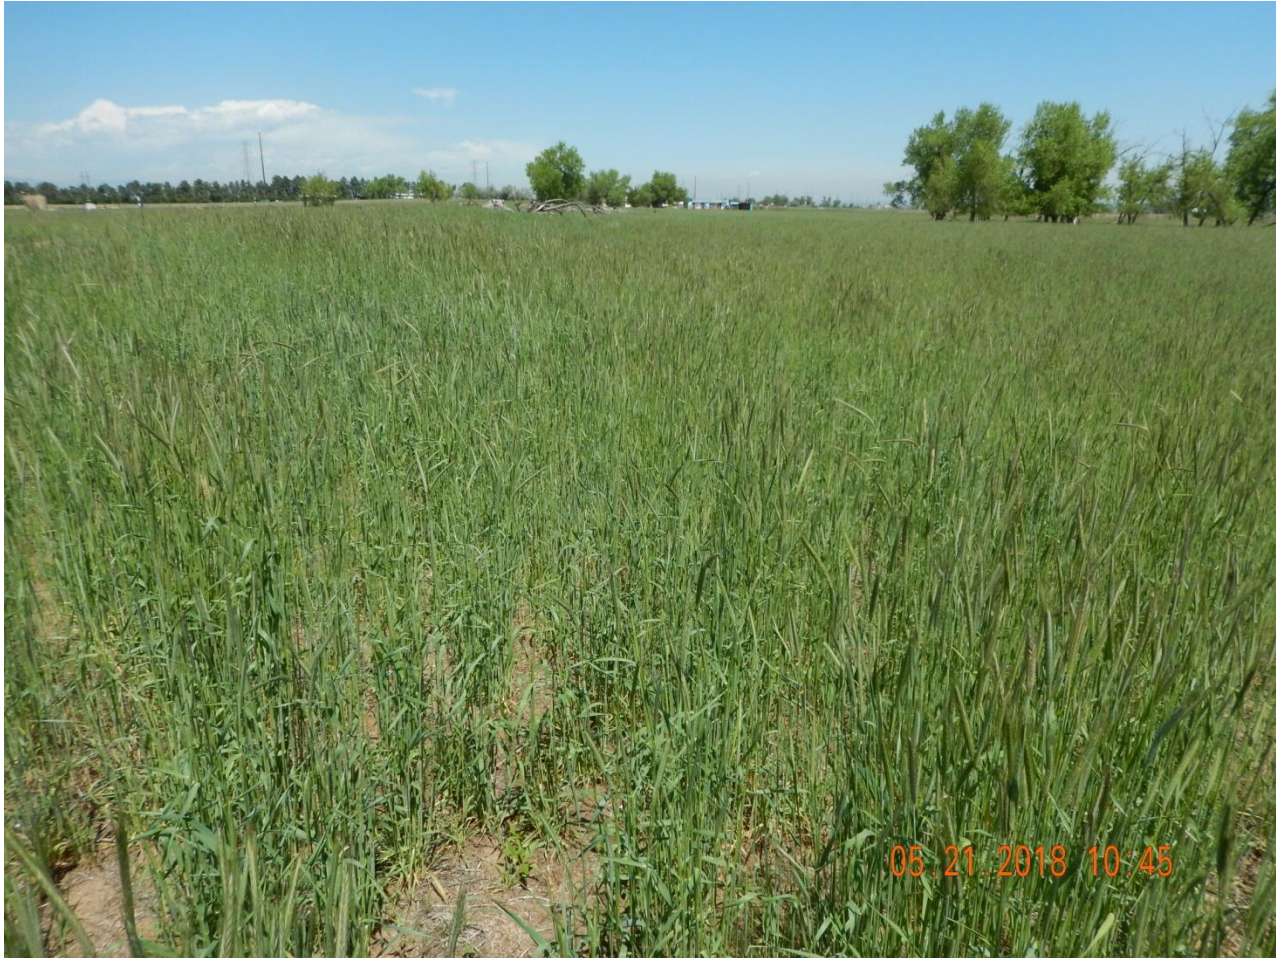
Photo 1. Photo taken from the northwestern interim area, facing North. Photo illustrates a cereal rye (*Secale cereale*) grass species that has established throughout the interim areas. Smooth brome is the desired grass species but little establishment was observed.

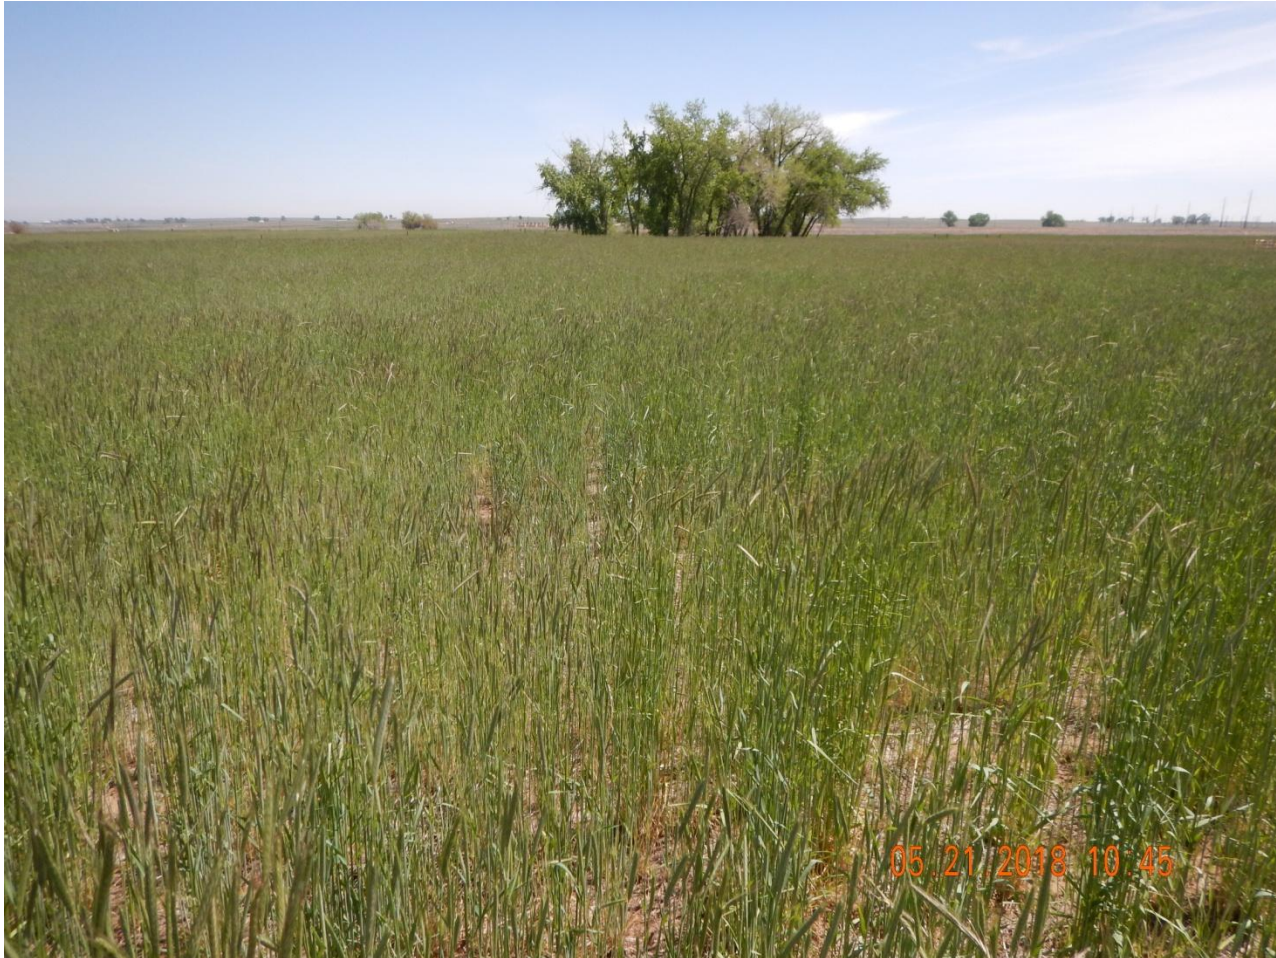
Photo 2. Photo taken from the northwestern interim area, facing East. See comments under Photo 1.

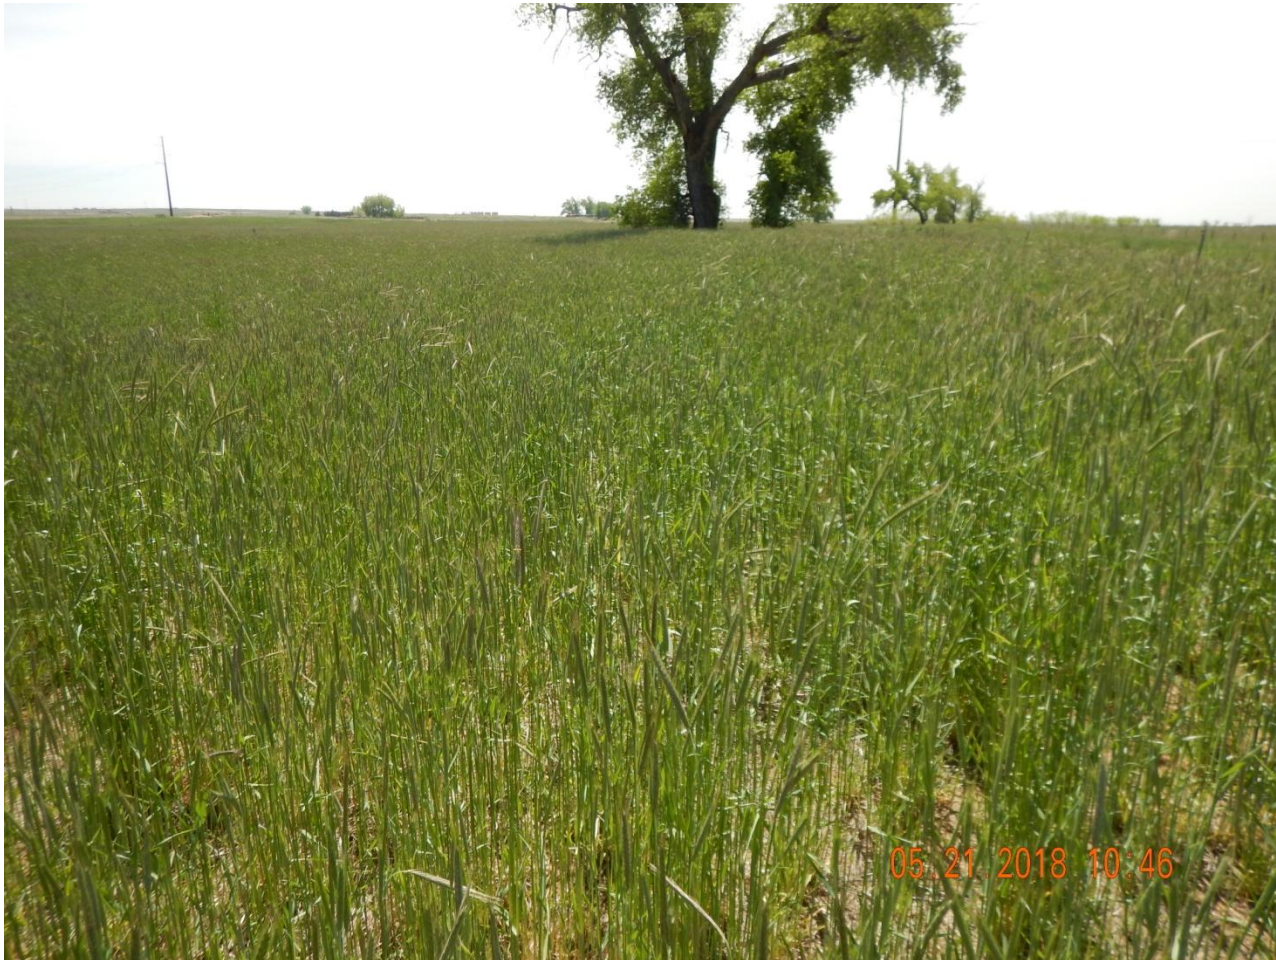
Photo 3. Photo taken from the northwestern interim area, facing South. See comments under Photo 1.

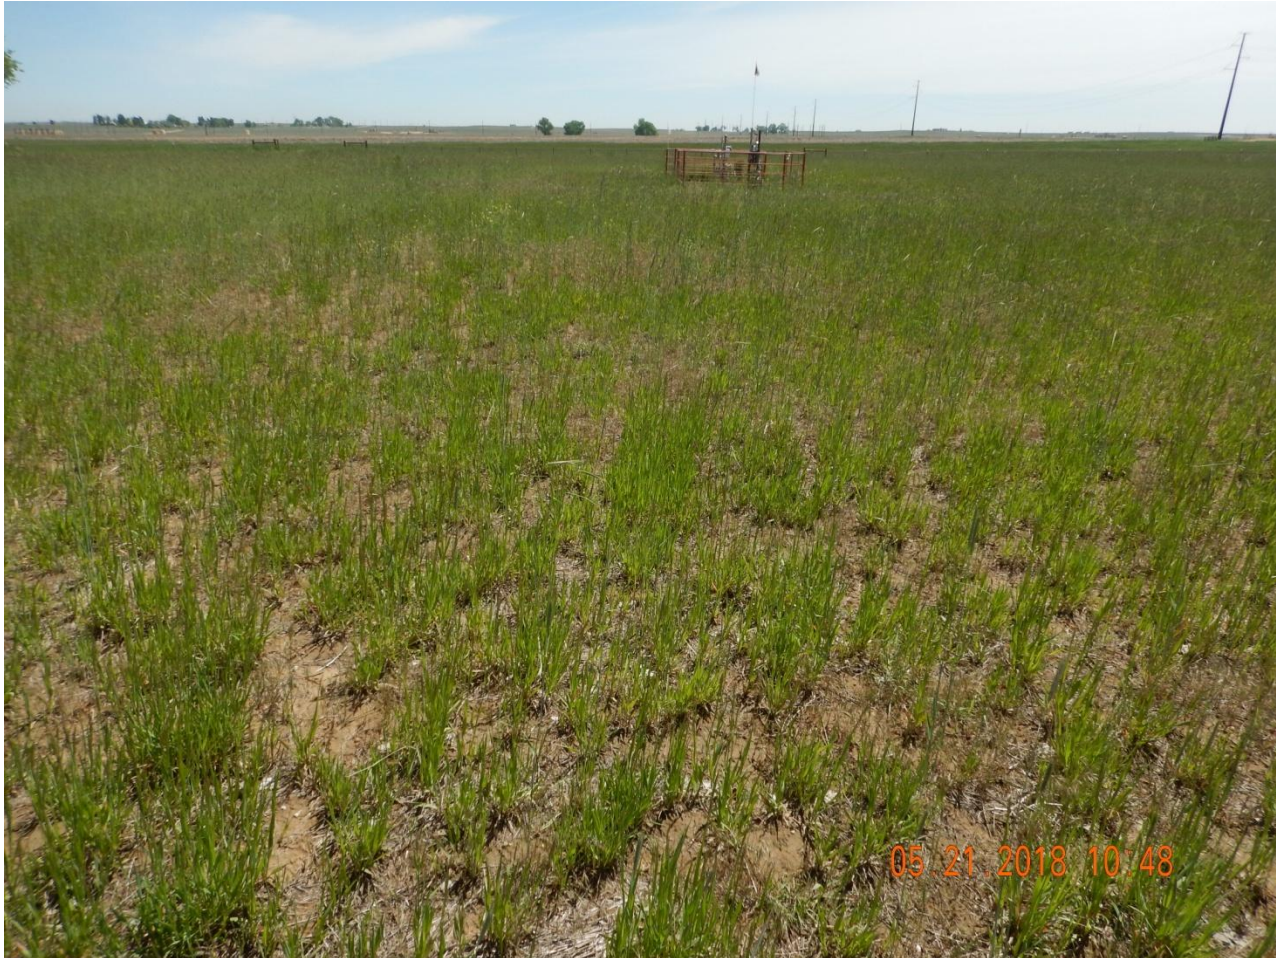
Photo 4. Photo taken west of the wells, facing East. Photo illustrates smooth brome establishment which is the desired vegetation. This is a portion of the land that was excavated from a release and topsoil was later brought in.

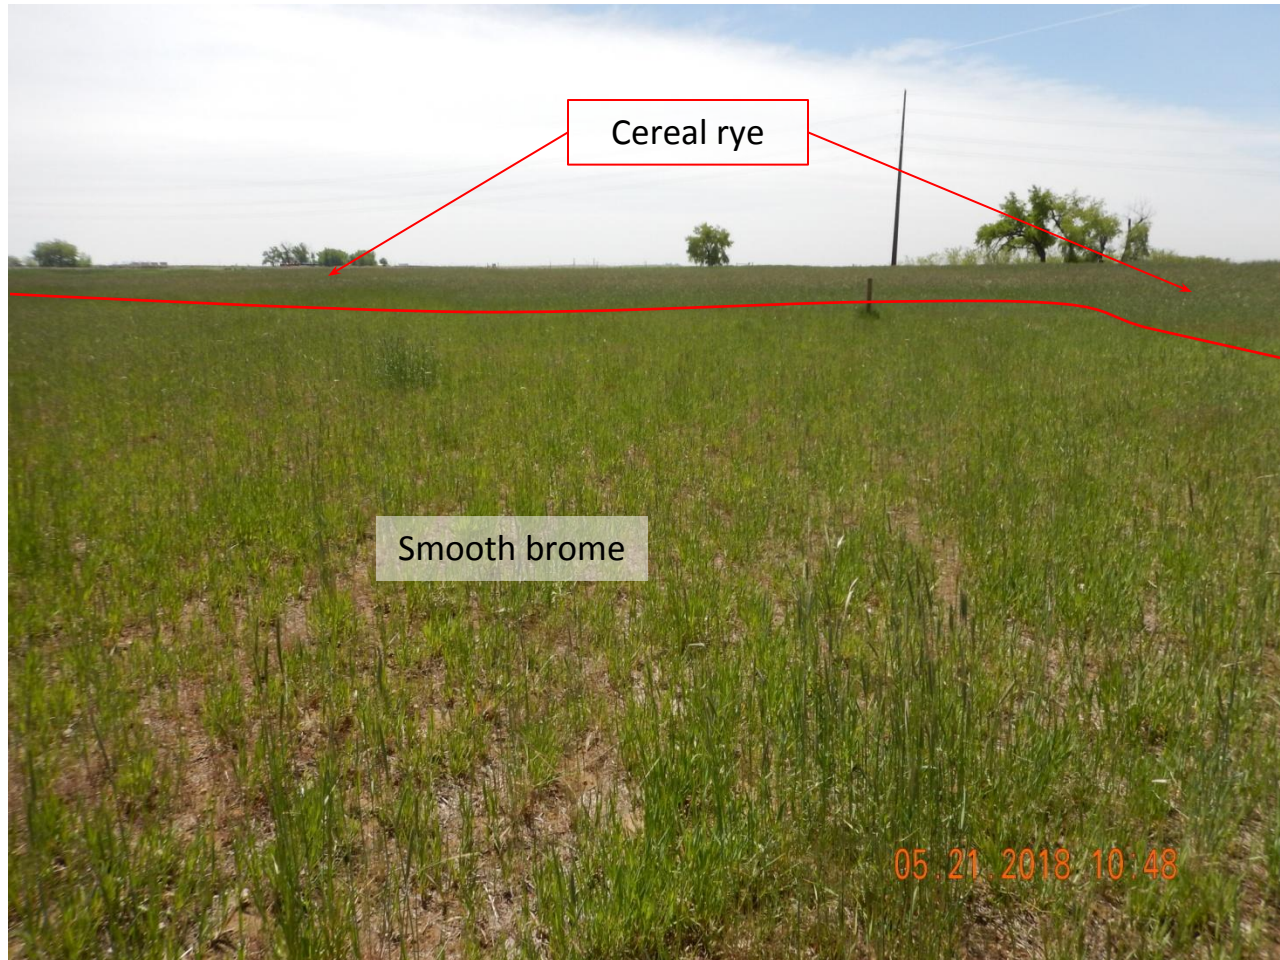
Photo 5. Photo taken west of the wells, facing South. Photo illustrates smooth brome establishment within the areas of excavation which is the desired vegetation with cereal rye in the background.

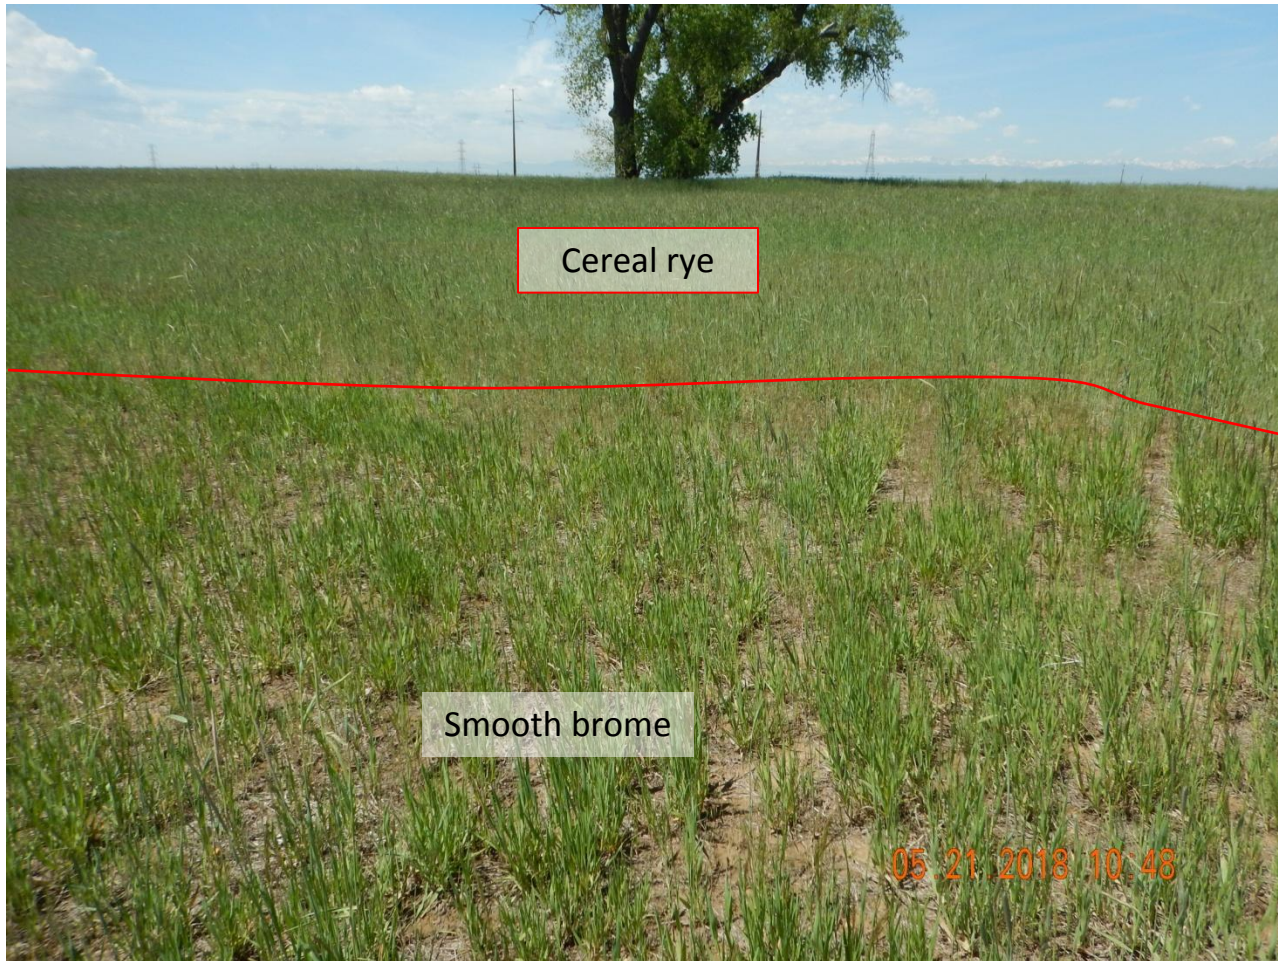
Photo 6. Photo taken west of the wells, facing West. See comments under Photo 5.

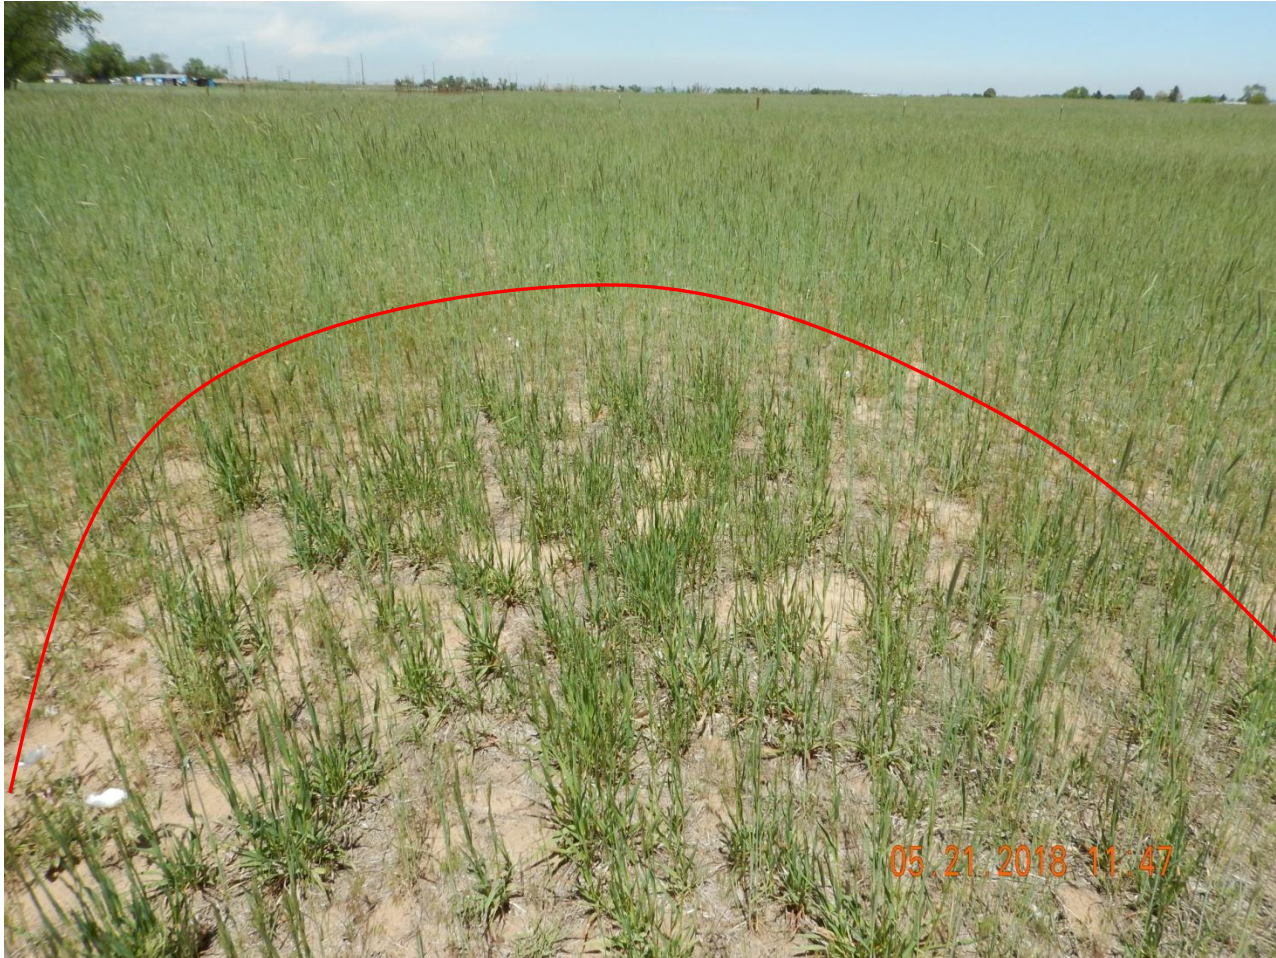
Photo 7. Photo taken north of the wells, facing North. In the foreground of the photo, it illustrates a patch of smooth brome establishment within the cereal rye.
