# Interim Reclamation Inspection

Operator: KERR MCGEE OIL & GAS ONSHORE LP #47120

Location ID: 327882

Inspection Photos  
Location Name: HSR-CONLEY #11-36A  
Location ID: 327882

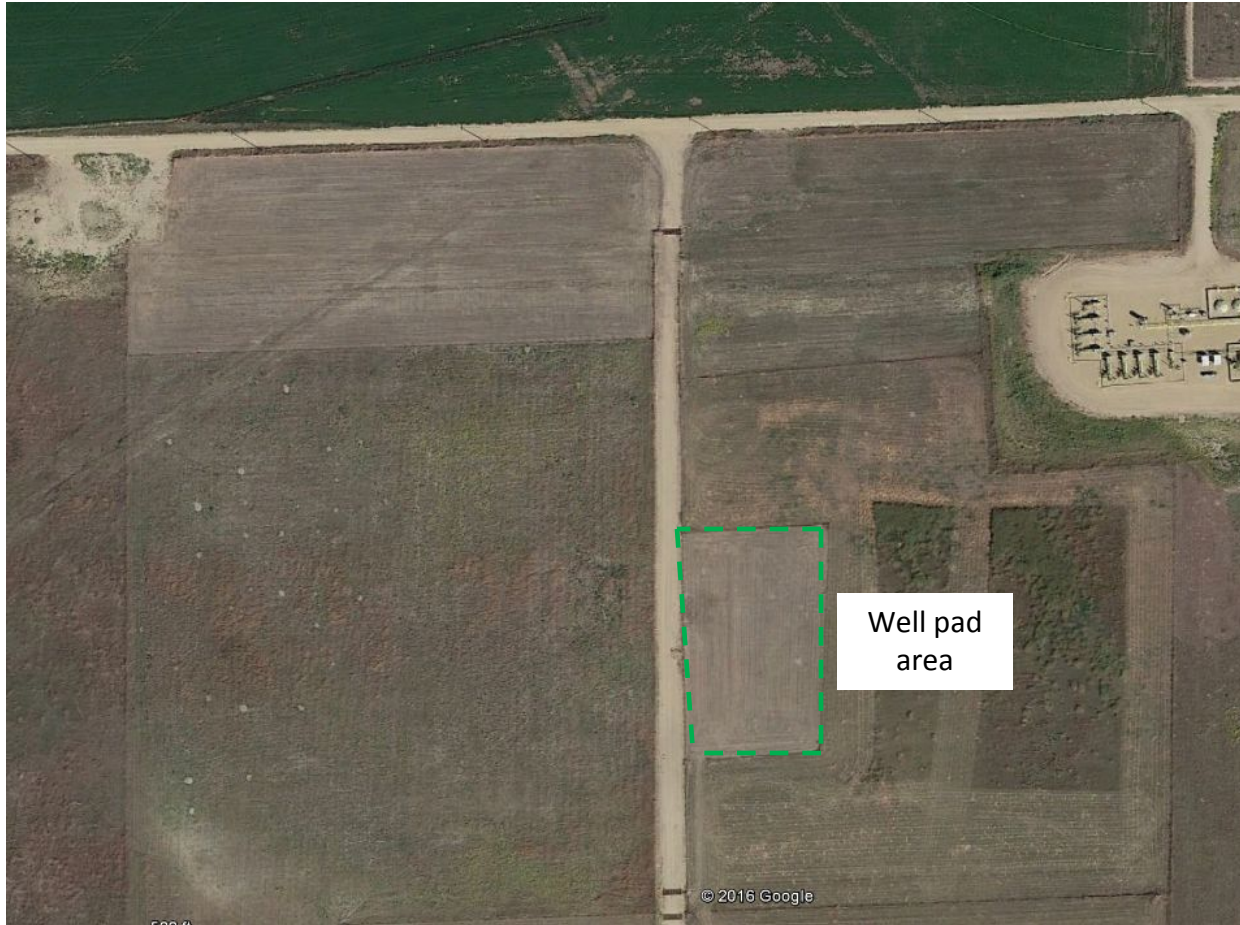
Google Earth aerial imagery taken September 7, 2016 illustrating the subject well pad for this follow-up interim reclamation inspection (outlined in the green dashed line).

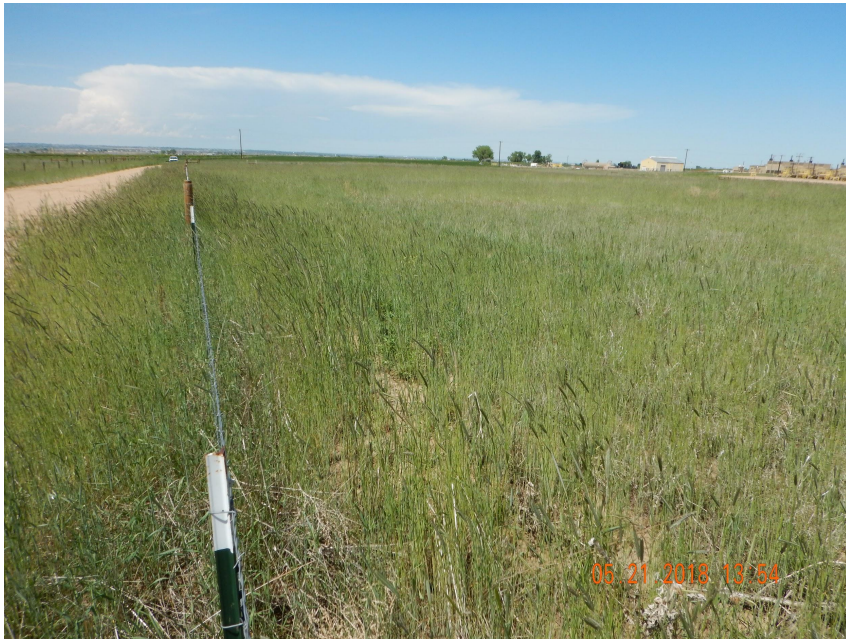
**Photo 1.** Photo taken from the western interim area, facing North. Desirable plant species establishment is evident throughout this area and will remain in-process until it meet Rule 1003 standards. Operator mentioned weed management practices are planned and scheduled.

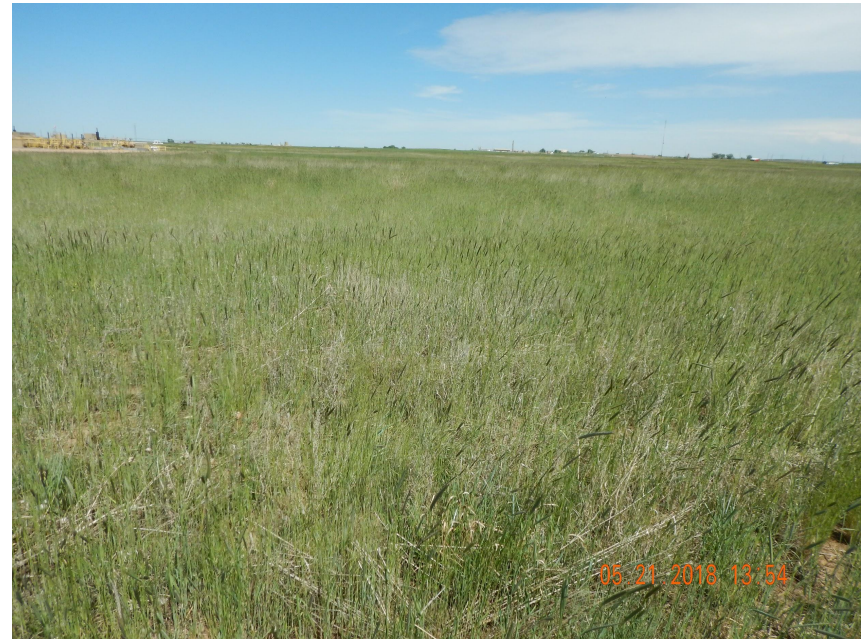
**Photo 2.** Photo taken from the western interim area, facing East. See comments under Photo 1.

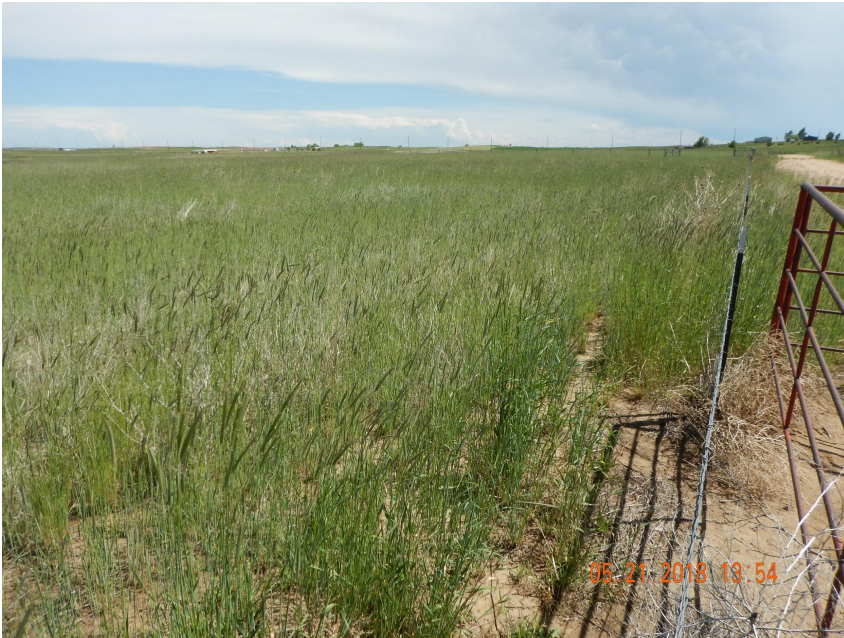
**Photo 3.** Photo taken from the western interim area, facing South. See comments under Photo 1.
