# Inspection Photos

Operator: CM PRODUCTION LLC - 10352

Location ID: 317369

Inspection Doc. Number: 682503377

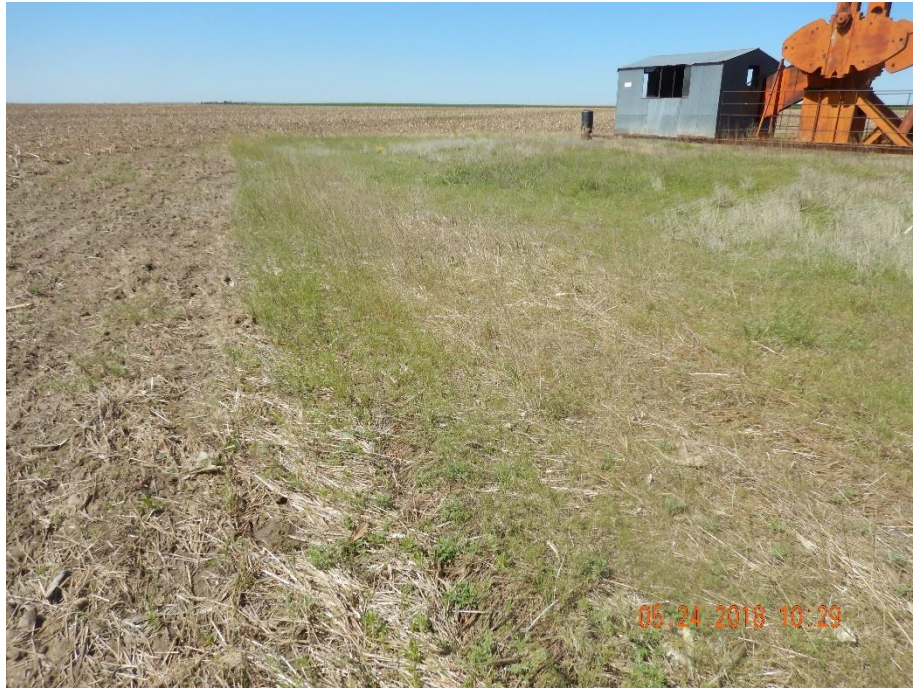
**Photo 1:** Photo taken east end of the tank battery facility, facing southwest. Photos 1-4 show an overview of the location, facing southwest, to west, to north. Vegetation seen on location predominantly sand dropseed, native forbs and cheatgrass.

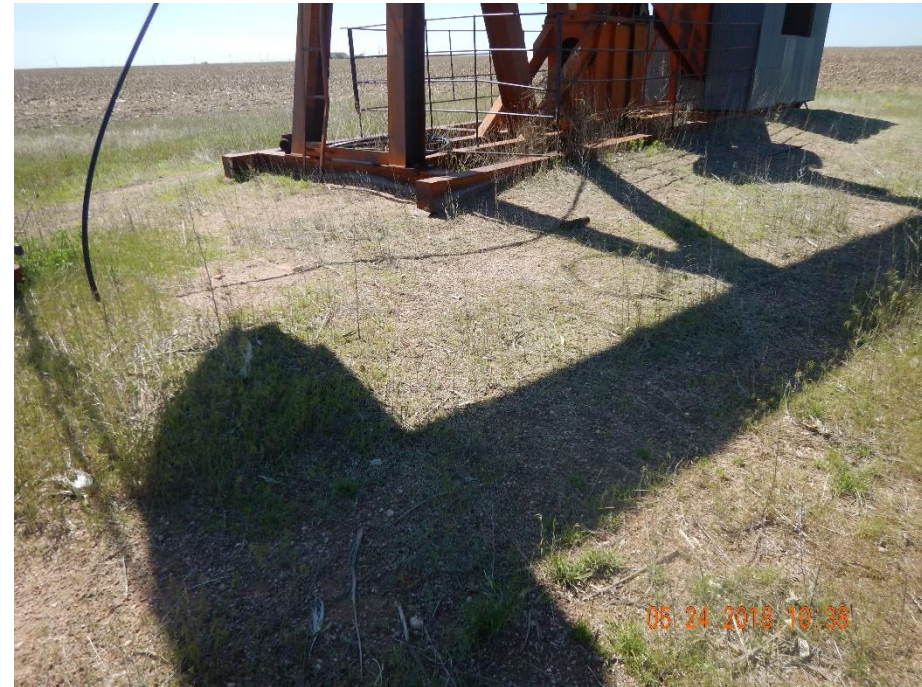
**Photo 4:** Photo taken from the northwest end of the well. Photo shows undesirable weedy plant establishment around areas of the well location

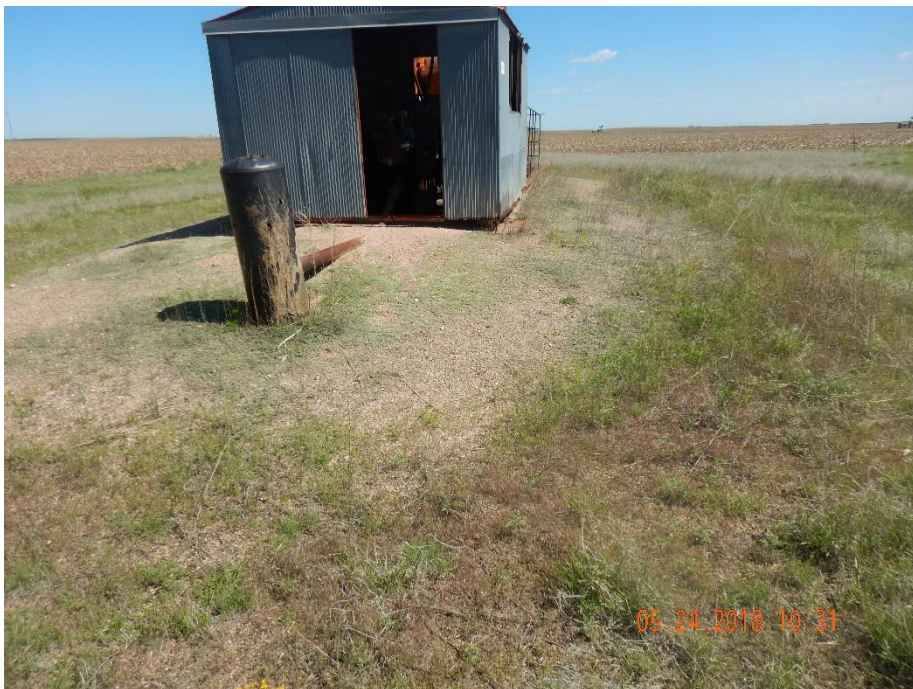
**Photo 5:** Photo taken from the south end of the well, facing north. Photo shows undesirable weedy plant establishment around areas of the well location

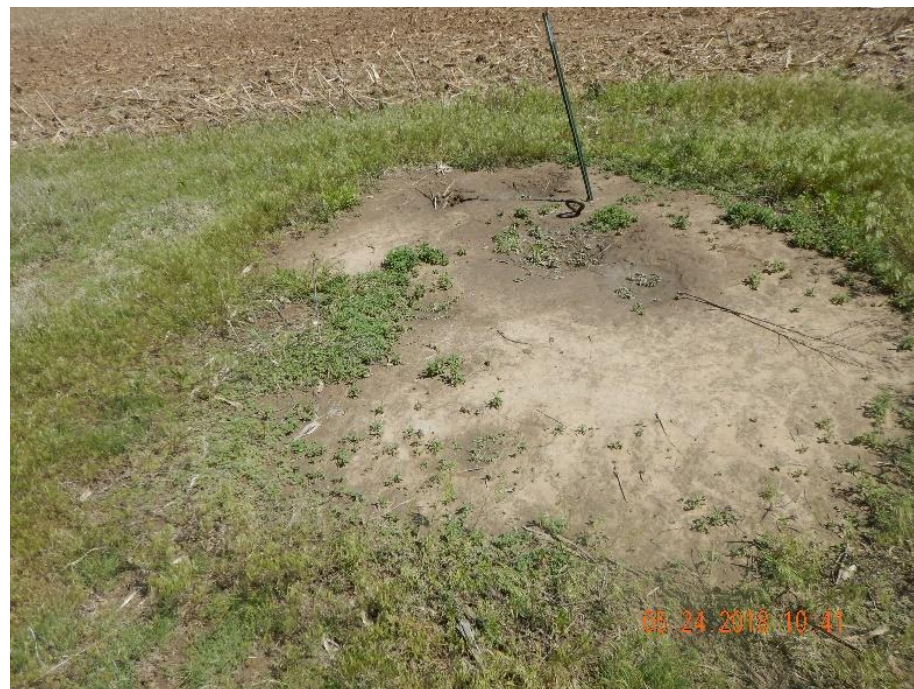
**Photo 6:** Photo taken from the northwest anchor of the location. Small patches of kochia germination and establishment can be observed at the anchors.

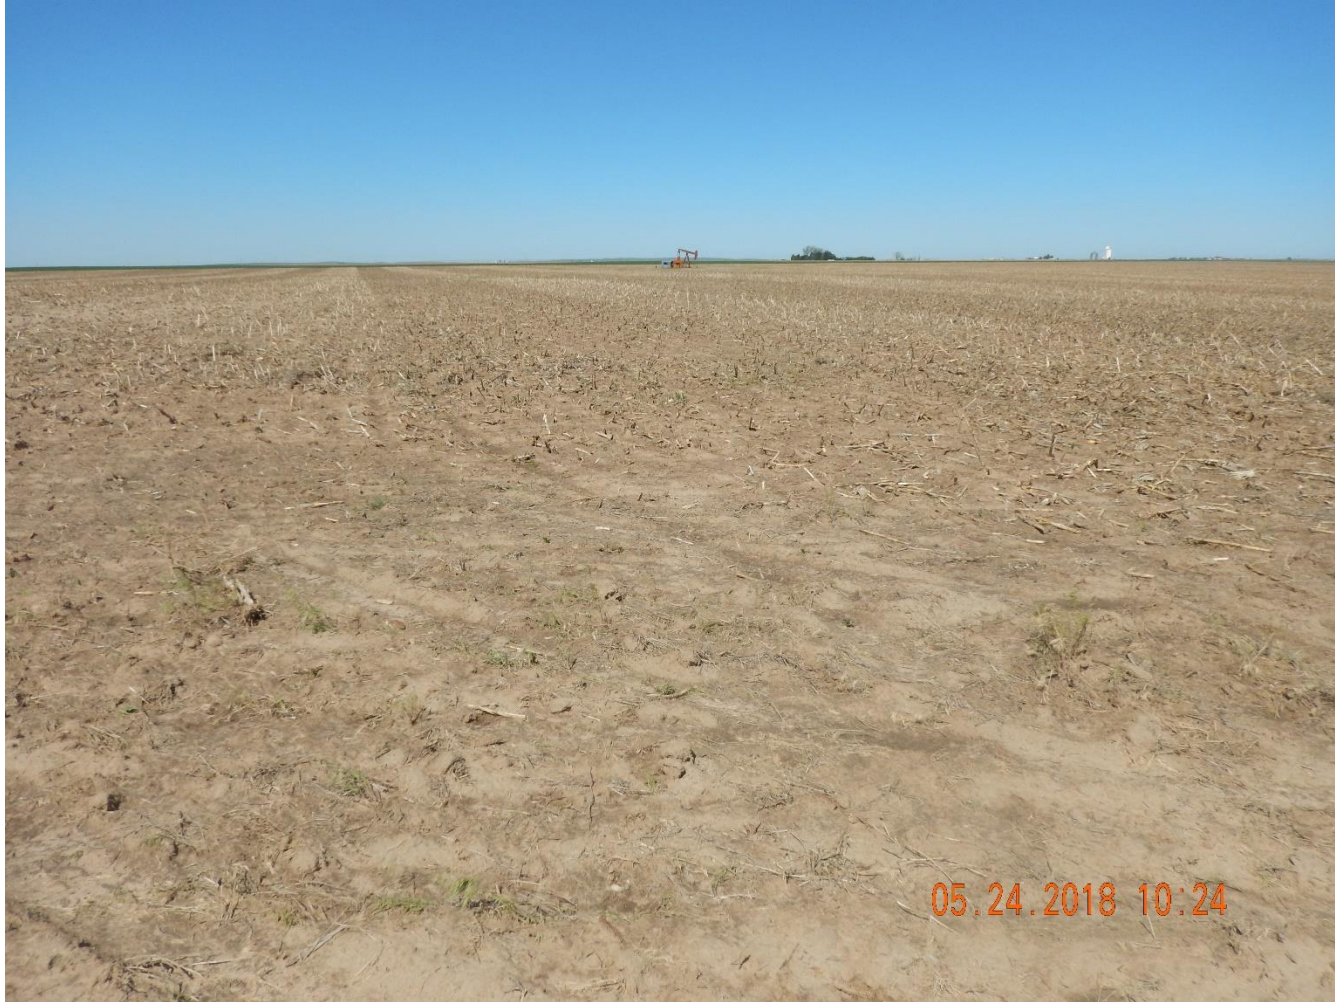
**Photo 7:** Photo taken from the Cannon 1-24 well, ~ ¼ mile east of the Cannon 33-24 (well in this inspection). Photo shows access road leading to the well has been plowed over.

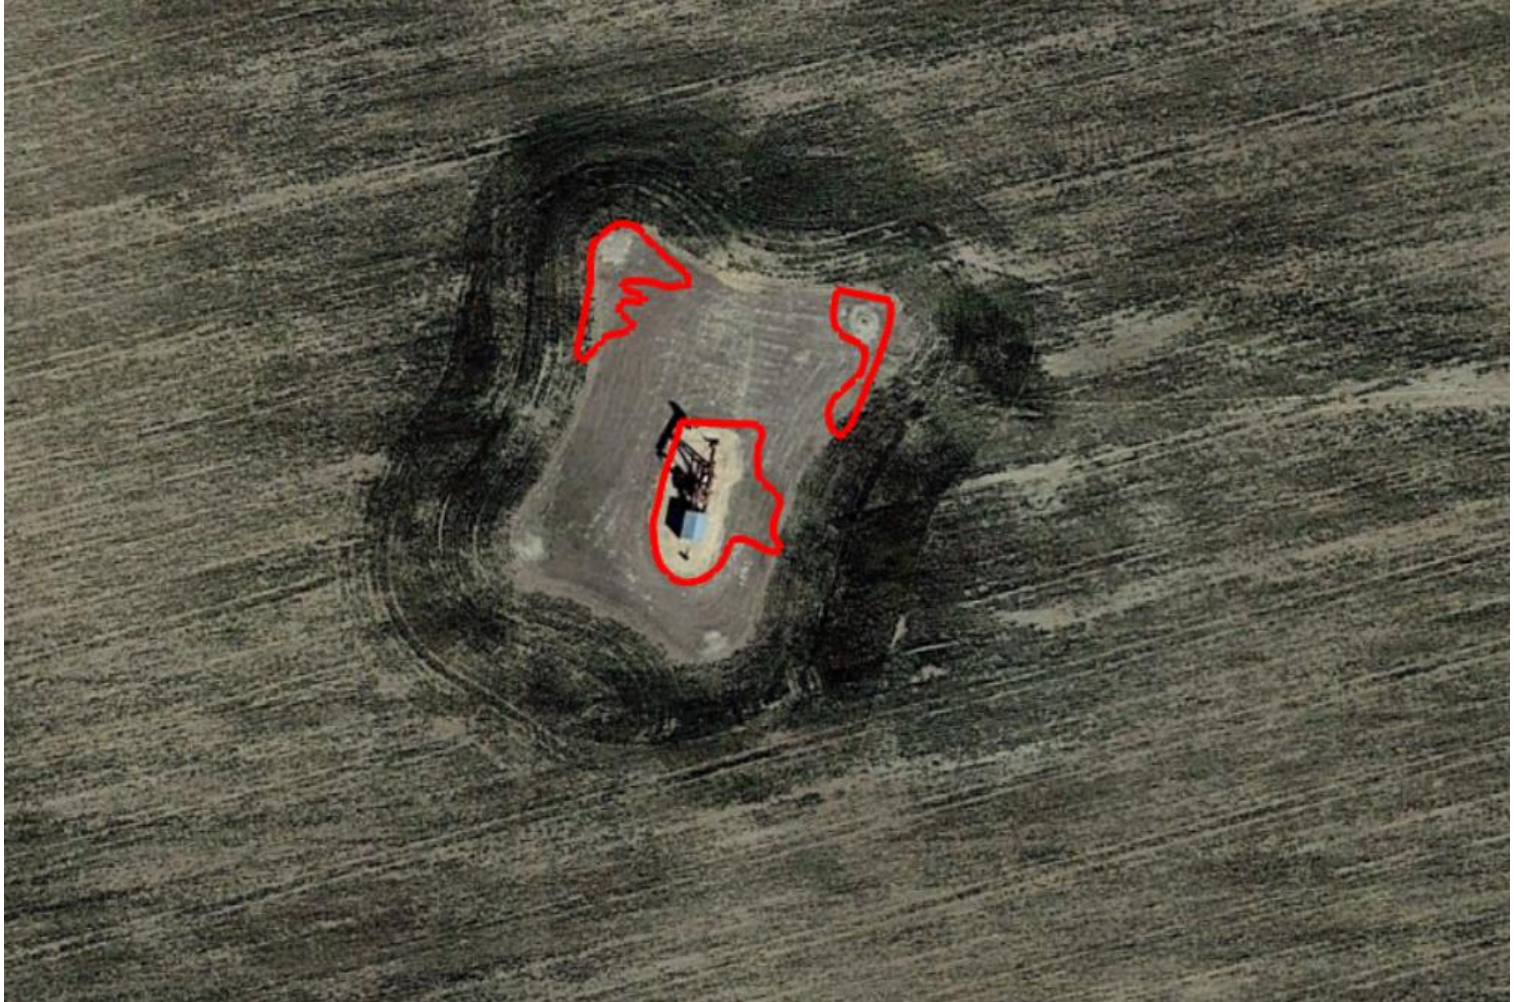
**Photo 8:** Aerial imagery showing areas where undesirable weedy plant species, such as kochia, were observed in higher densities. Areas are 0.15 acres in size, conservatively.
