Inspection Photos

Operator: CM PRODUCTION LLC - 10352

Location ID: 317255

Inspection Doc. Number: 682503381

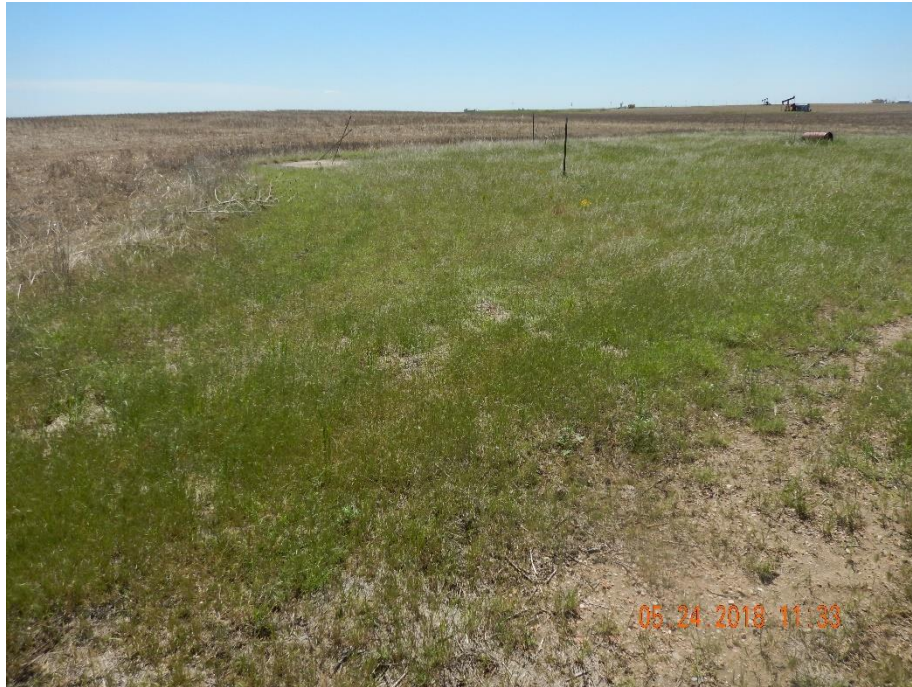
Photo 1: Photo taken from the north end of the location, facing southeast. Photos 1-3 show an overview of the location, facing southeast, to south, to north. Vegetation seen on location predominantly sand dropseed, smooth brome native forbs and cheatgrass.

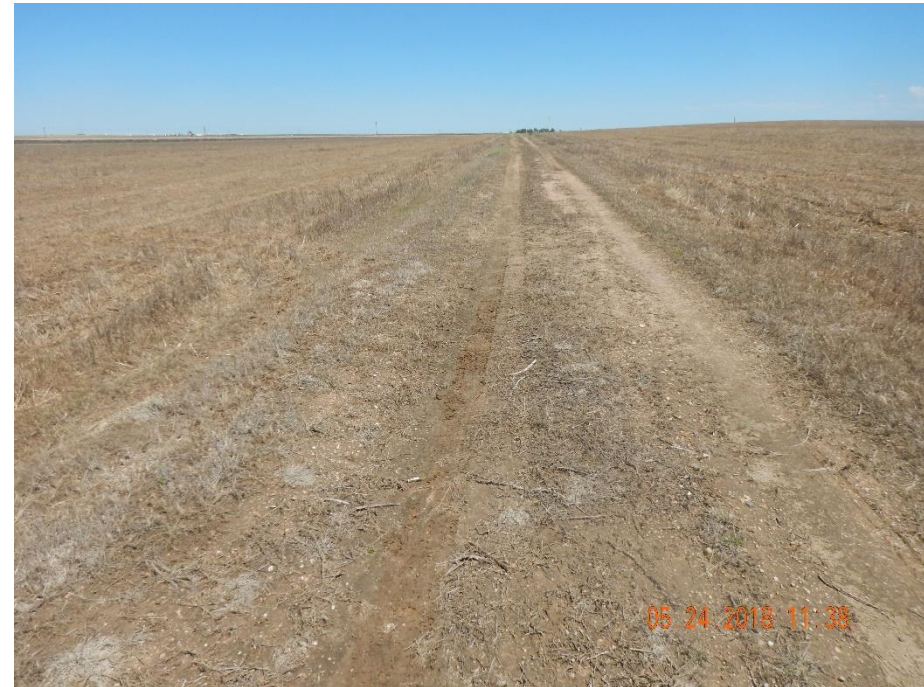
Photo 4: Photo taken from the north end of the location, facing north. Photo shows access road appears to be in good condition.

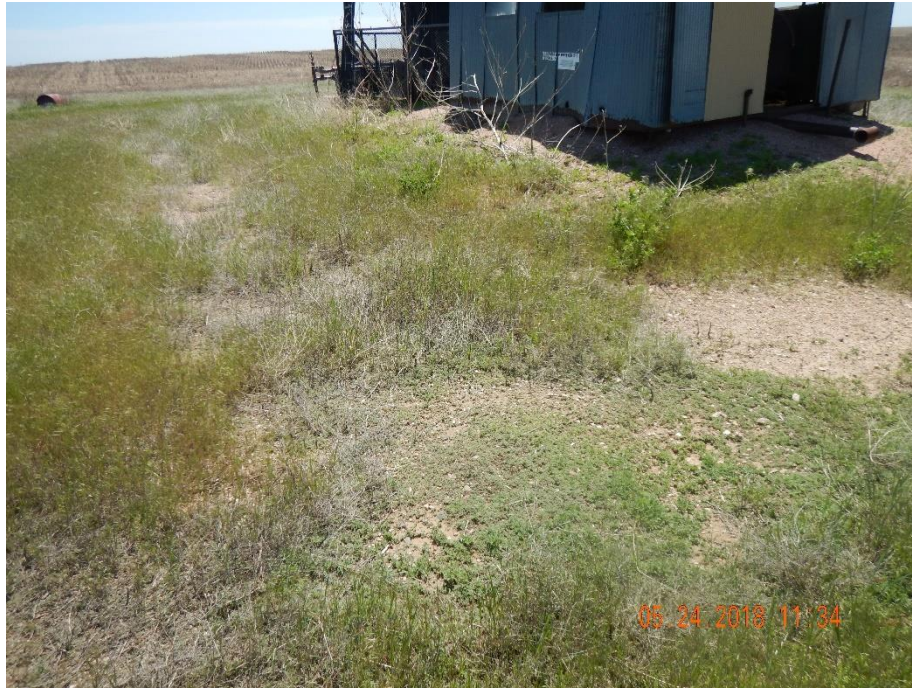
Photo 5: Photo taken from the west end of the well, facing east. Photo shows undesirable weedy plant establishment around areas of the well location

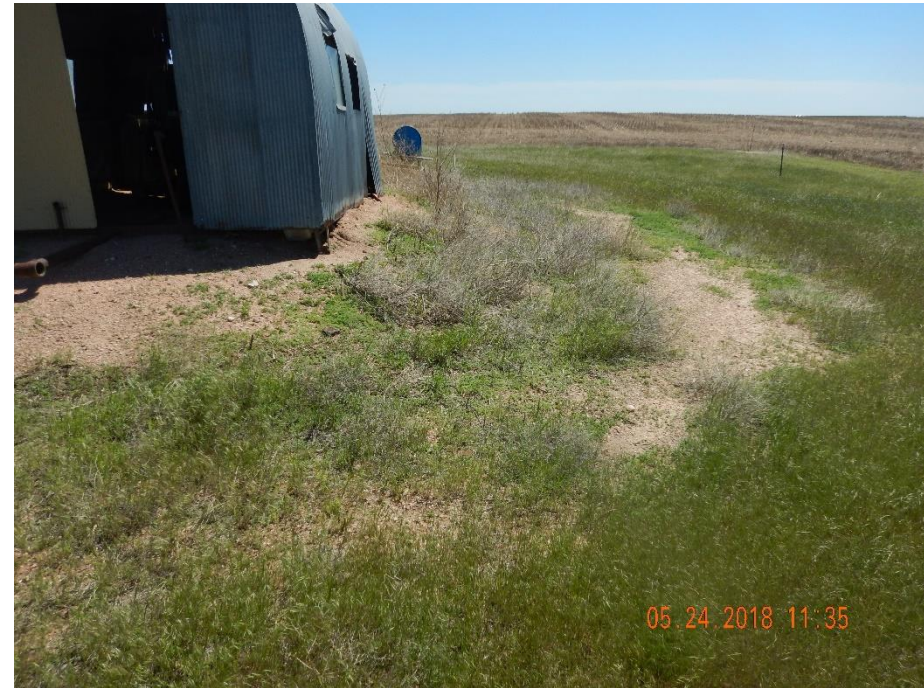
Photo 6: Photo taken from the southwest end of the well, facing east. Photo shows undesirable weedy plant establishment around areas of the well location

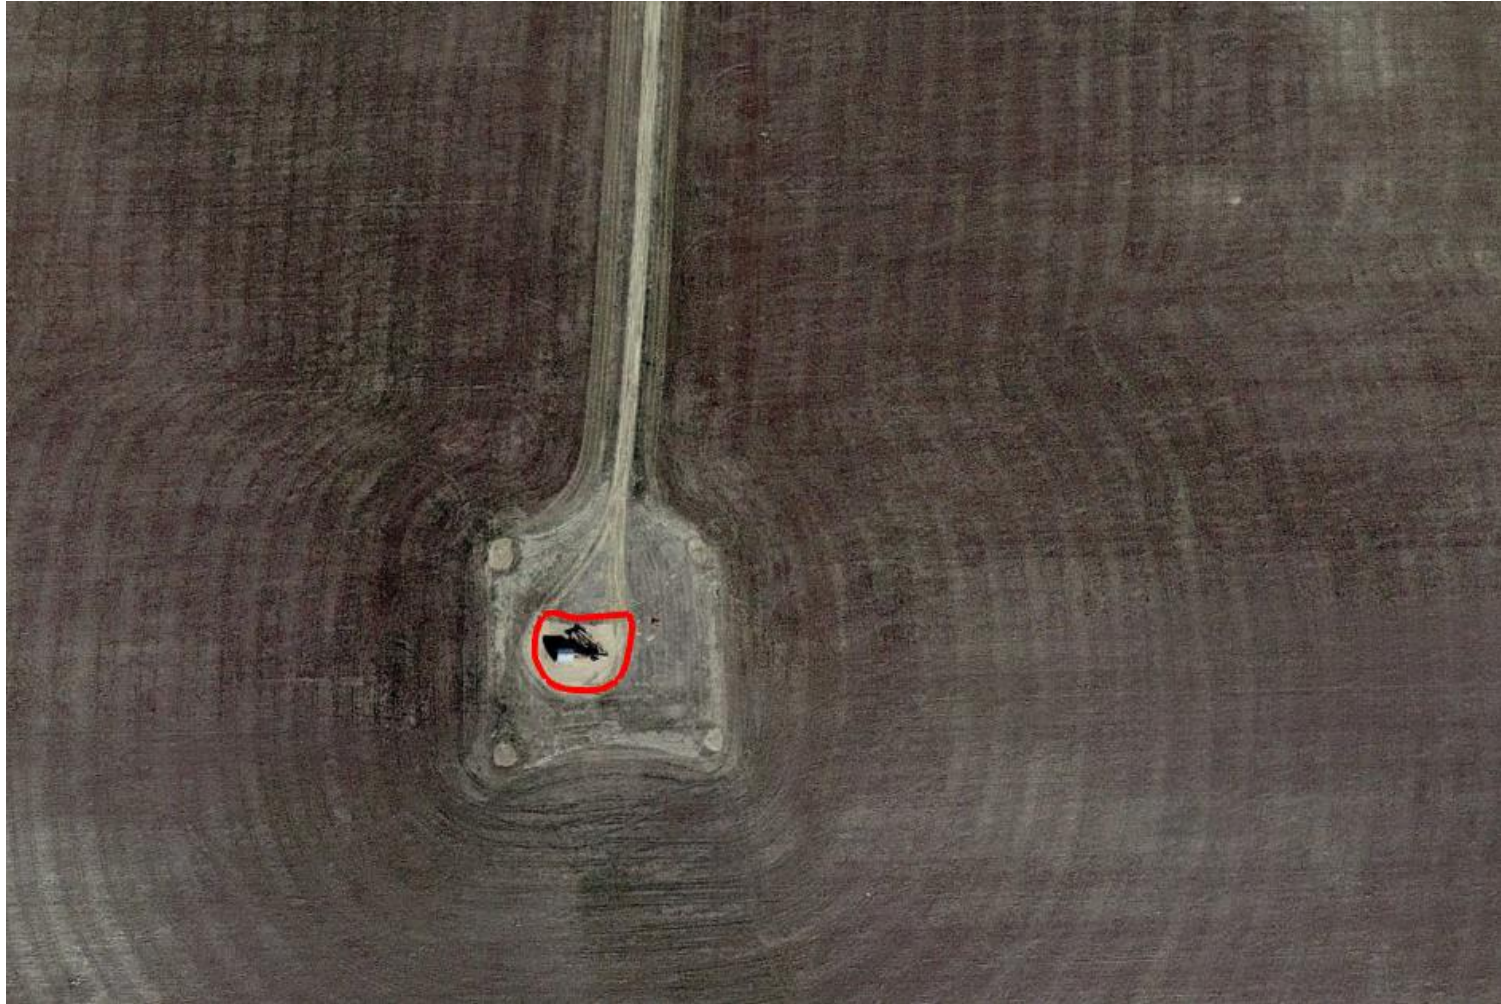
Photo 7: Aerial imagery showing areas where undesirable weedy plant species, such as kochia, were observed in higher densities. Areas are 0.1 acres in size, conservatively.
