Inspection Photos

Variance Request for Multiple Pit Locations

Operator: Kinder Morgan CO2 Co.

YE7

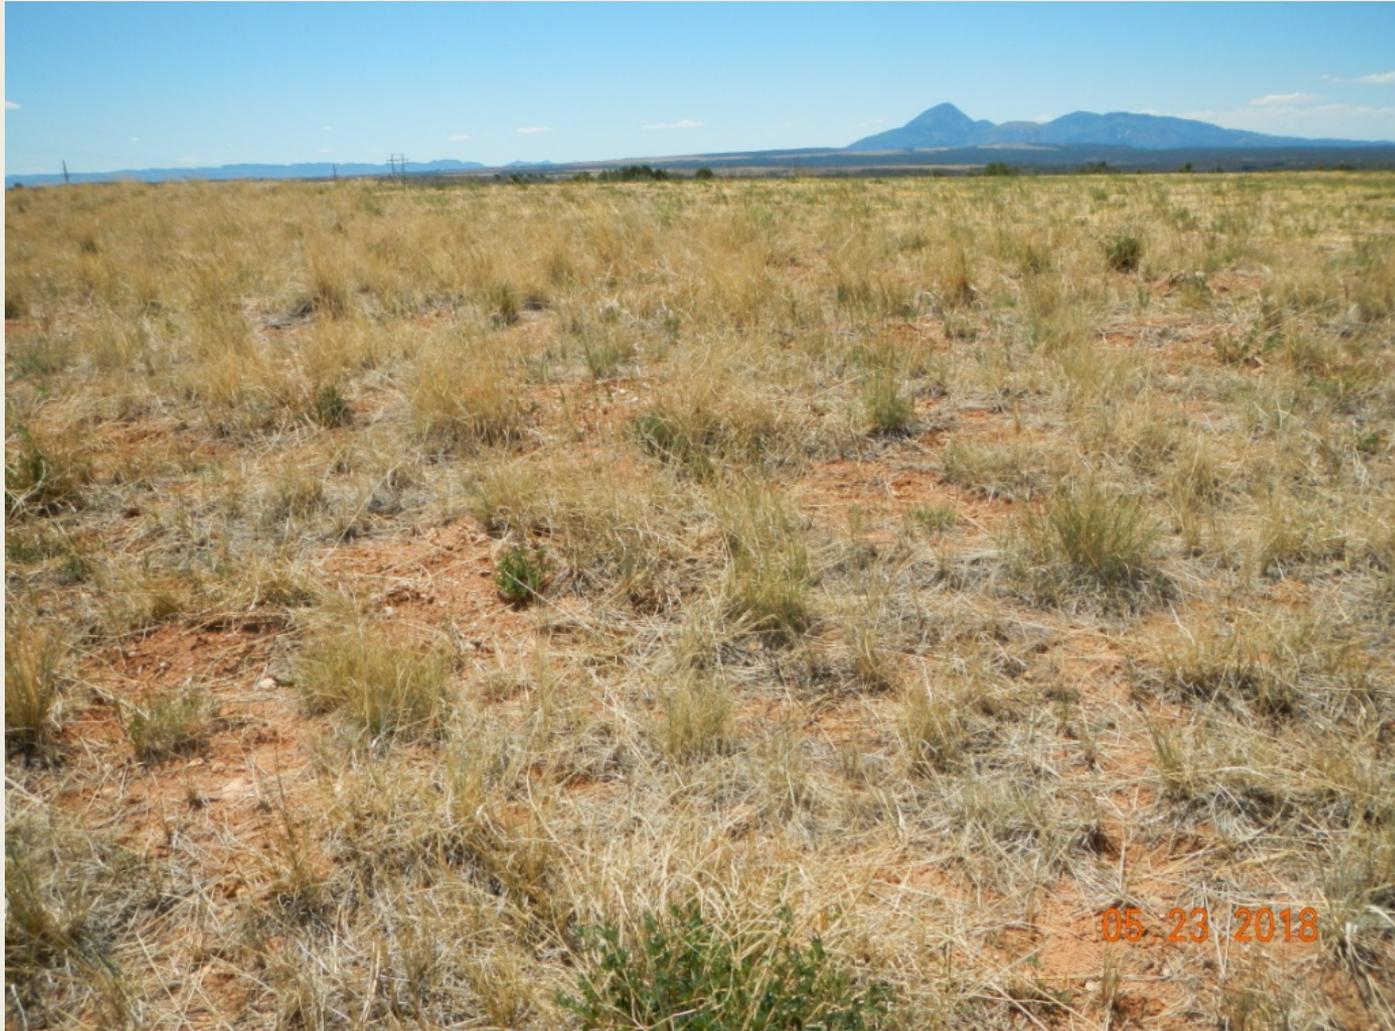
Photo 1. View of former pit area located north of well pad from northern portion facing southward. Revegetation is largely comprised of crested wheatgrass (*Agropyron cristatum*), western wheatgrass (*Pascopyrum smithii*), and rubber rabbitbrush (*Chrysothamnus nauseosus*).

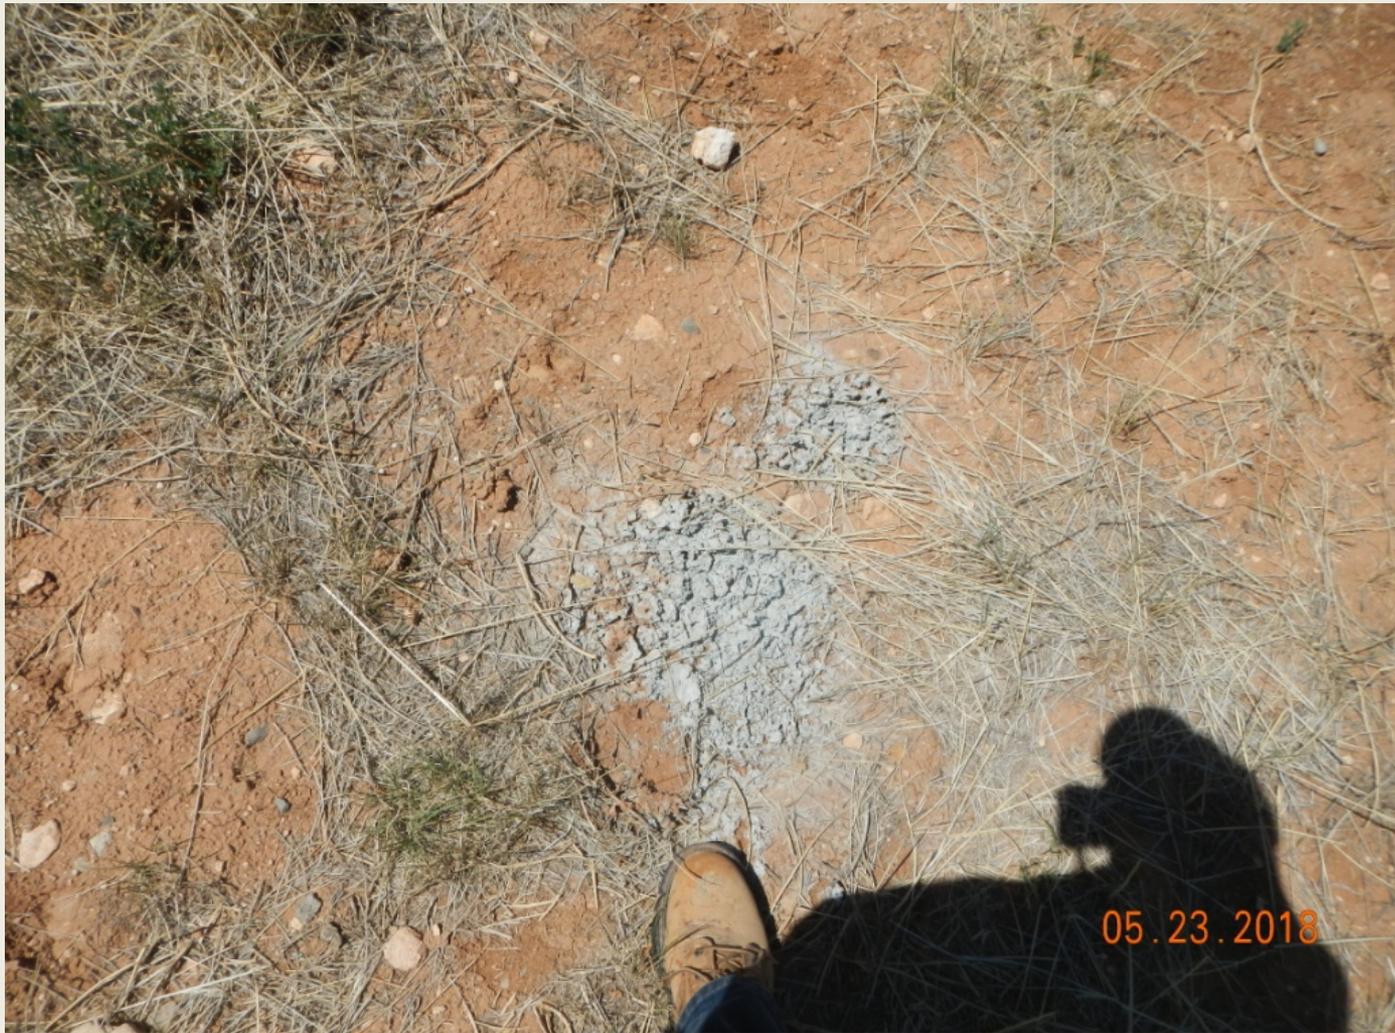
Photo 2. View of discolored soil indicating area of Cool-Ox[®] as indicated by Mike Hannigan. Approx. 15 of these observed.

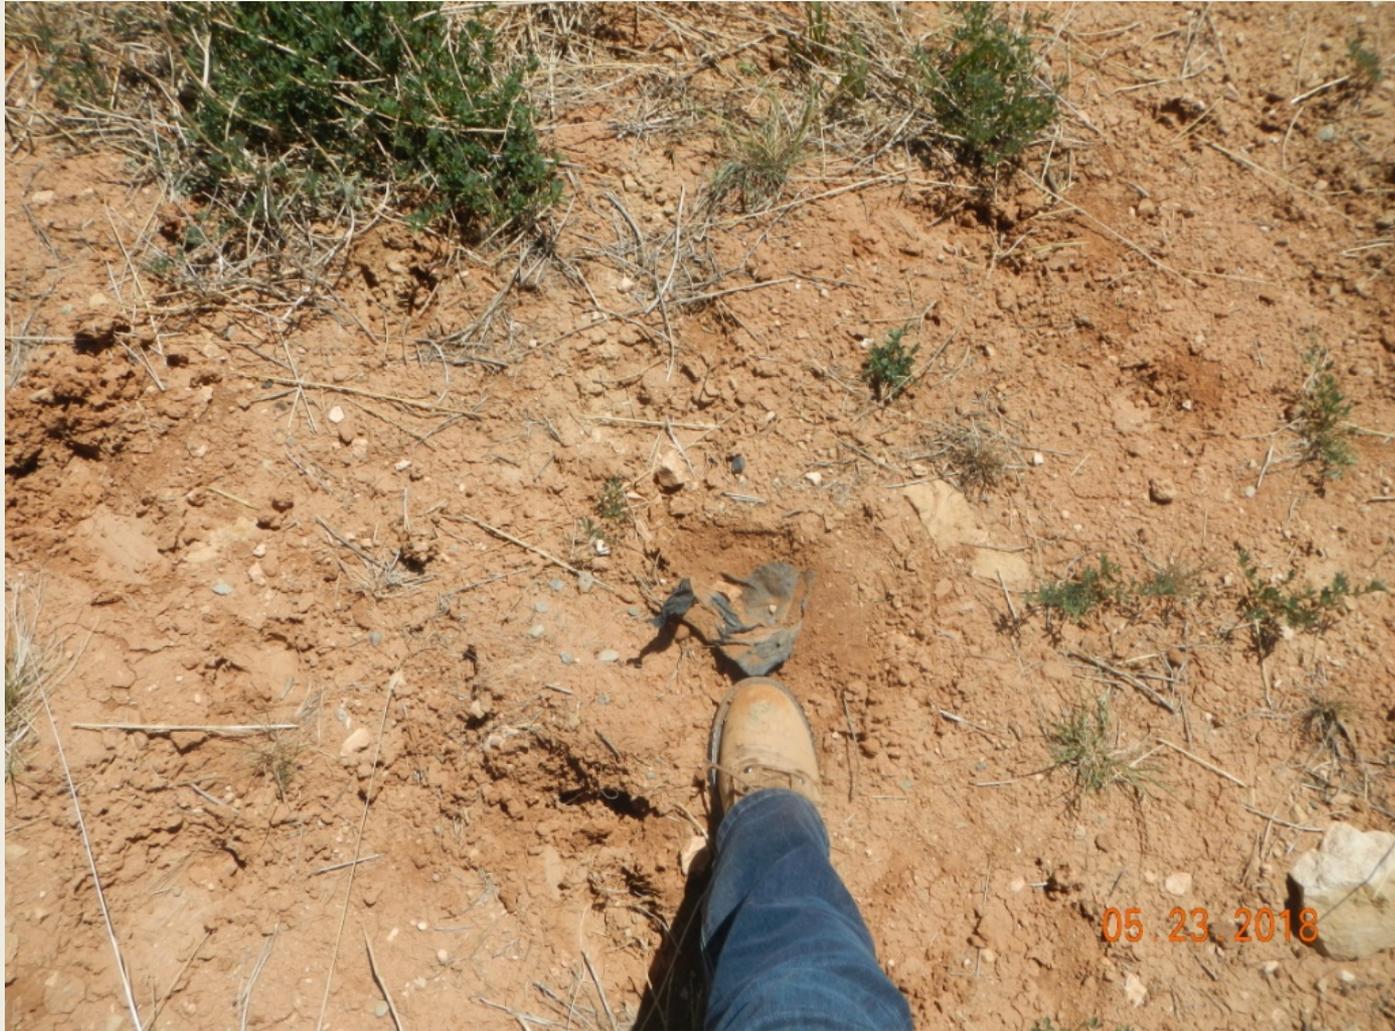
Photo 3. View of small piece of black plastic in former pit area. Several of these observed.

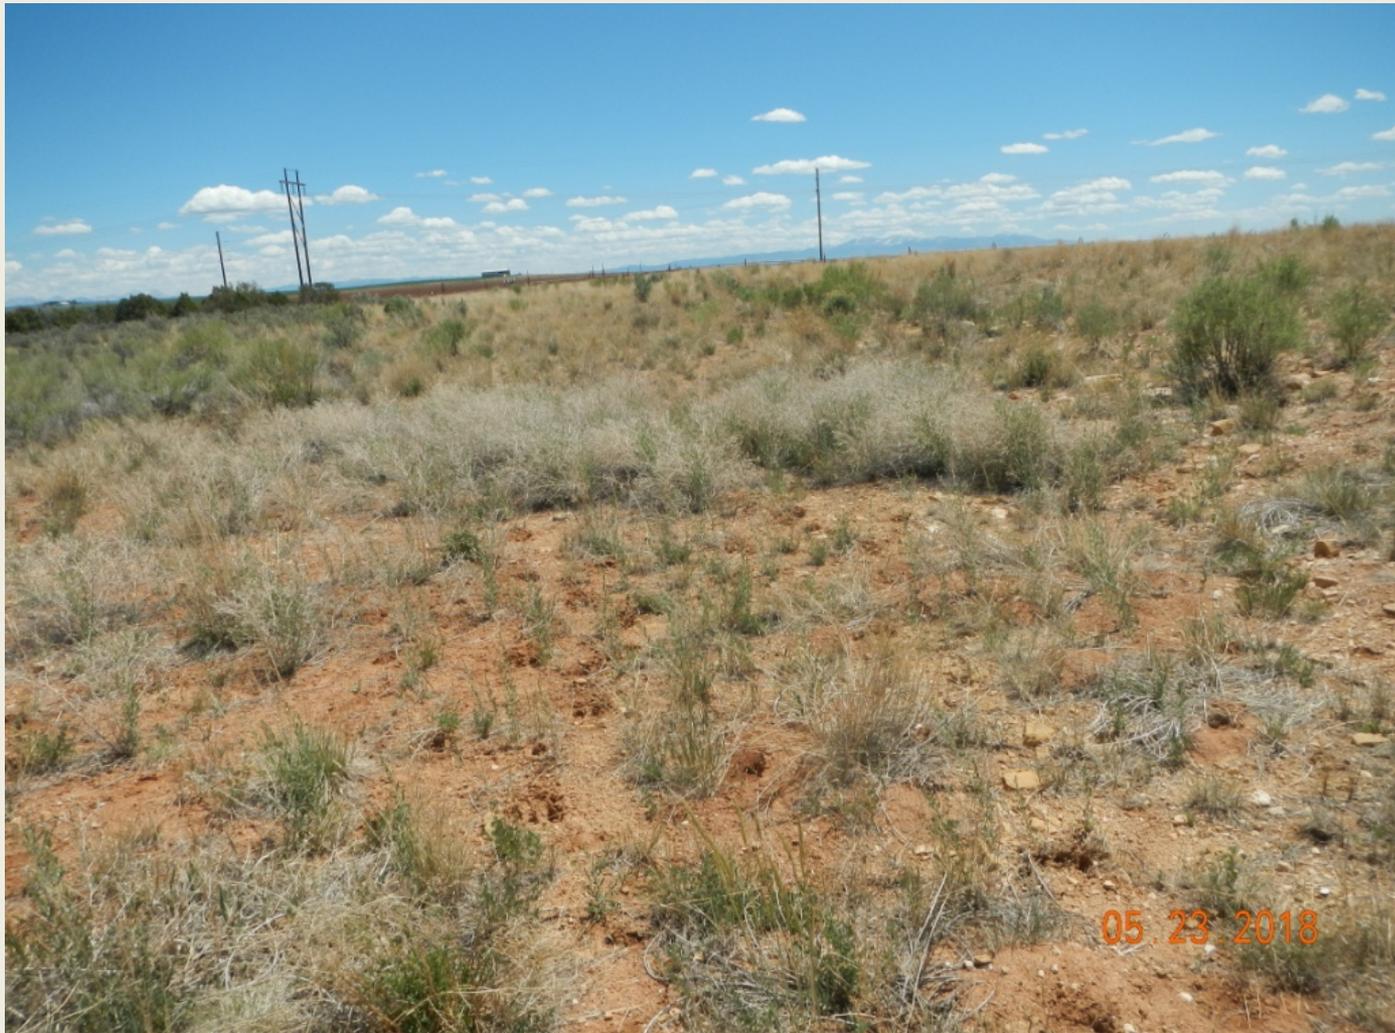
Photo 4. View of Russian knapweed (*Acroptilon repens*) infestation along the northern edge of the former pit area. Approximately 2000 individuals observed. Weed control technician was onsite and actively spraying during the inspection.
