Final Reclamation and Stormwater Inspection

Operator: EXTRACTION OIL & GAS INC - 10459

Location ID: 318393

NWNW Section 32 T2N R67W

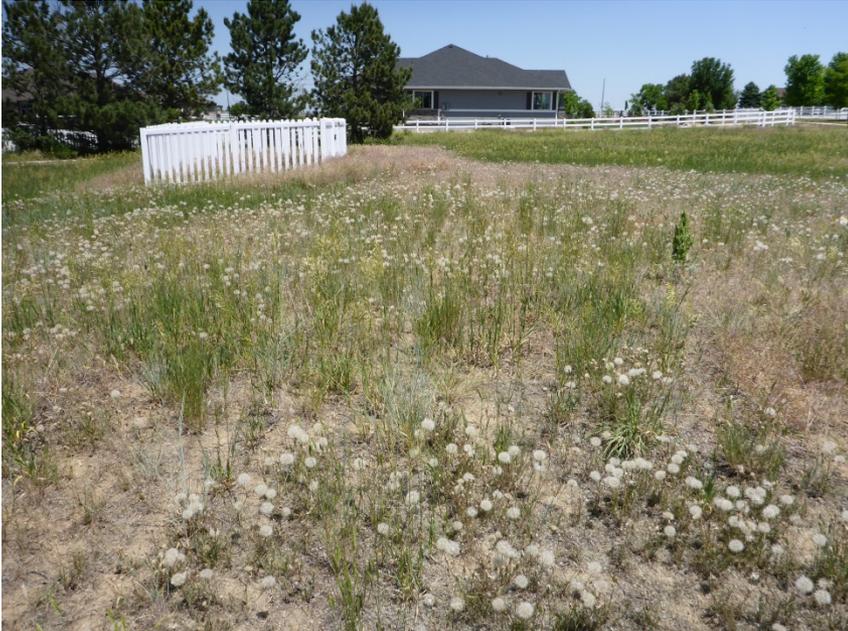
Photo 1. Photo taken from the location, facing North. Appears the Operator has performed reclamation activities with perennial grasses establishing on site. There is a fence left on location with adjacent annual weeds including Russian thistle and a List C Colorado Noxious weed species cheatgrass and bindweed.

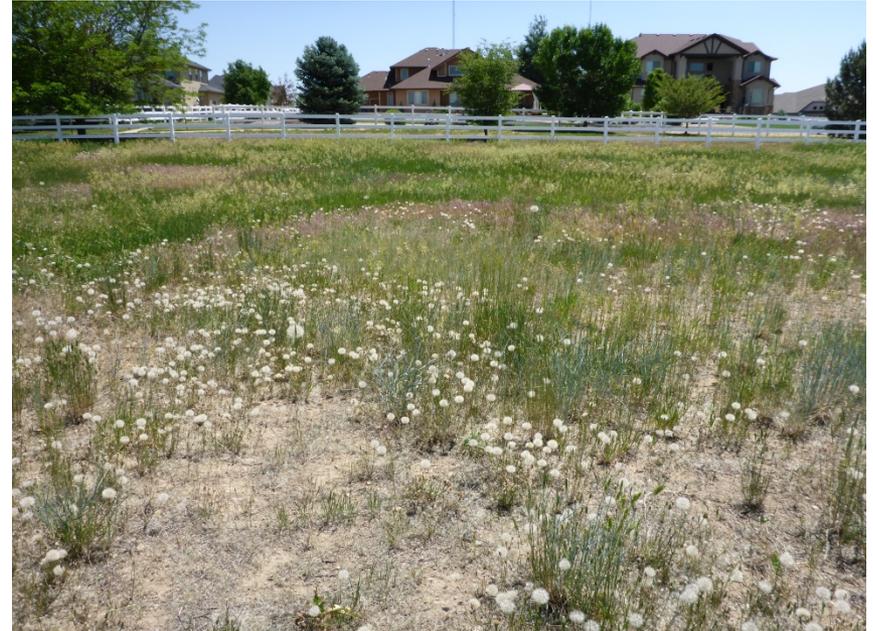
Photo 2. Photo taken from the well location, facing East. See comments from Photo 1.

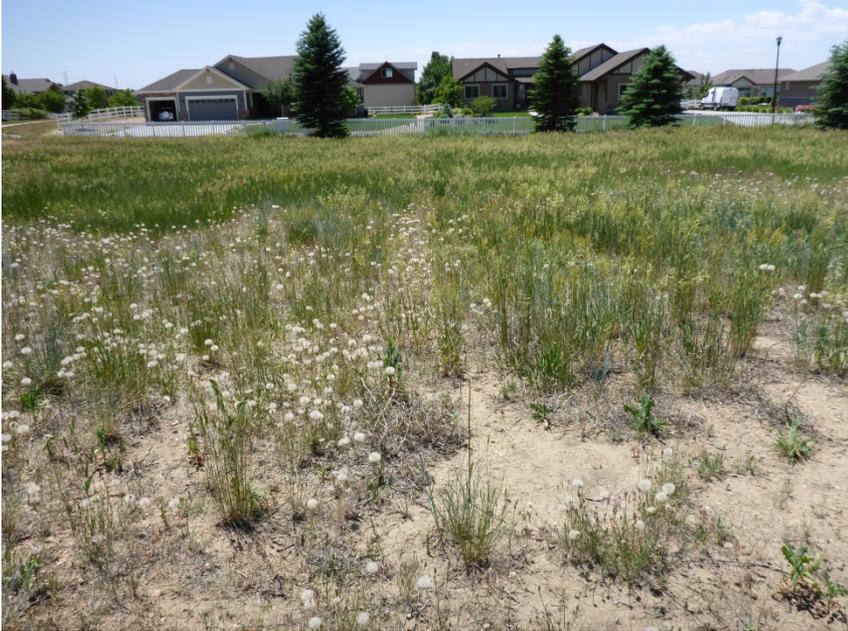
Photo 3. Photo taken from the location, facing South. See comments from Photo 1.

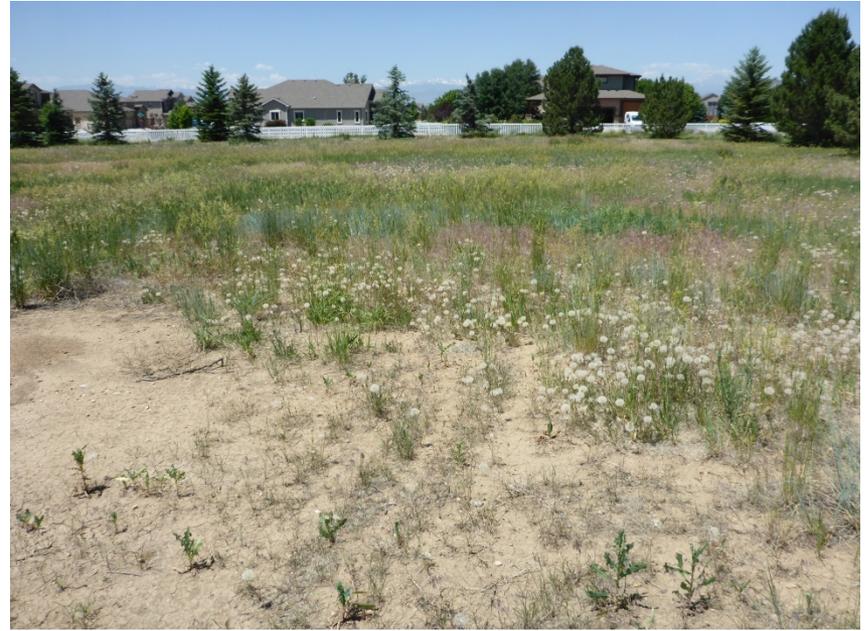
Photo 4. Photo taken from the location, facing West. See comments from Photo 1. There is a barren area at the location that may benefit from additional seeding.

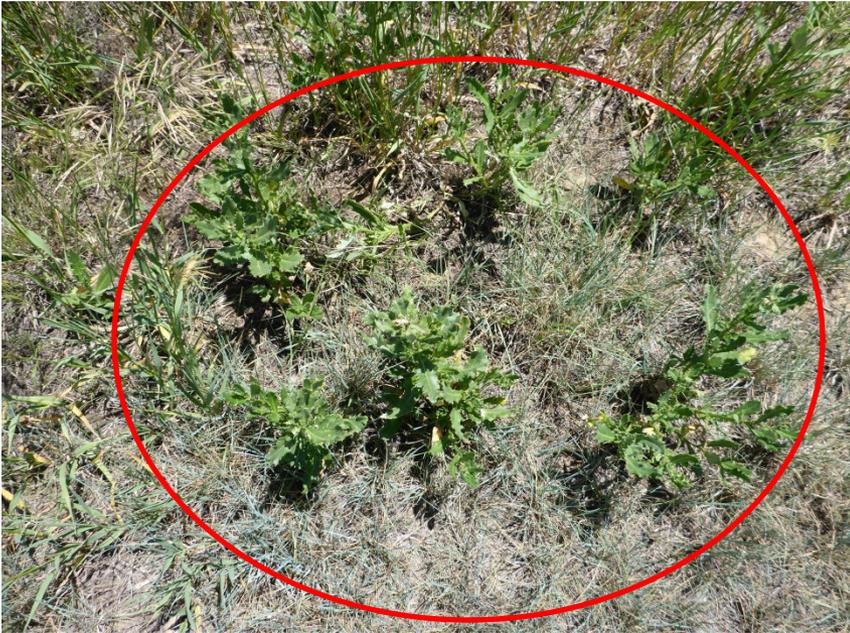
Photo 5. Photo taken from the East end of the location. A List B Colorado Noxious weed species, Canada thistle (*Cirsium arvense*), is found at low densities.

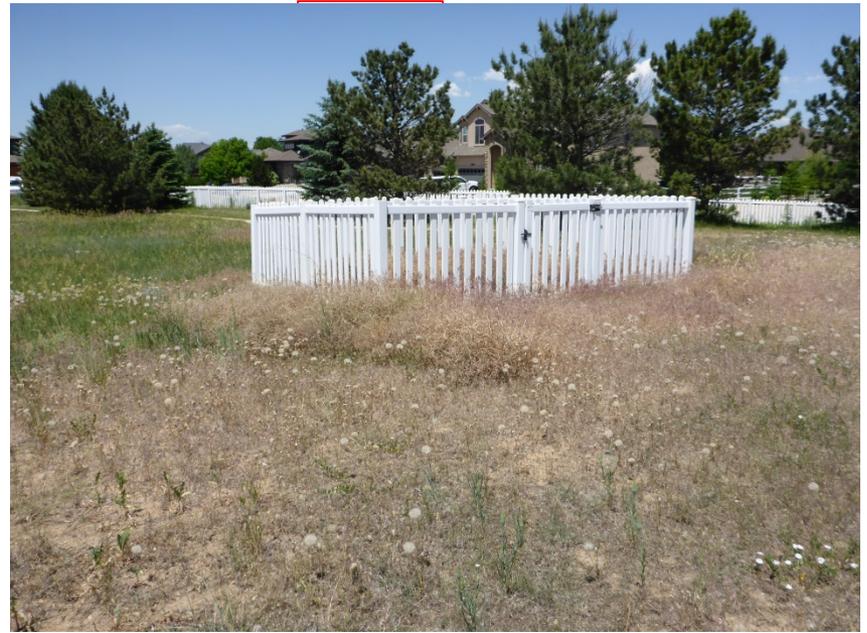
Photo 6. Photo taken from the North end of the location, facing Northwest. See comments from Photo 1.
