Final Reclamation and Stormwater Inspection

June 13, 2018

Location ID: 409042

Inspection Document #: 674902214

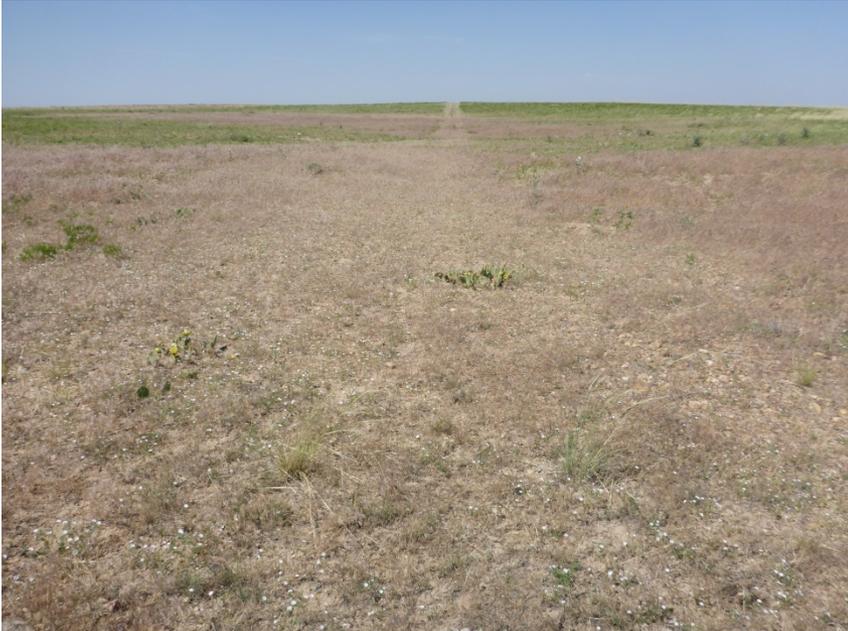
Photo 1. Photo taken from the access road looking towards the well location, facing East. Appears the Operator has not performed any reclamation activities on the access road itself but has on the well pad location.

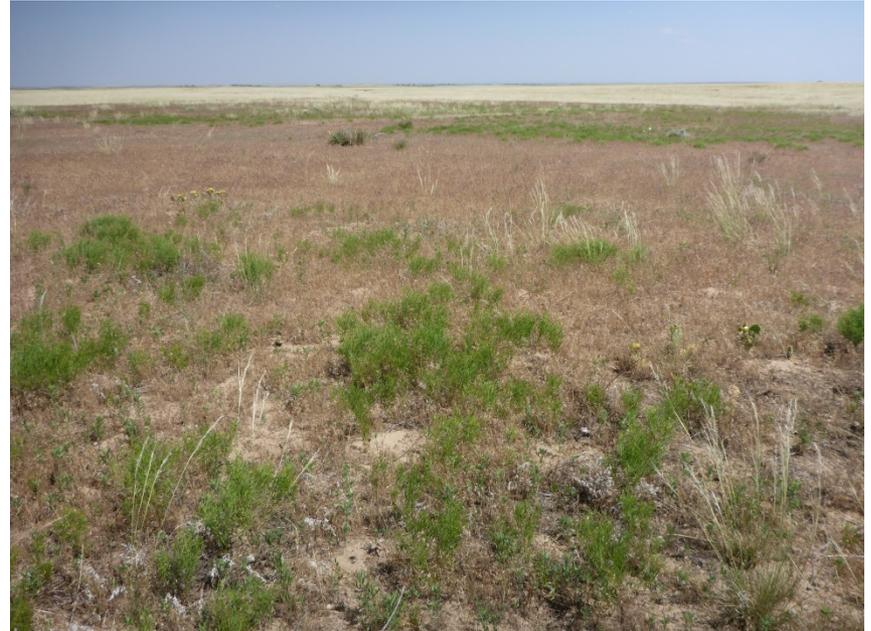
Photo 2. Photo taken from the well location, facing North. The reclamation operations have failed to generate perennial vegetation cover. Disturbance area is currently dominated by the annual List C Colorado Noxious Weed cheatgrass.

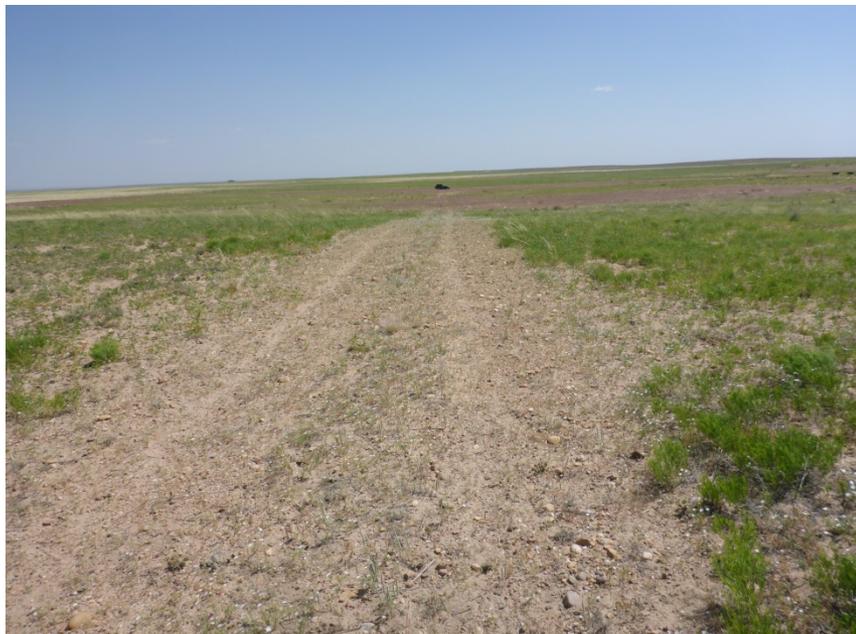
Photo 3. Photo taken from the well location, facing Northeast. See comments from Photo 1.

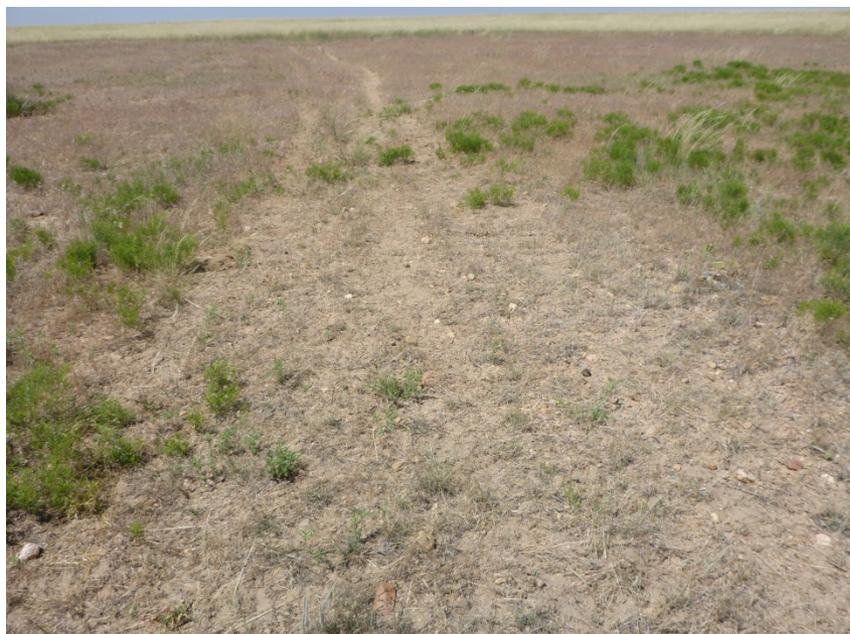
Photo 4. Photo taken from the well location, facing Southwest. See comments from Photo 1.

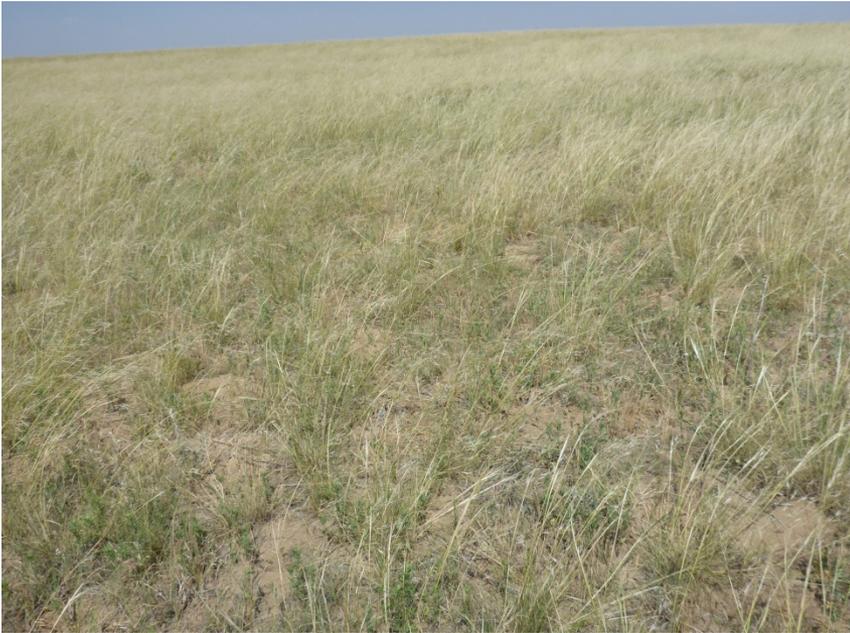
Photo 5. Photo taken from the adjacent reference area., facing North. Showing dominant perennial grass cover, needle and thread grass. See comments under Photo 2.

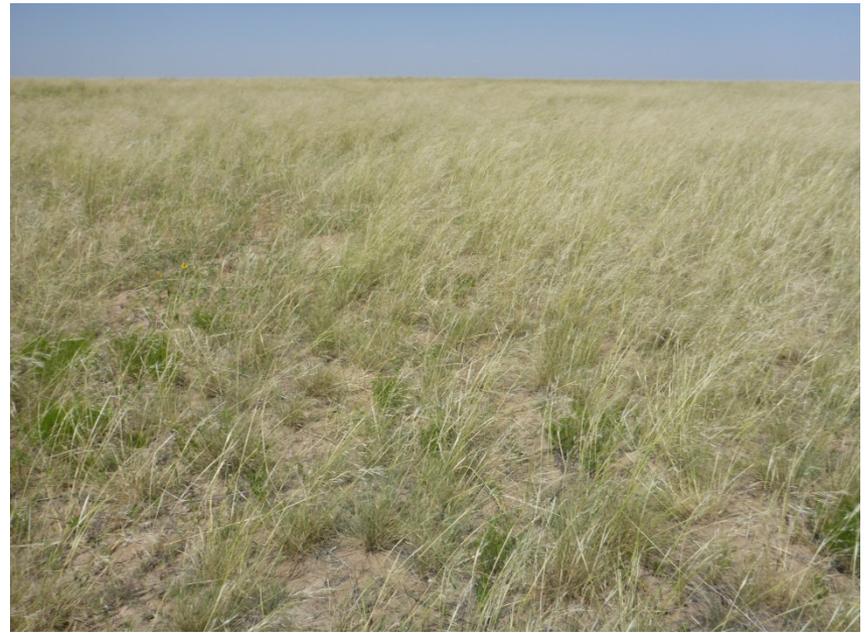
Photo 6. Photo taken from the adjacent reference area, facing West. Showing dominant perennial grass cover, needle and thread grass. See comments under Photo 2.
