Final Reclamation Inspection

Operator: PDC ENERGY INC - 69175

API: 05-001-08989

Location Name: CALDWELL FARMS #1-A

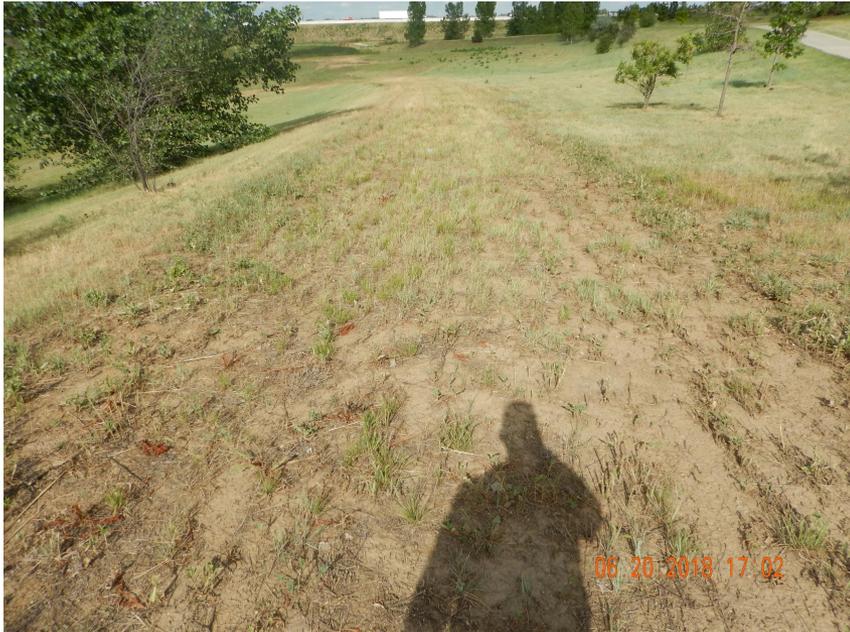
Photo 1. Photo taken from the start of the access road, facing East. Appears location was recently mowed. Access road and well location have desirable germination of vegetation but noxious weeds (Canada thistle, Puncture vine, and Cheatgrass) were observed throughout portions of the disturbance area. At a minimum, Operator shall control Canada thistle, as it is a List B Colorado noxious weed. Mowing operations would not be considered a long term weed control management practice for Canada thistle.

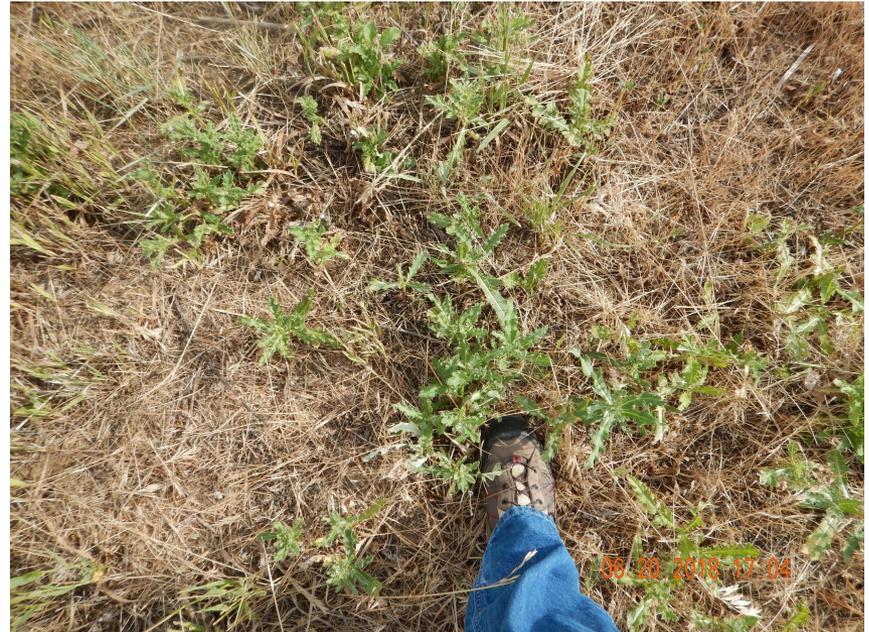
Photo 2. Photo taken along a portion of the disturbance area, illustrating Canada thistle that has been recently mowed.

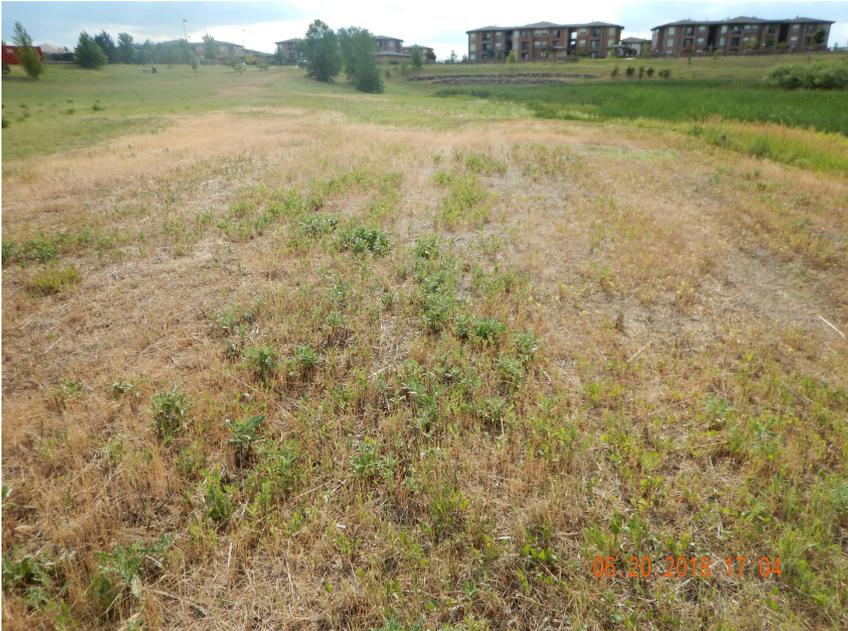
Photo 3. Photo taken from the well location, facing West. See comments under Photo 1.

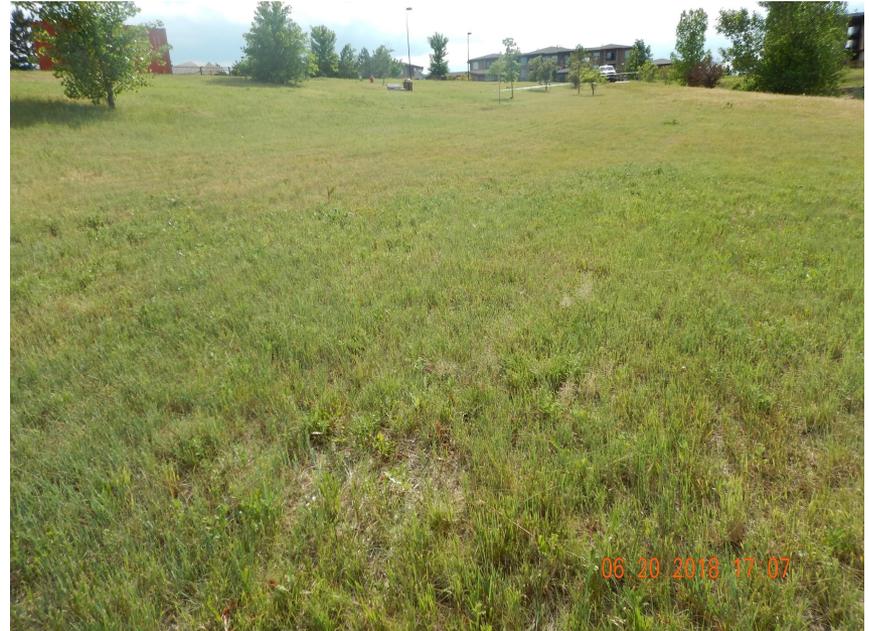
Photo 4. Reference photo taken south of the well location, facing West. Access road and well location will remain IN-PROCESS has vegetation is not reflective of reference area vegetative levels.
