# Construction and Stormwater Inspection

Operator: BURLINGTON RESOURCES OIL & GAS LP- #26580

Location ID: 449179

Inspection Photos  
Location Name: Bear 3-65 22-23  
Location ID: 449179

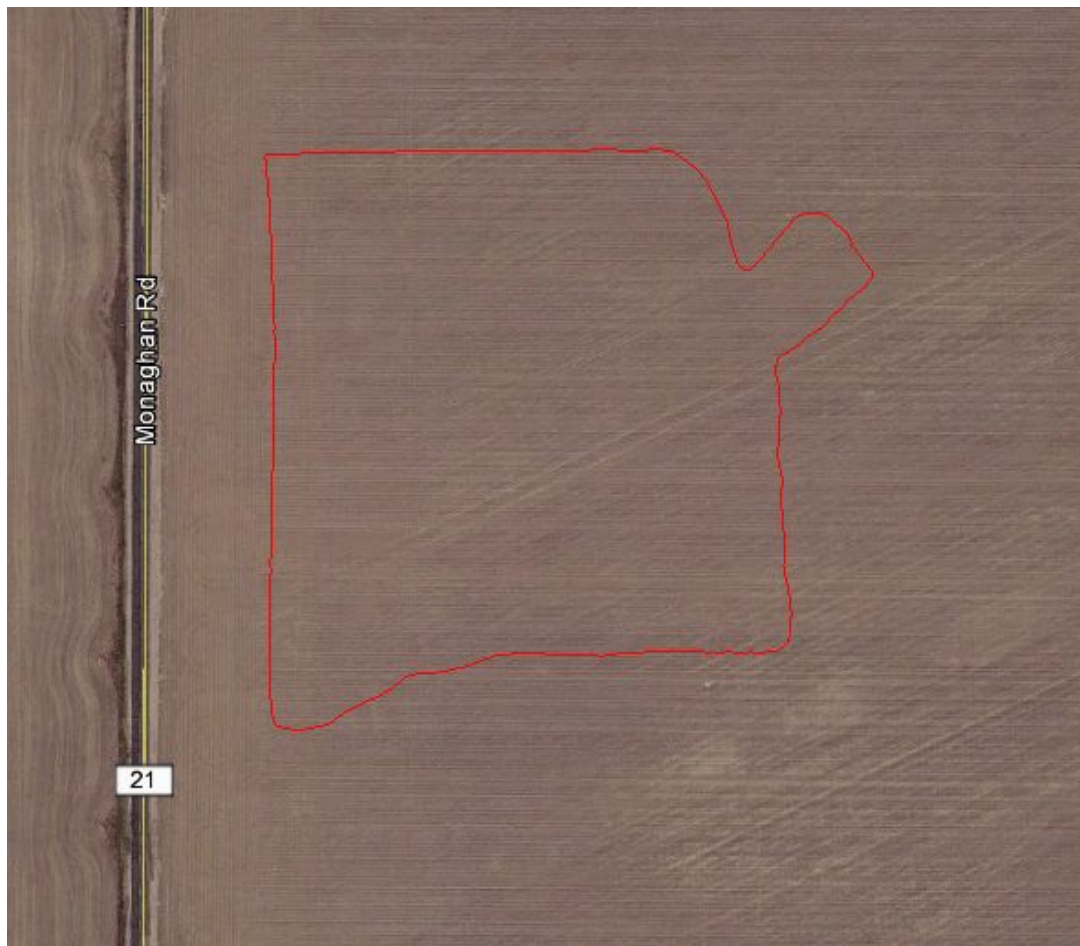
Google Earth aerial imagery taken on 6/9/2017, prior to construction operations. Field collected data on 6/20/2018, using a Trimble handheld GPS (red line), would indicate total disturbance after construction operations is approximately 8.00 acres. This does not appear to be the approved total permitted disturbance. Appears the Operator may not have accounted for soil stockpile storage areas and stormwater BMP areas for the total disturbance area.

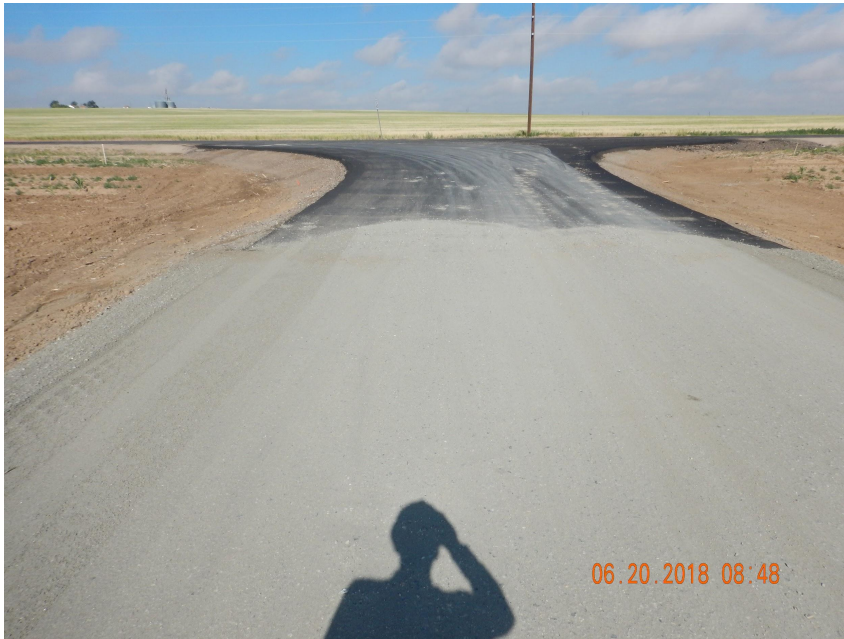
**Photo 1.** Photo taken from the entrance of location, facing West. Operator has constructed the approach and access road to the location.

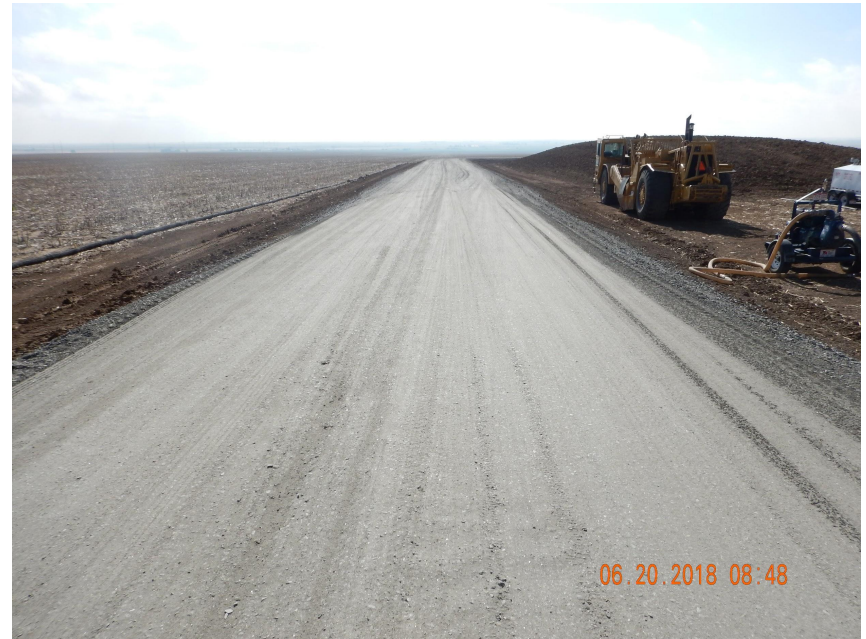
**Photo 2.** Photo taken from the entrance of location, facing East. See comments under Photo 1.

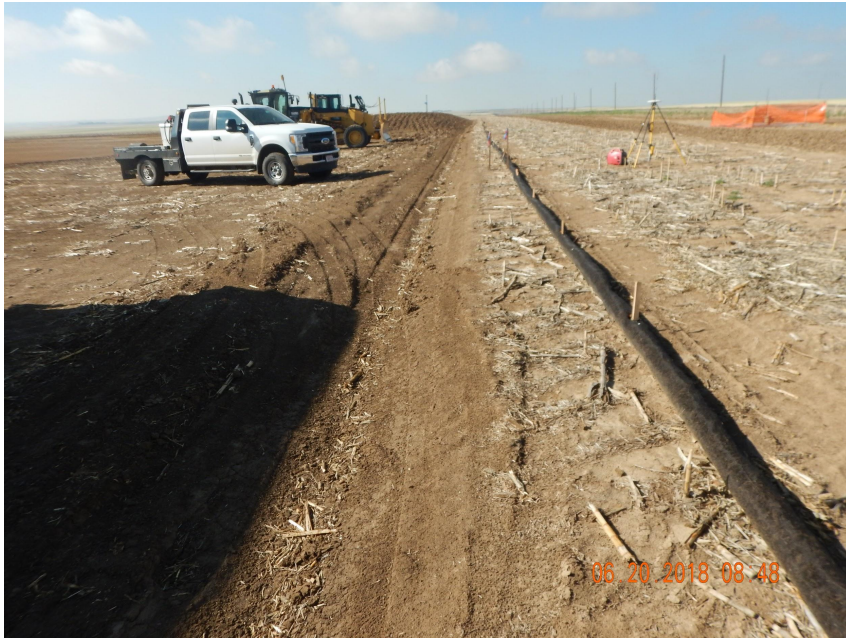
**Photo 3.** Photo taken from the northwestern perimeter of the location, facing South. Ditch BMP has been installed around the entire perimeter of the location which is directed to a sediment trap. In addition, filtrex wattles have been installed to the outer perimeter of the ditch BMP.

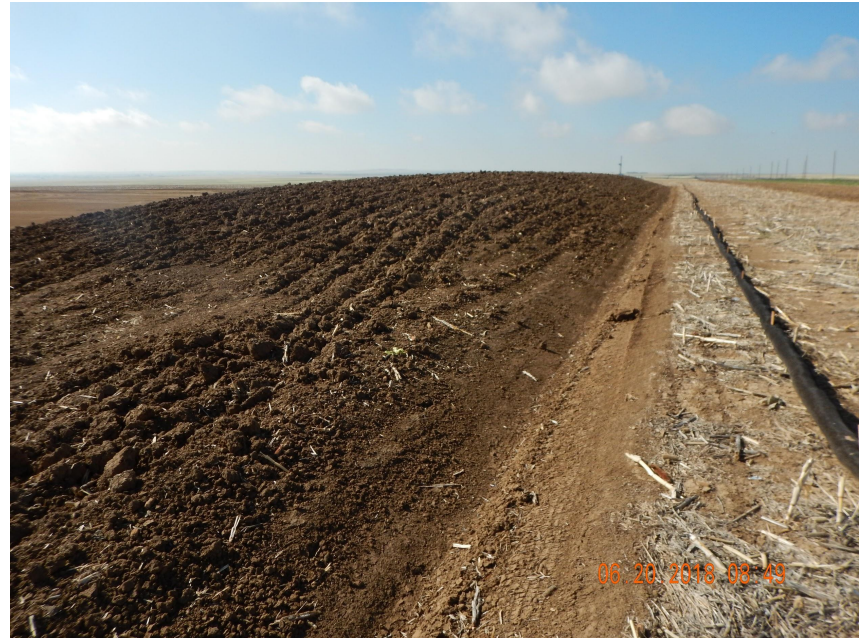
**Photo 4.** Photo taken from the western perimeter of the location, facing South. Photo illustrates the topsoil stockpile that has been stockpiled.

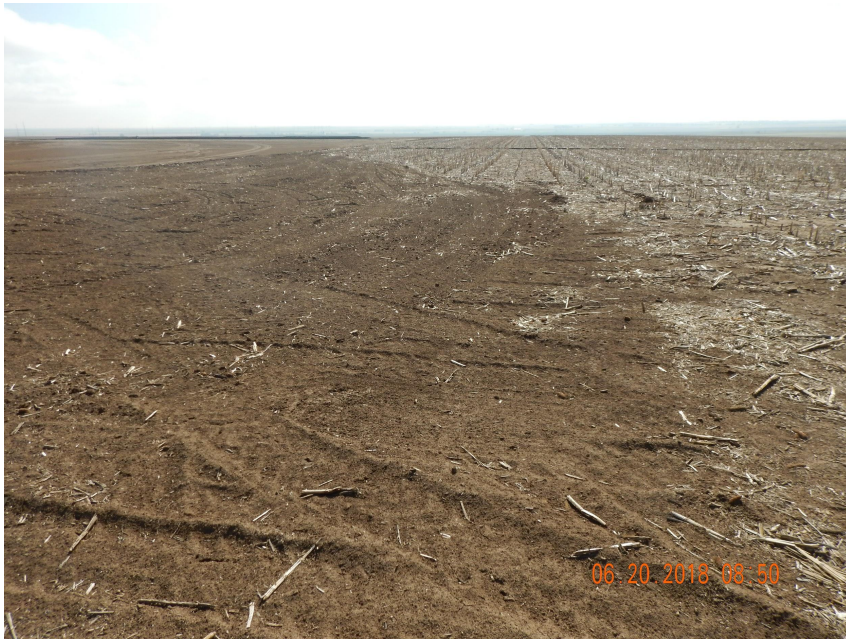
**Photo 5.** Photo taken from the southwest perimeter of the location, facing East. Filtrex wattles have been installed to the outer perimeter of the ditch BMP which is not visible in this photo.

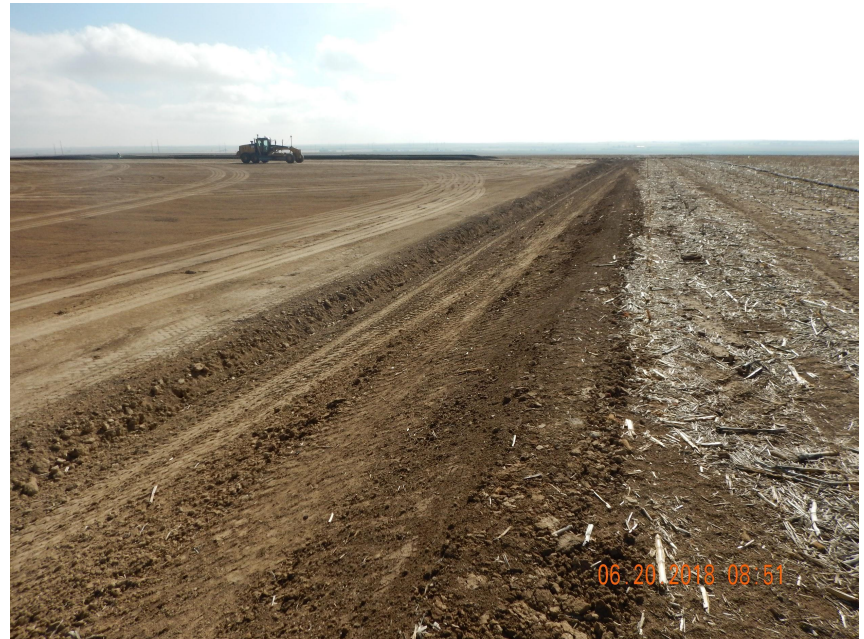
**Photo 6.** Photo taken from the southern perimeter of the location, facing East. See comments under Photo 3.

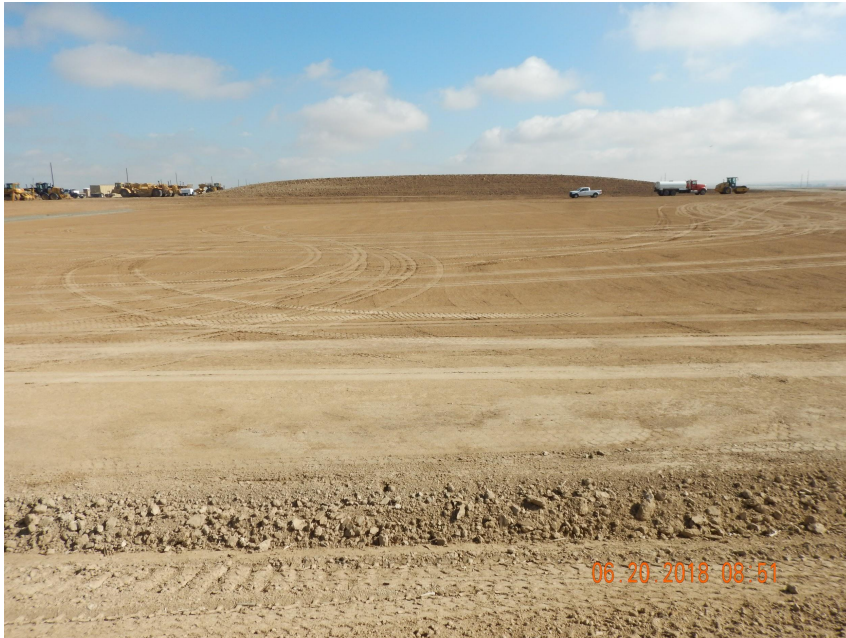
**Photo 7.** Photo taken from the southern perimeter of the location, facing North. Photo illustrates the operational well pad area with the spoils stockpile to the north.

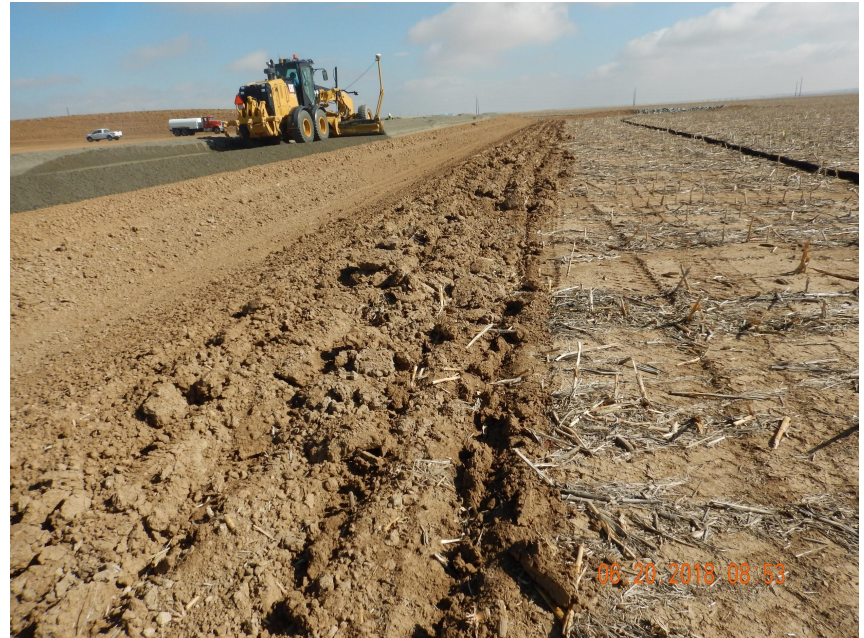
**Photo 8.** Photo taken from the southeastern perimeter of the location, facing North. Ditch, surface roughening, and wattle BPMs installed along the eastern perimeter.

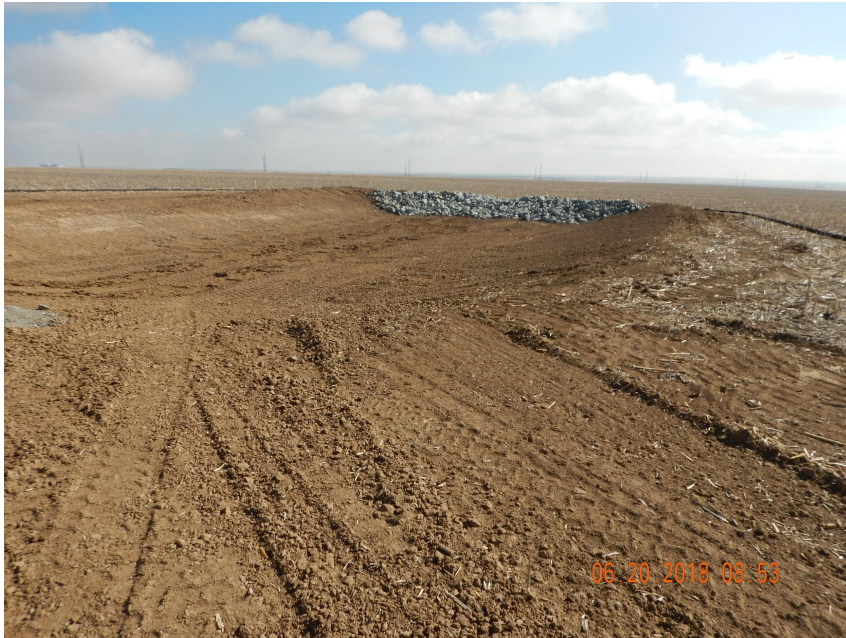
**Photo 9.** Photo taken from the northeastern perimeter of the location, facing North. Photo illustrates the sediment trap BMP.

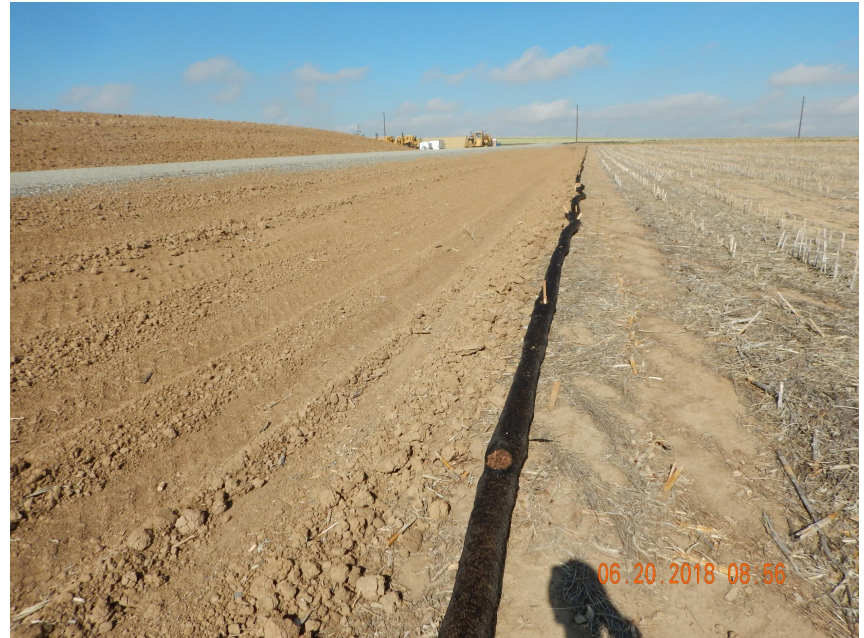
**Photo 10.** Photo taken from the southeastern perimeter of the location, facing North. Ditch, surface roughening, and wattle BMPs installed along the eastern perimeter.
