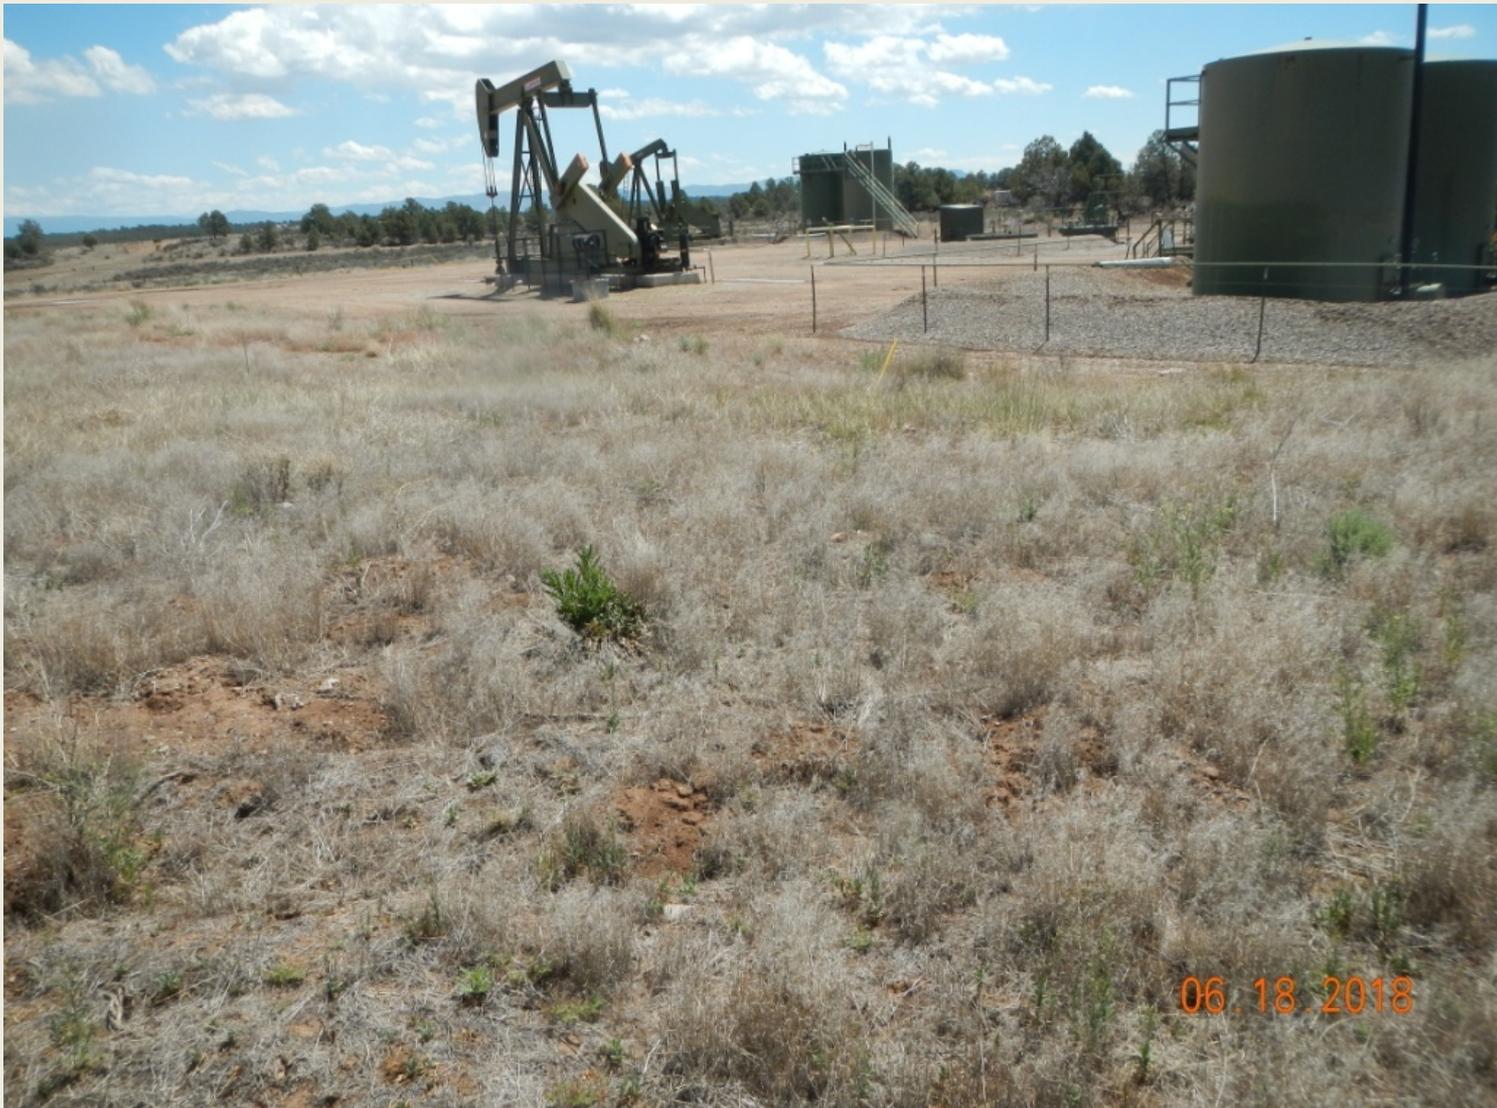
**Photo 1. View of the project area from the western corner facing center.**

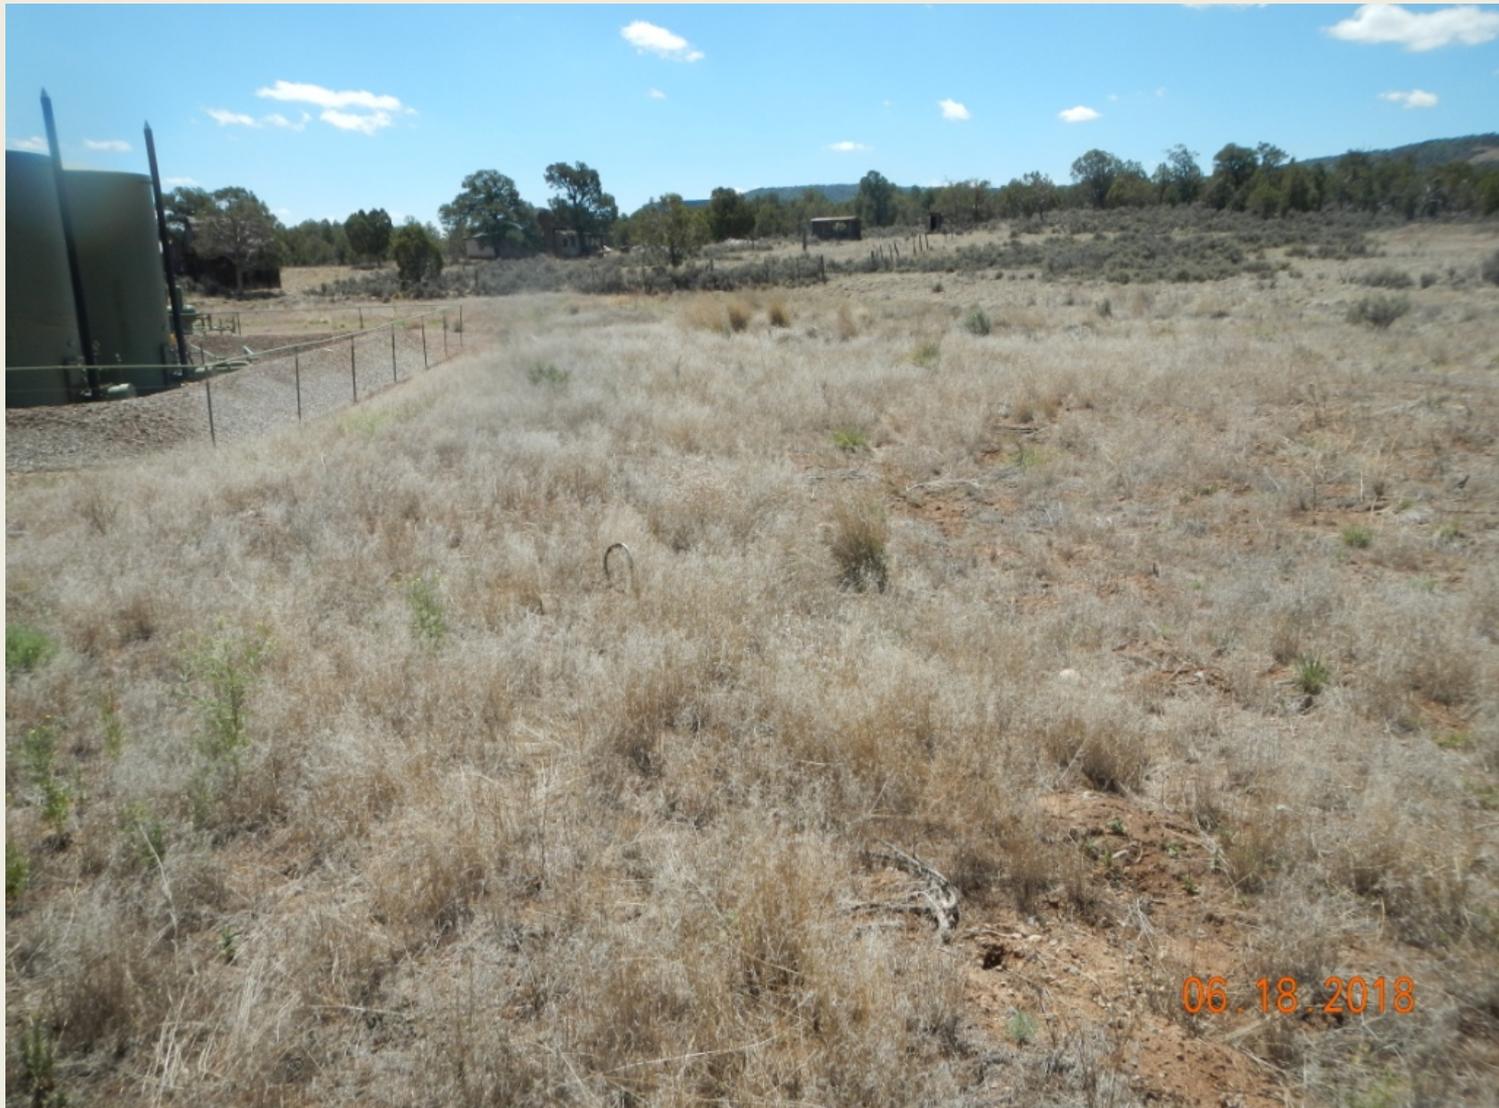
**Photo 2. View of the southwestern portion of the project area from the western corner facing southeastward. Revegetation is largely weedy, comprised with cheatgrass (*Bromus tectorum*). Some desirable vegetation is established and comprised of western wheatgrass (*Pascoopyrum smithii*), intermediate wheagrass (*Thinopyron intermedium*), and crested wheatgrass (*Agropyron cristatum*).**

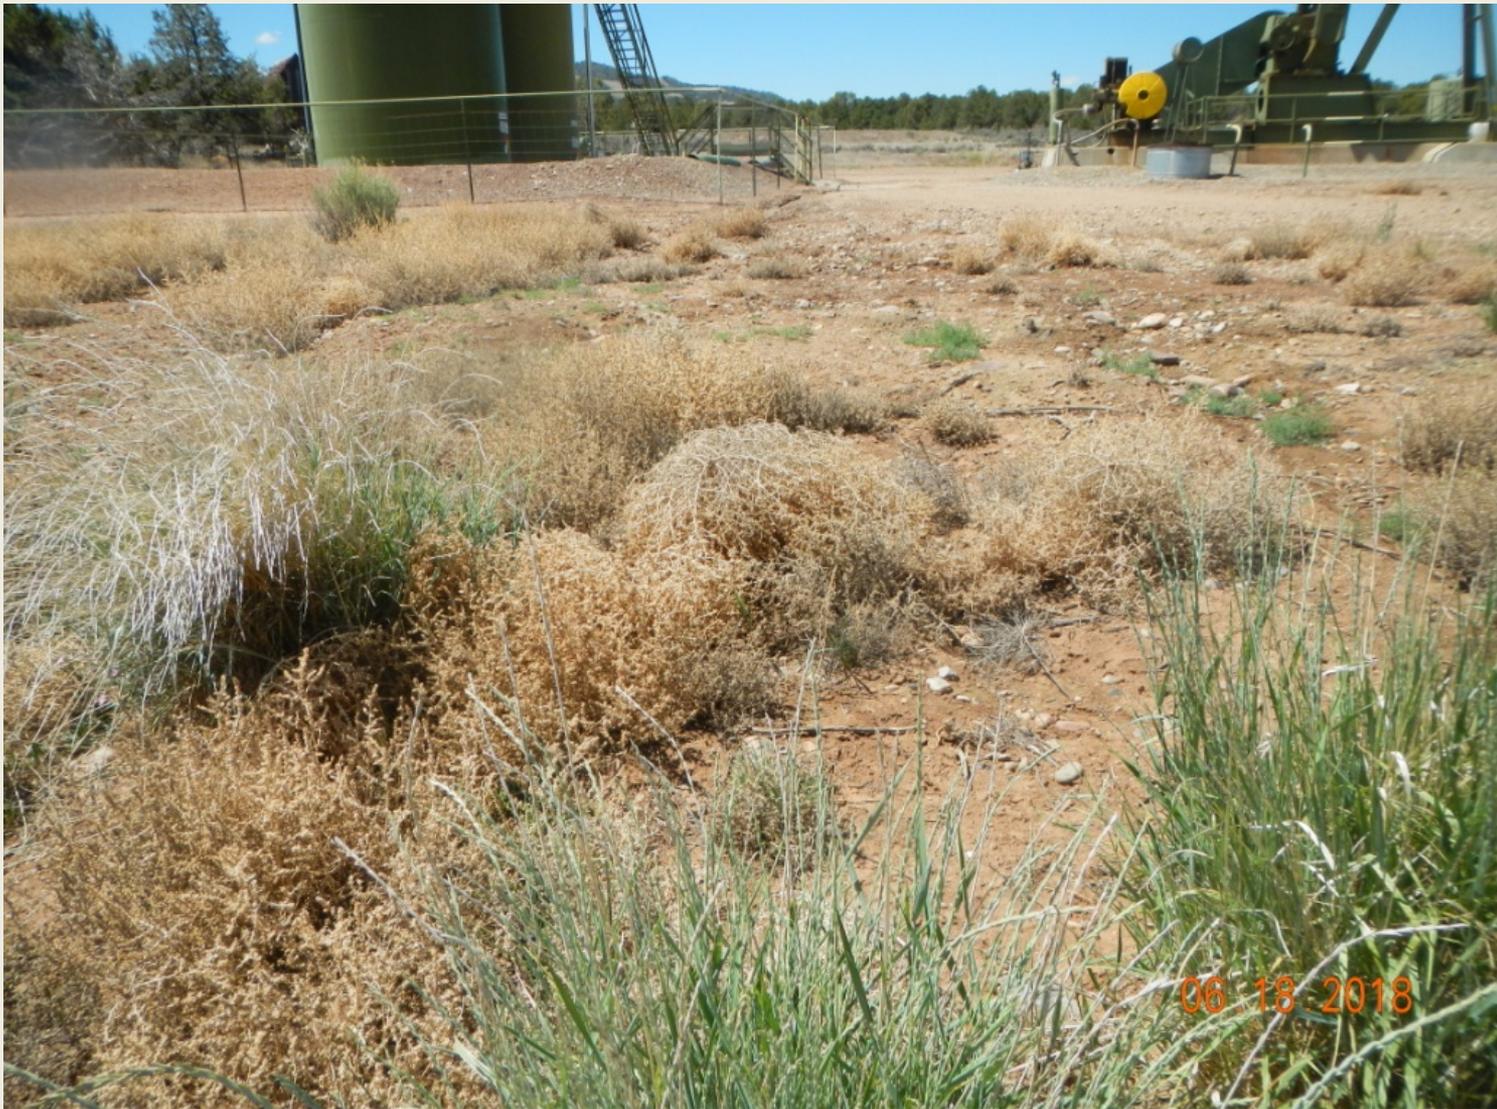
**Photo 4. View of area in the northeaster portion of the project area where there is Russian thistle debris and rilling from stormwater runoff from the well pad.**

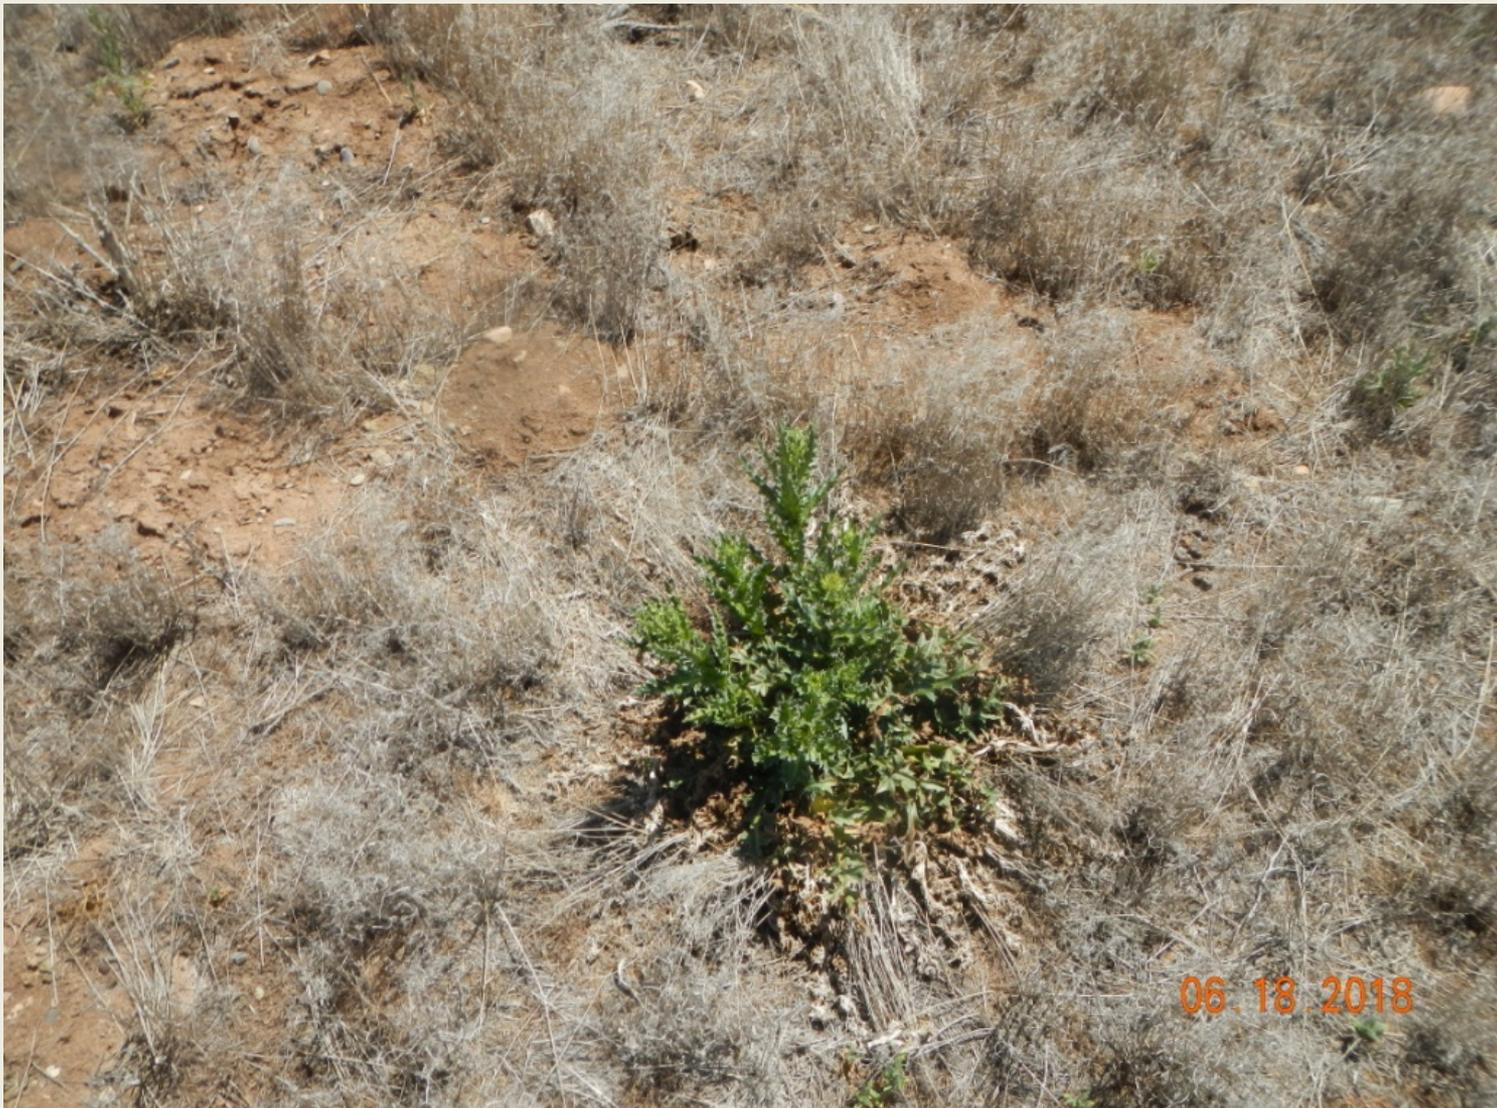
Photo 5. View of musk thistle (*Carduus nutans*) within the interim reclamation area.
