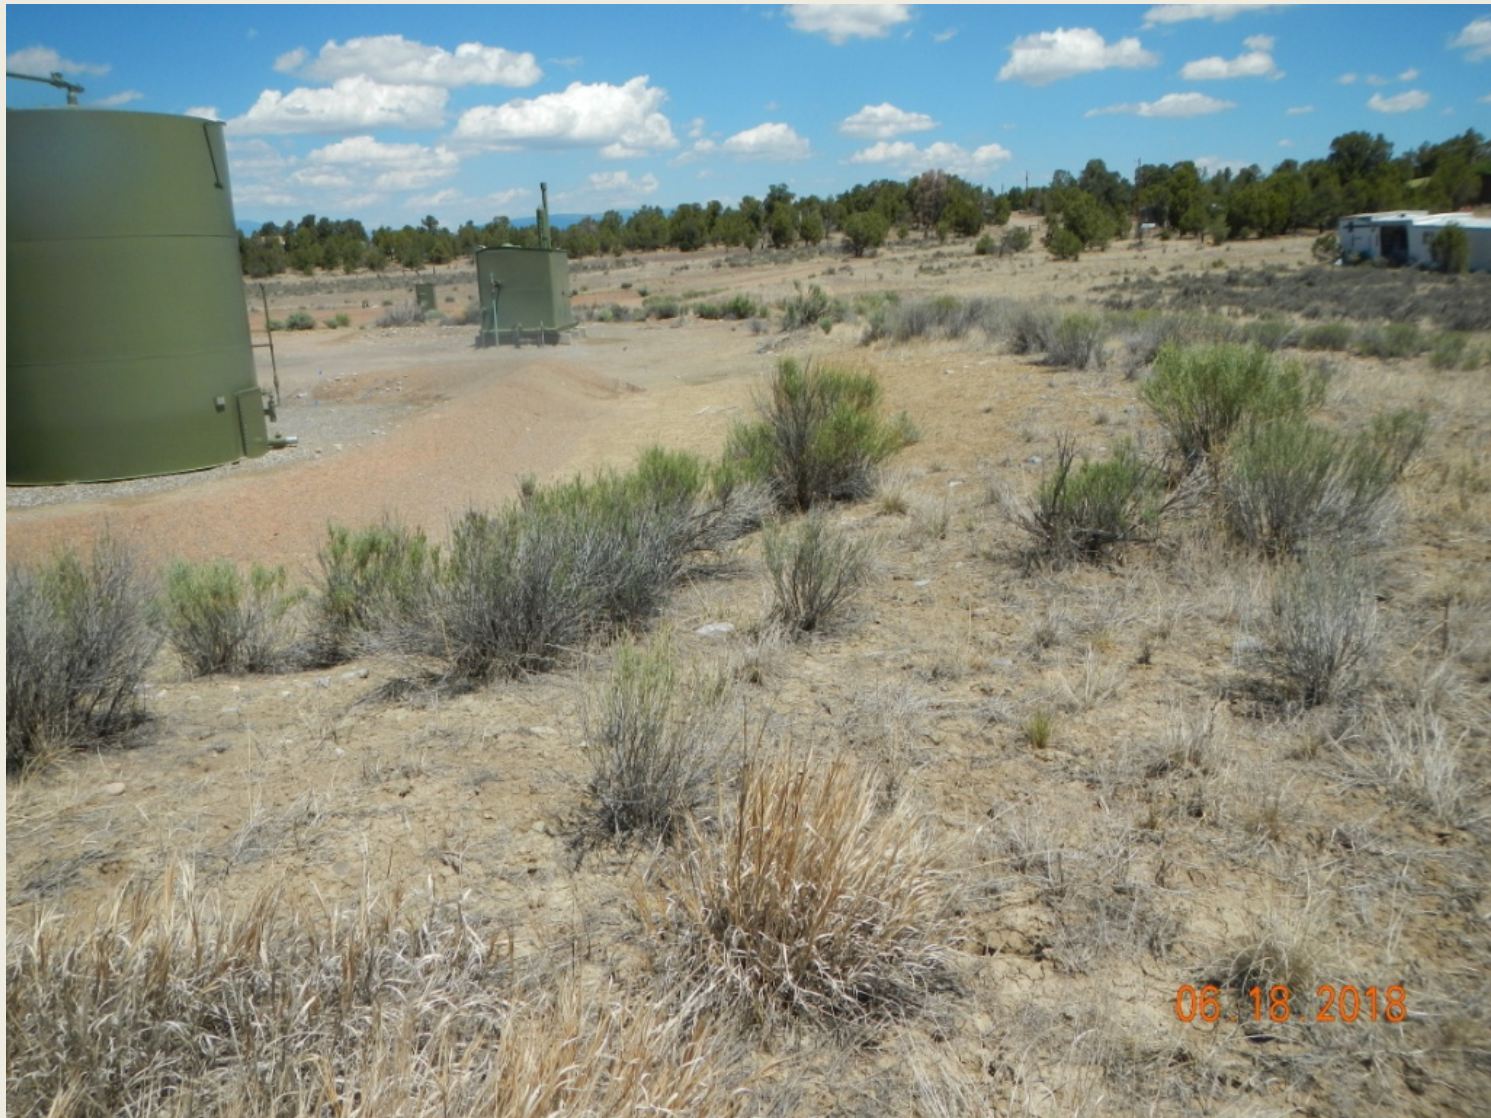
Photo 2. View of the eastern portion of the project area from the southeastern corner facing northward. Revegetation is progressing and comprised of grasses and shrubs such as western wheatgrass (*Pascoopyrum smithii*), smooth brome (*Bromus inermis*), and rubber rabbitbrush (*Chrysothamnus nauseosus*).

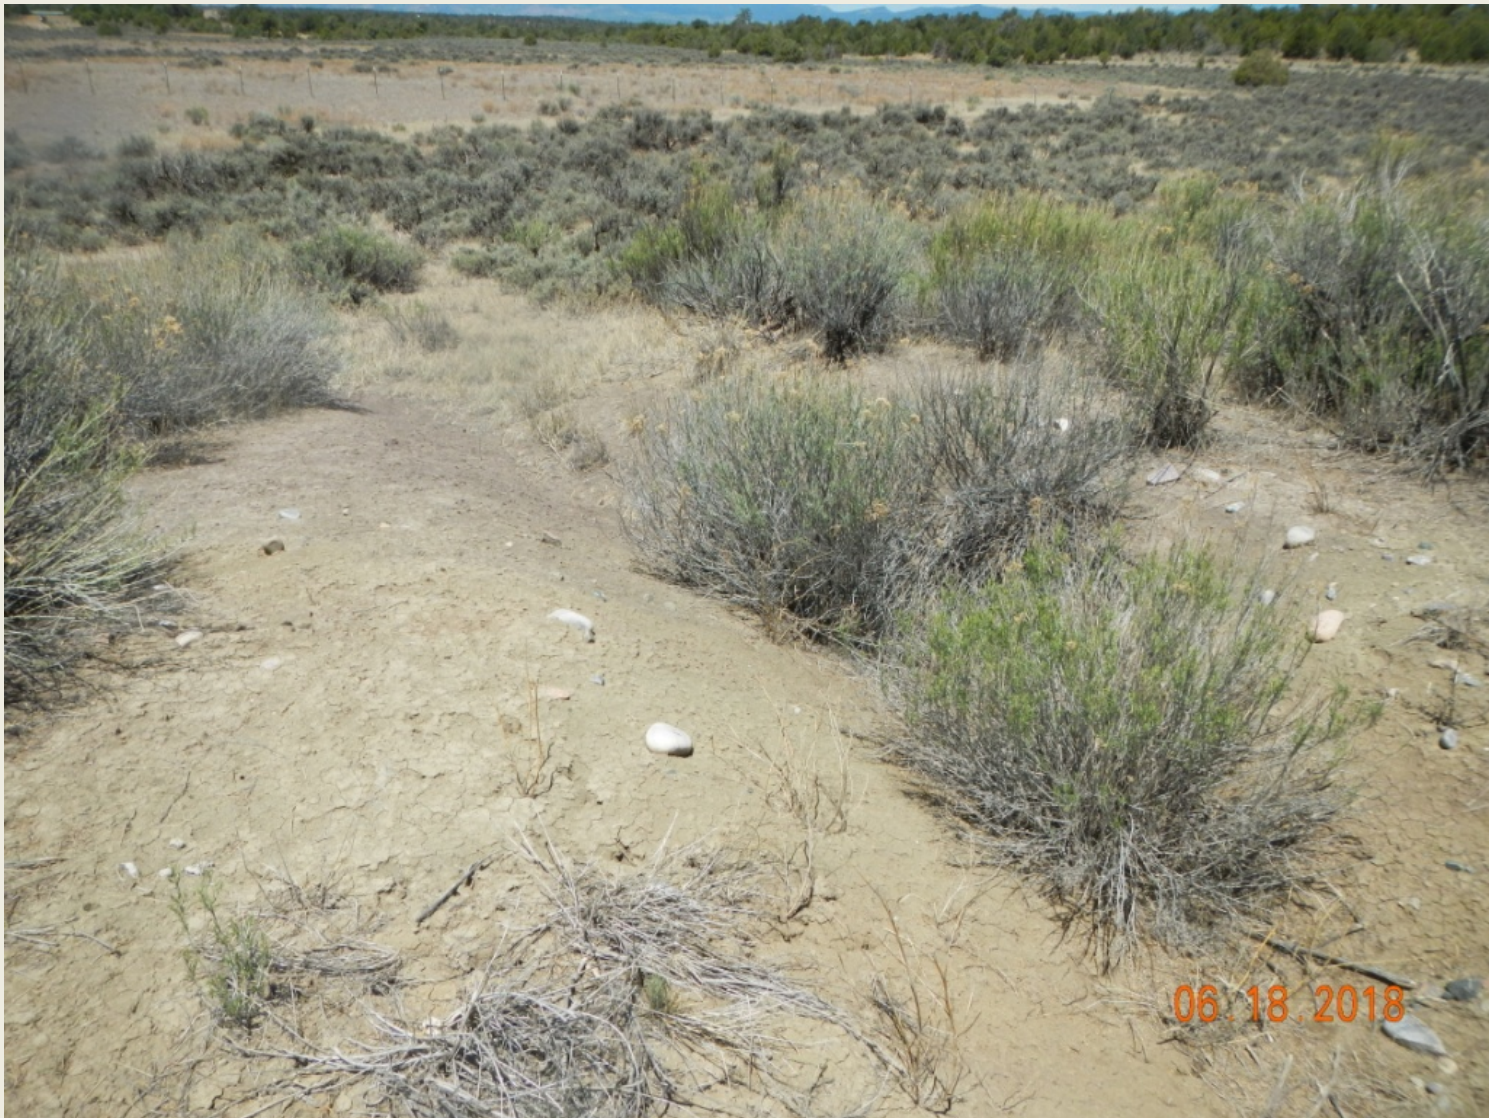
Photo 4. View of diversion in the southwestern portion of the project area facing westward. Diversion appears to be functioning at this time.

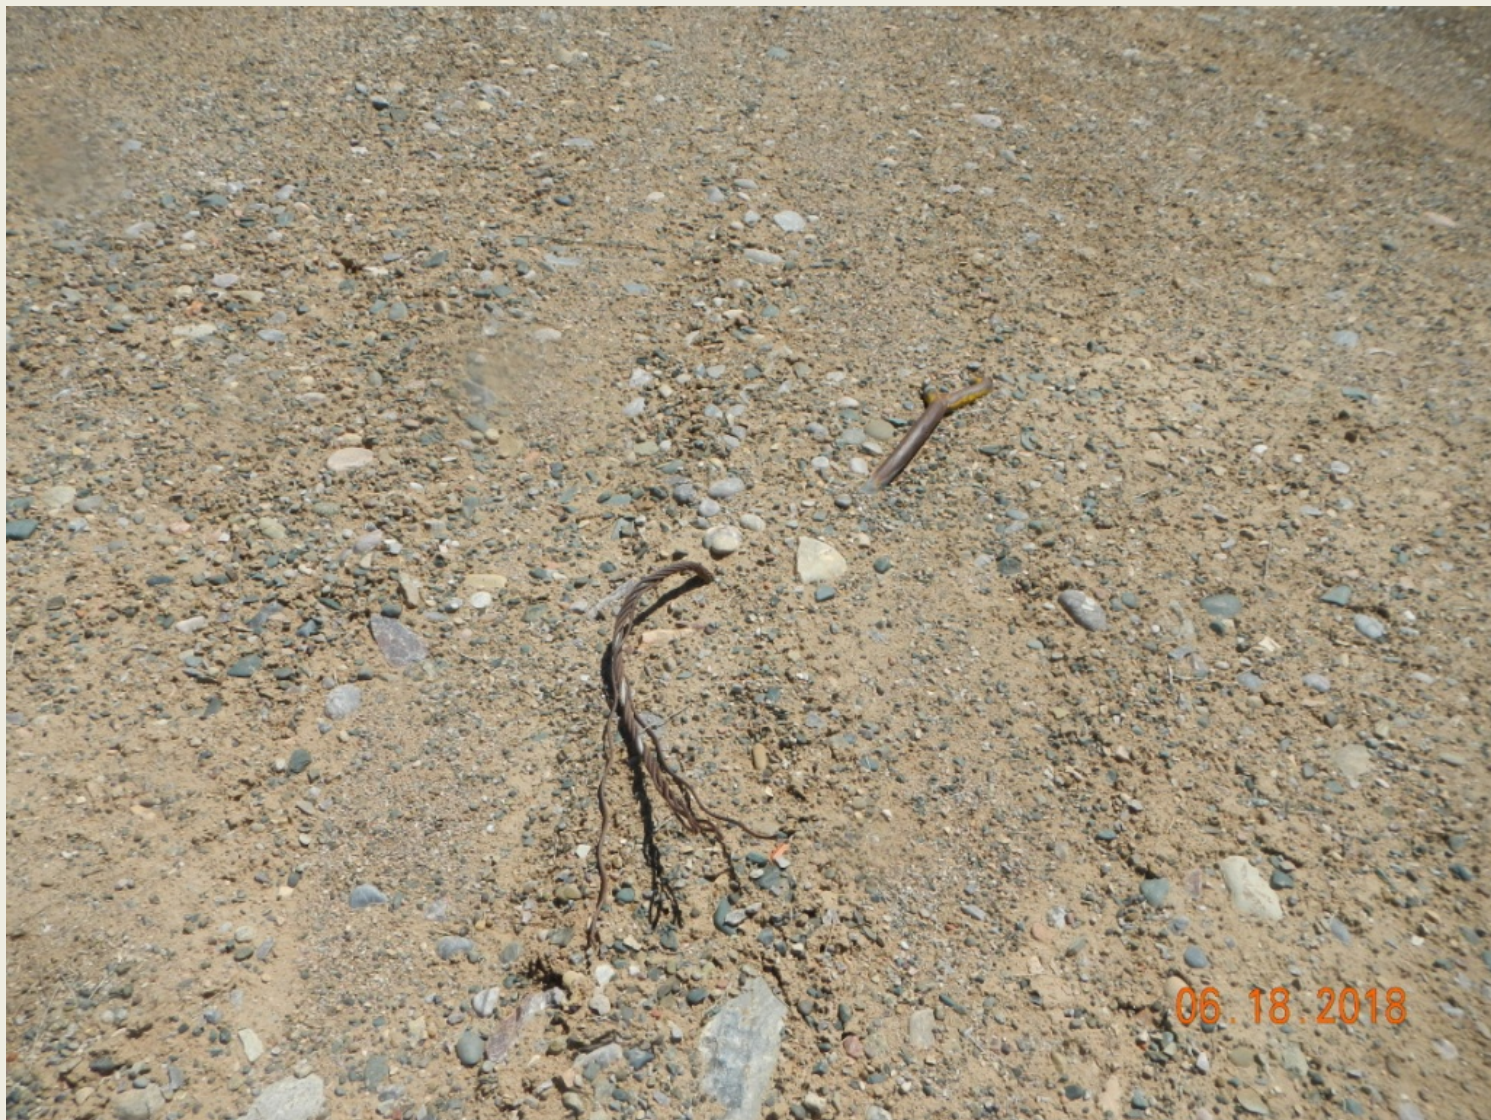
Photo 5. View of unmarked rig anchor within the western portion of the working area.
