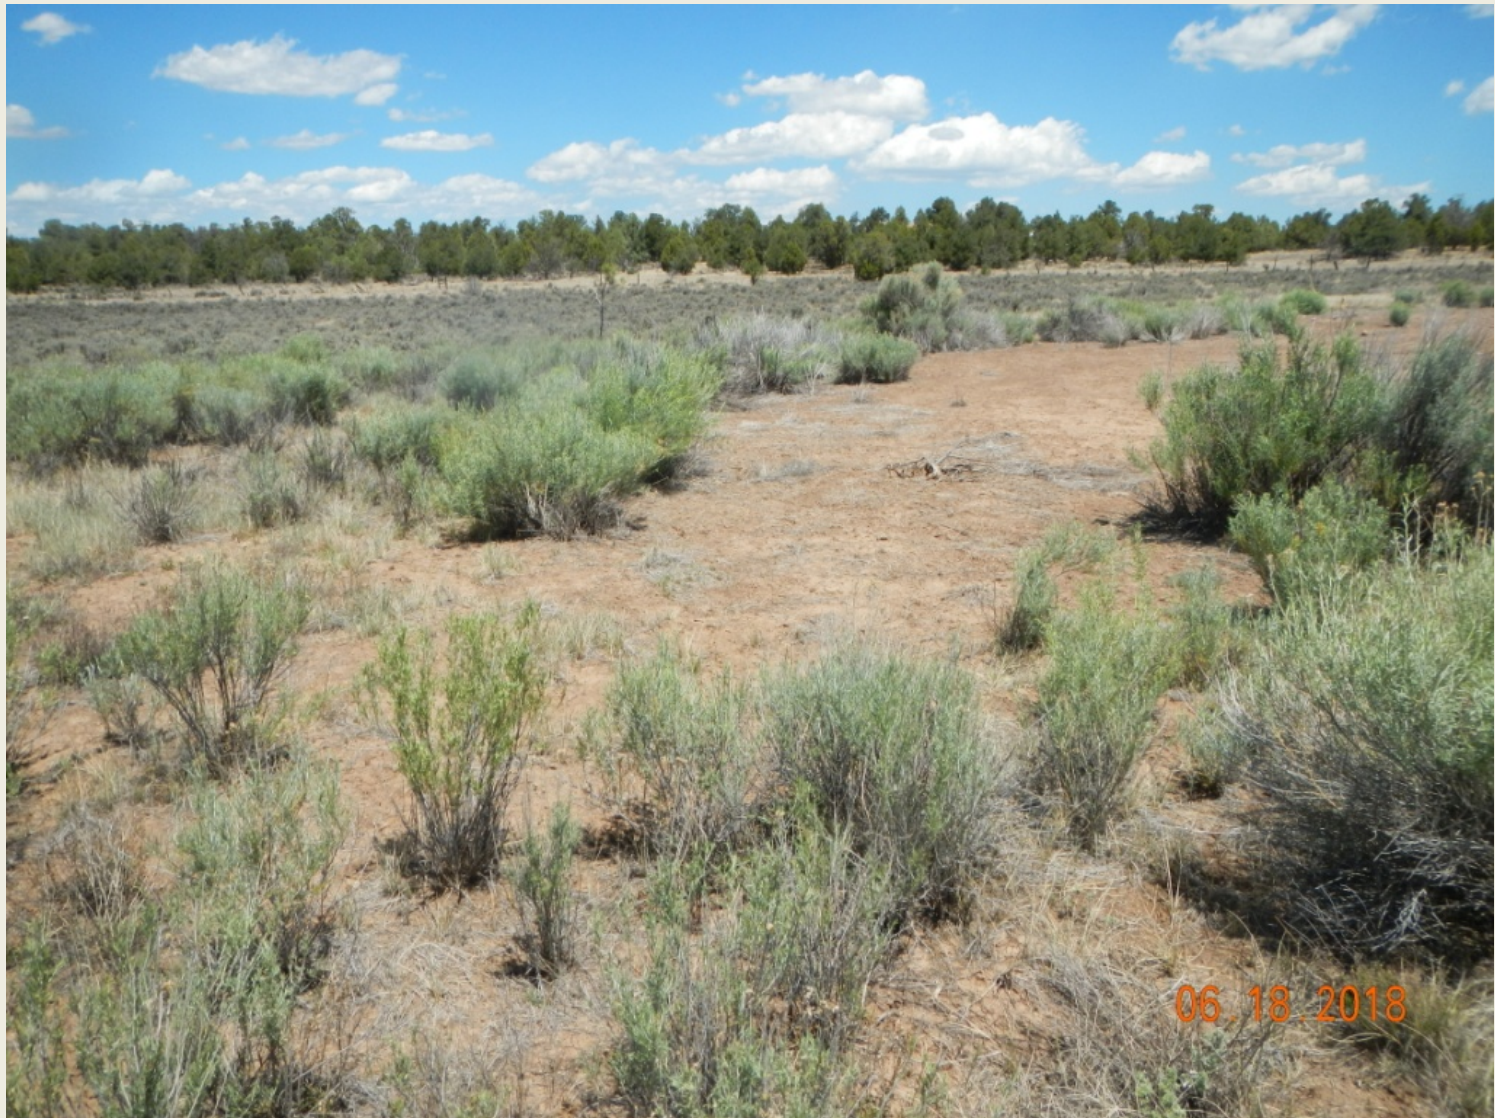
**Photo 2. View of the western portion of the project area from the southwestern corner facing northward. Revegetation is progressing and comprised of grasses and shrubs such as western wheatgrass (*Pascoopyrum smithii*), smooth brome (*Bromus inermis*), and rubber rabbitbrush (*Chrysothamnus nauseosus*).**

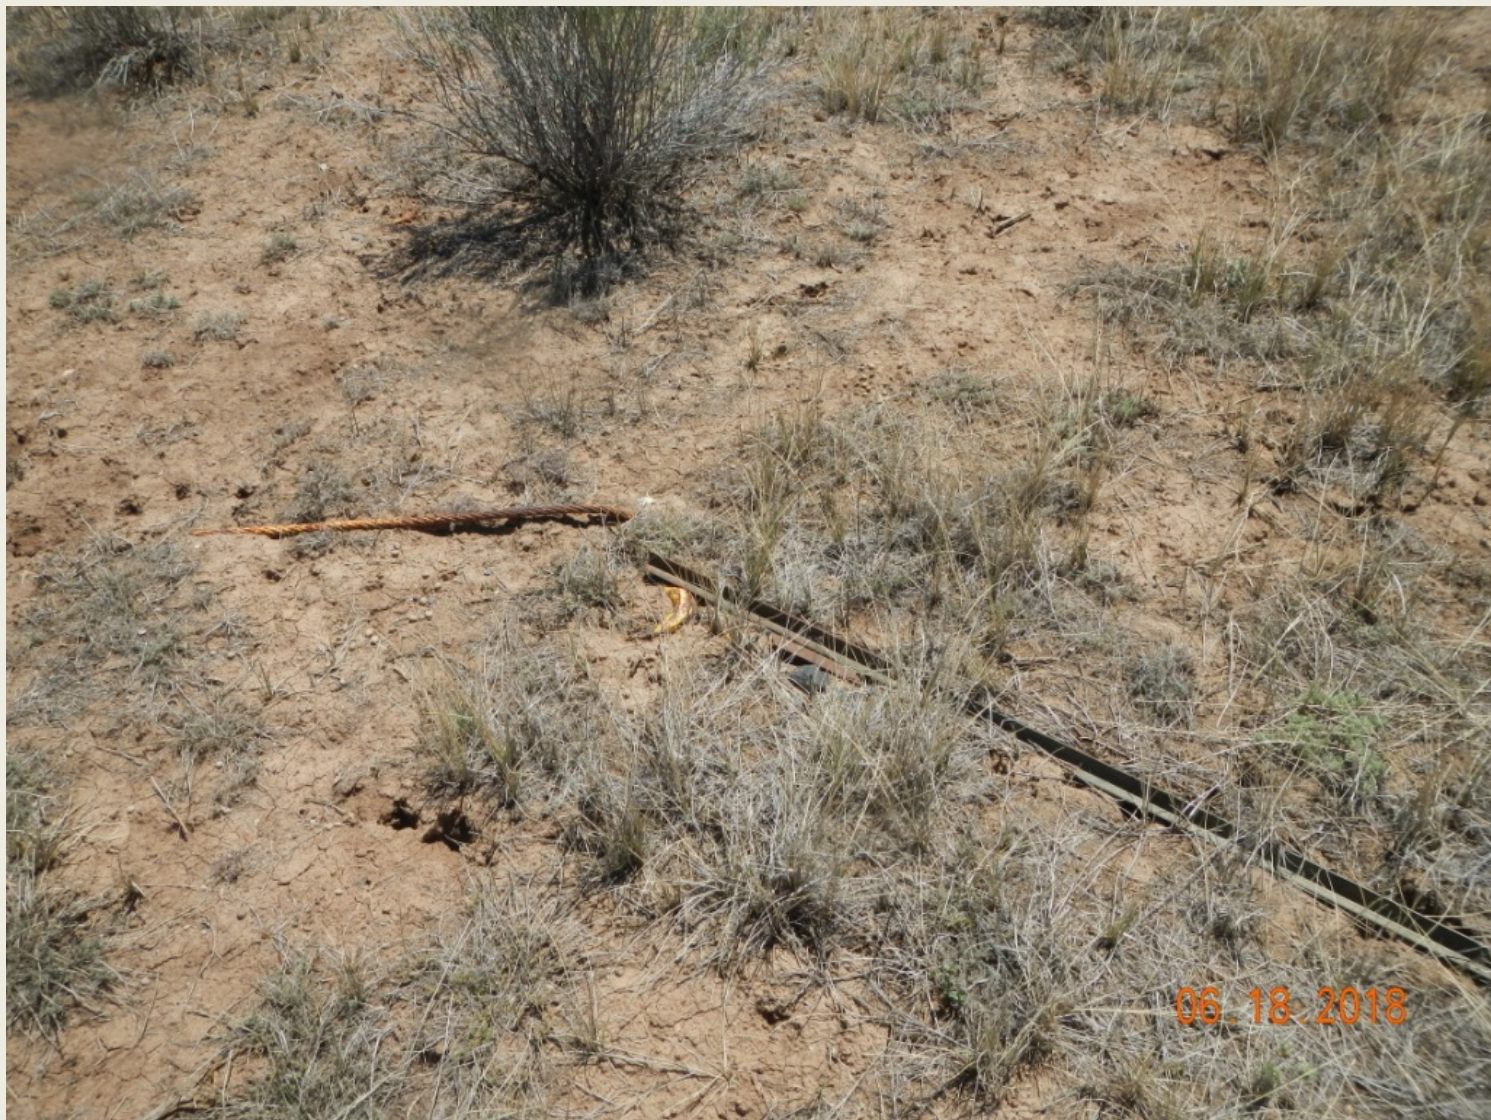
**Photo 4. View of unmarked rig anchor within the western portion of the project area.**

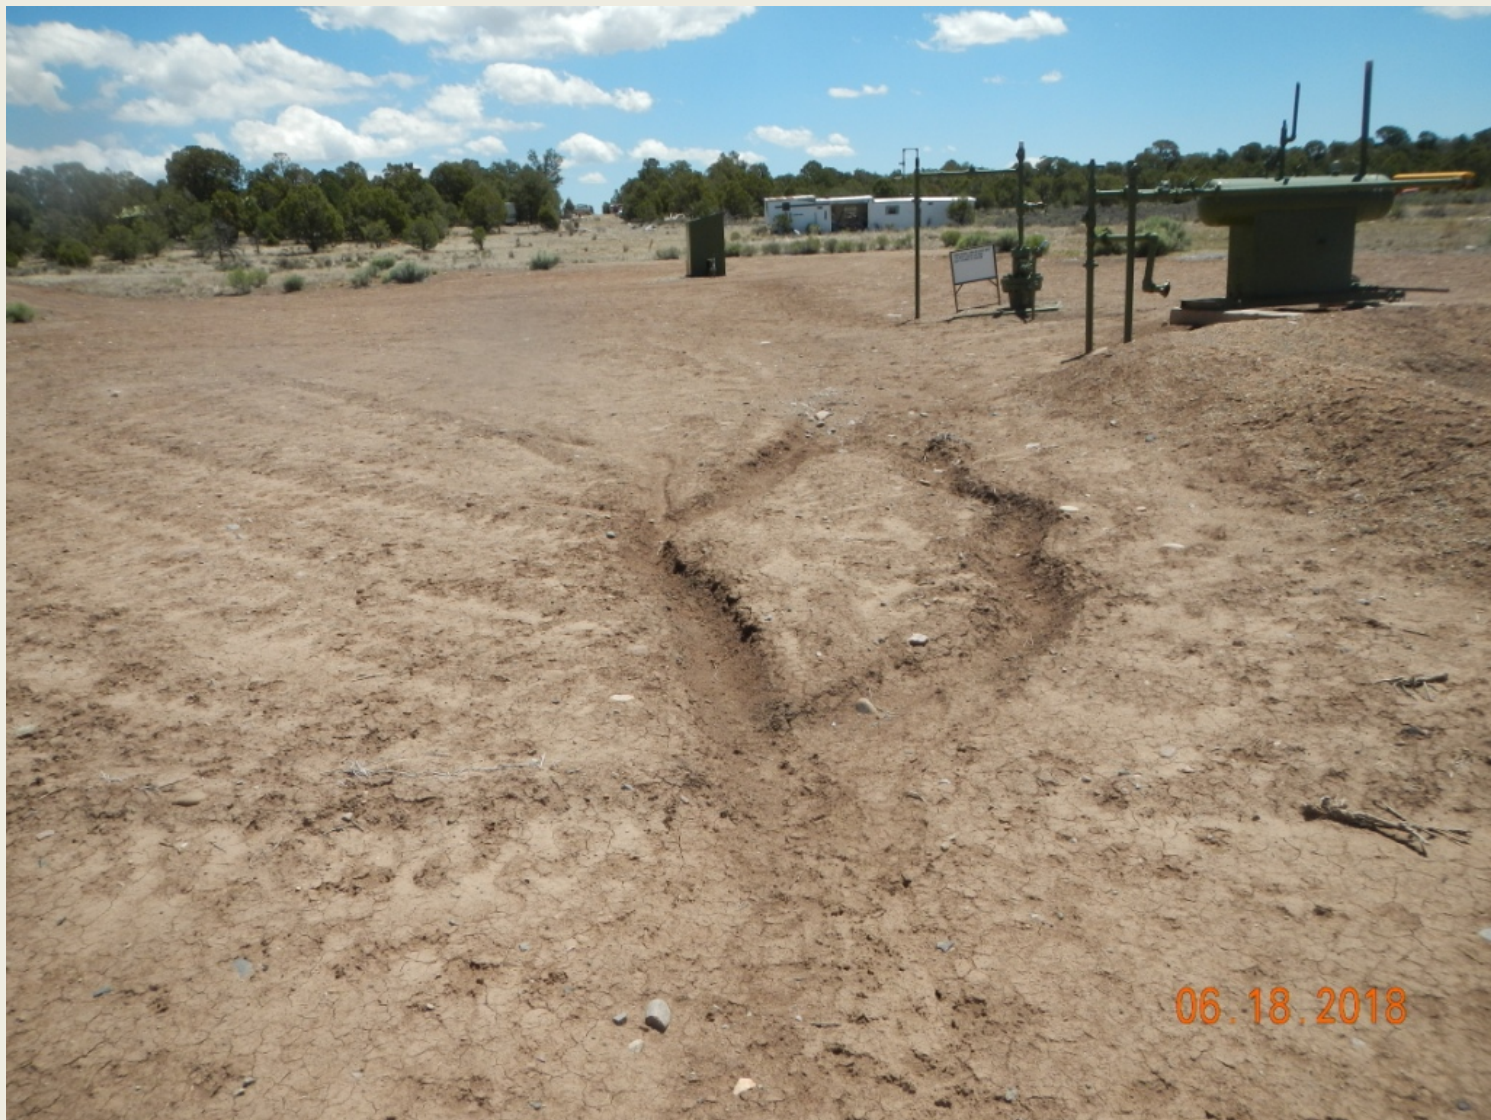
**Photo 5. View area in the western portion of the working area where concentrated stormwater becomes concentrated and is eroding the western portion of the project area.**
