# Final Reclamation Inspection

July 3, 2018

Operator: KERR MCGEE OIL & GAS ONSHORE LP #47120

API: 05-123-14957

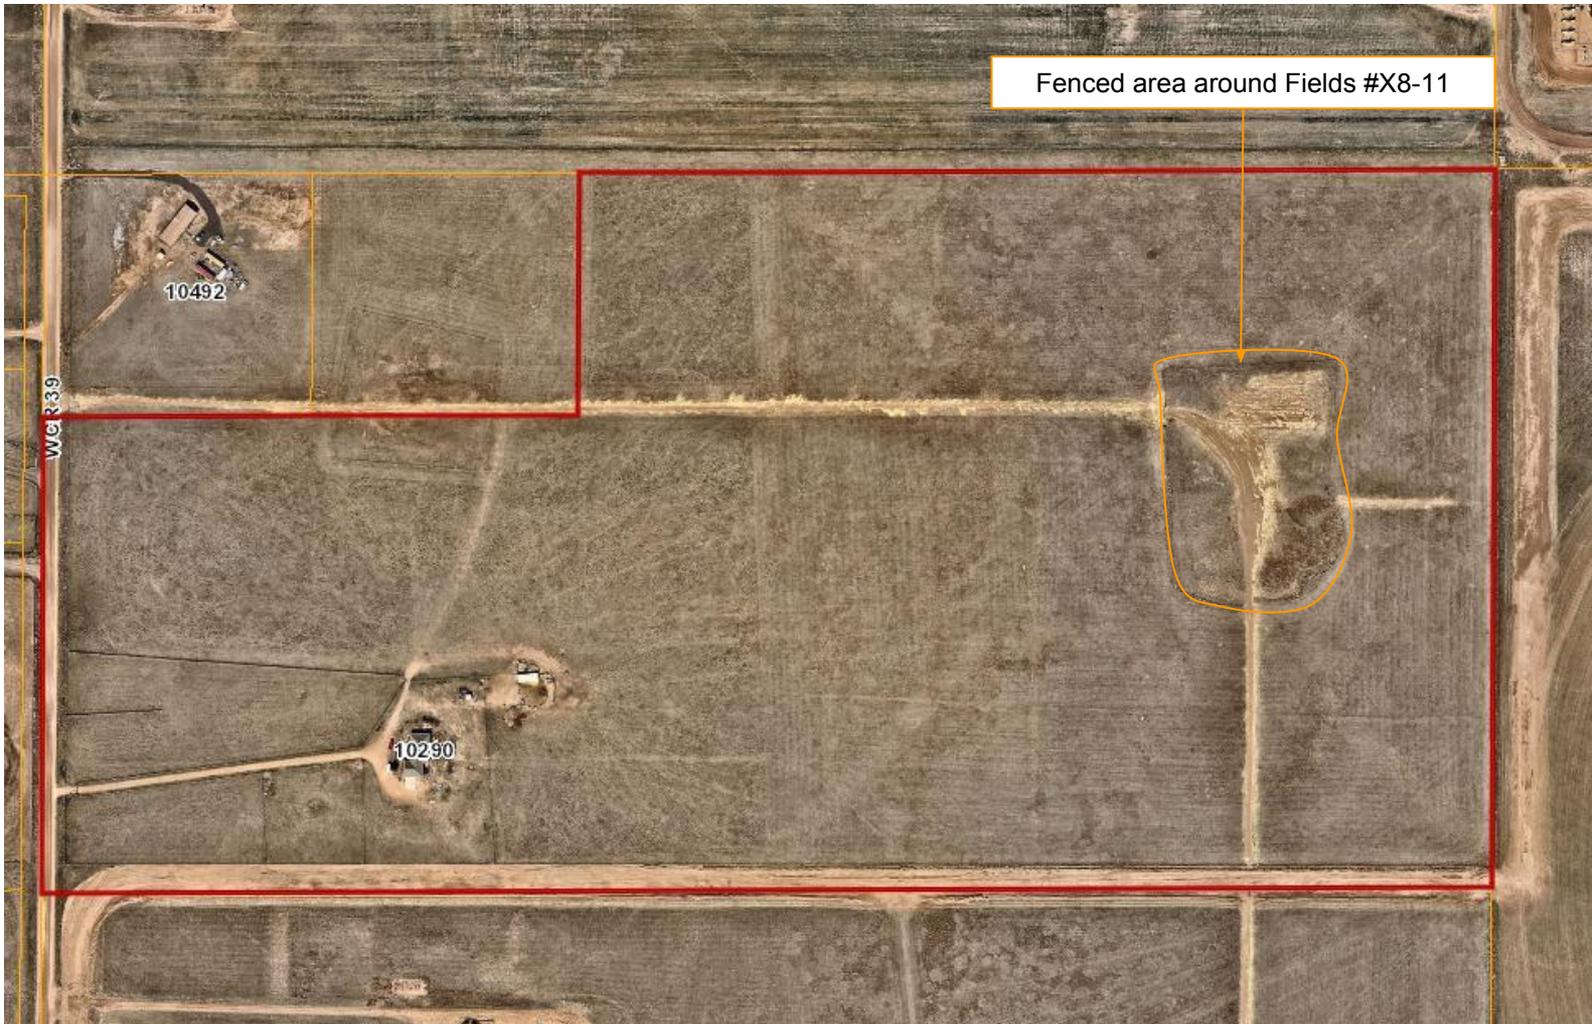
Weld County aerial imagery taken 2018, illustrating the approximate fenced, plugged and abandoned area (orange line) and the surface owner property line (red line). Scotch thistle (*Onopordum acanthium*), a Colorado List B noxious weed, has spread off location- see the following image of the approximate extent off location.

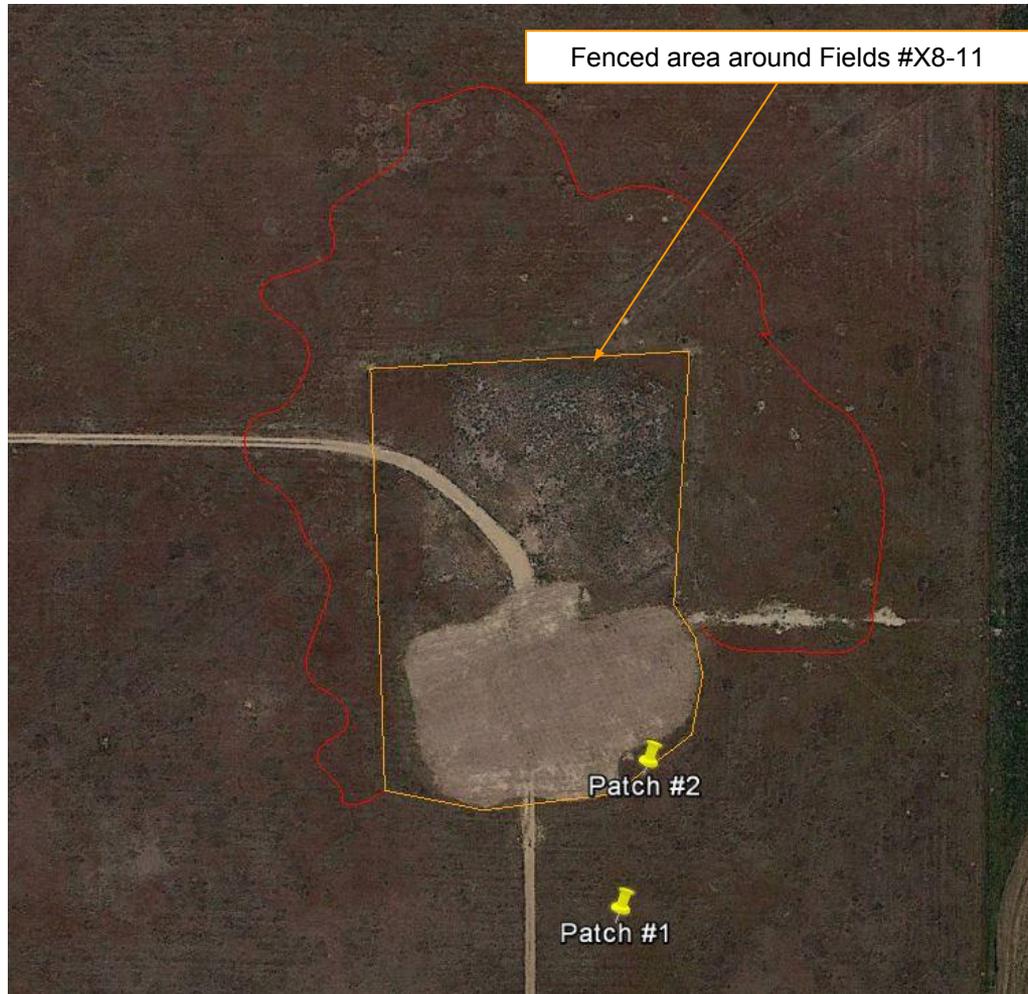
Google Earth aerial imagery taken 6/9/2017, illustrating the approximate fenced area (orange line) and the approximate extent of Scotch thistle (red line). Scotch thistle has spread off location (~200' east; ~250' north; ~125' west; and patches observed south of the location). Complainant indicated that Scotch thistle was not maintained during active operations and spread off location. Scotch thistle was not observed throughout any other portion of the surface owners property.

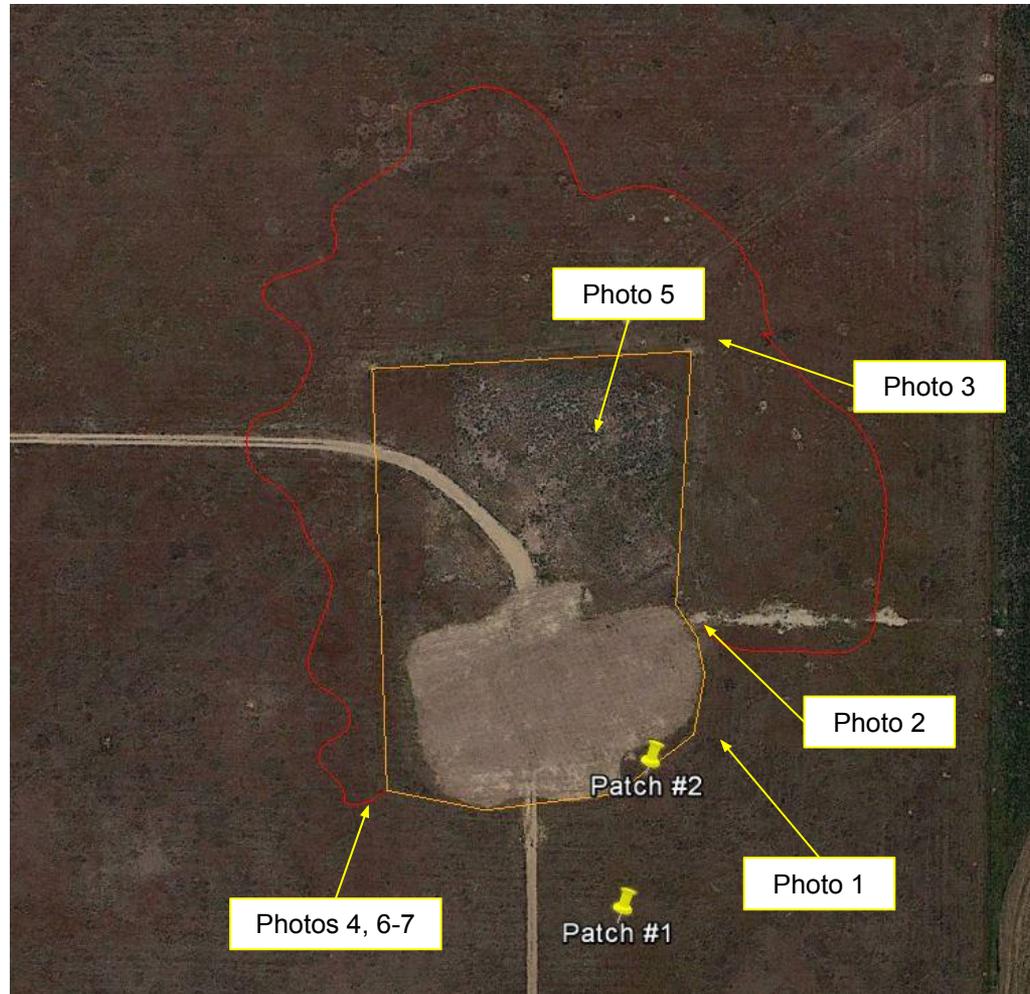
Google Earth aerial imagery taken on 6/9/2017, illustrating photo reference points to help illustrate approximate locations of the subject photo during the July 3, 2018 inspection.

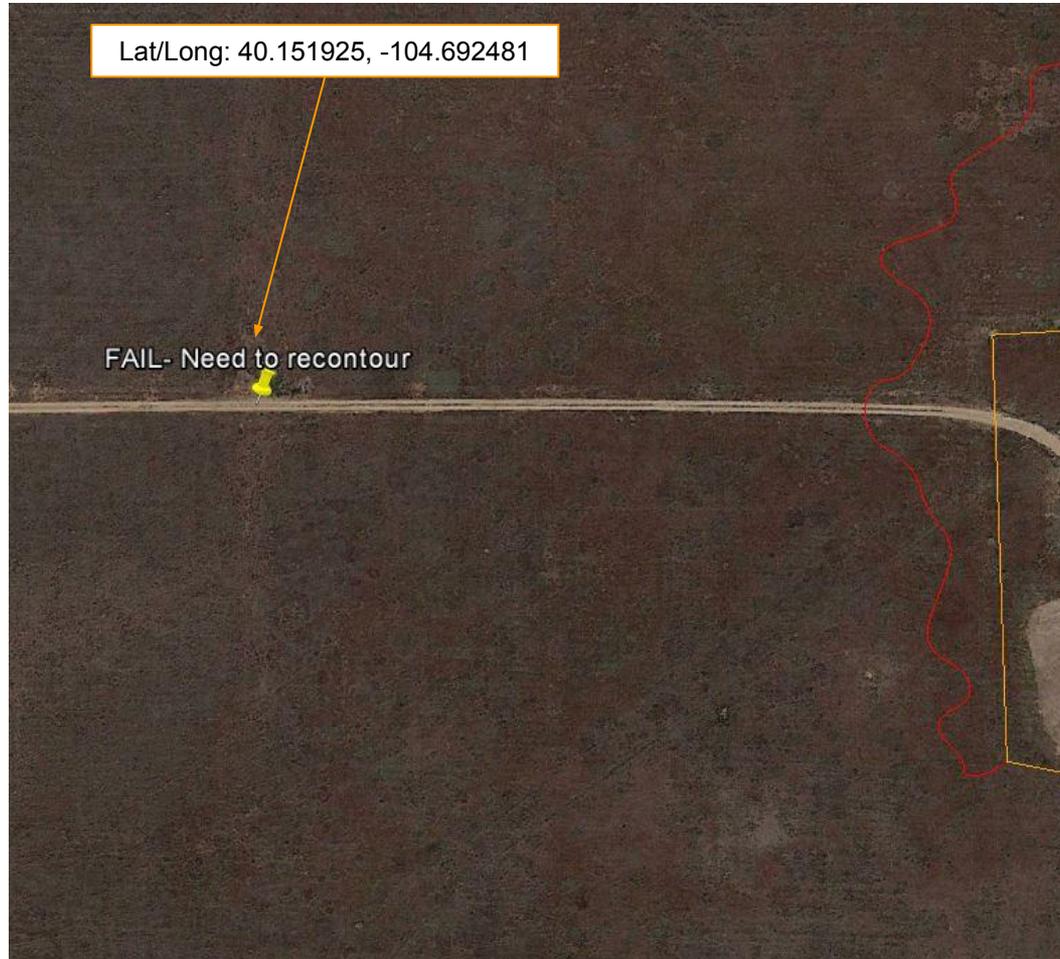
Google Earth aerial imagery taken 6/9/2017, illustrating a marked area of the access road that has not been properly contoured to match the surrounding landscape.

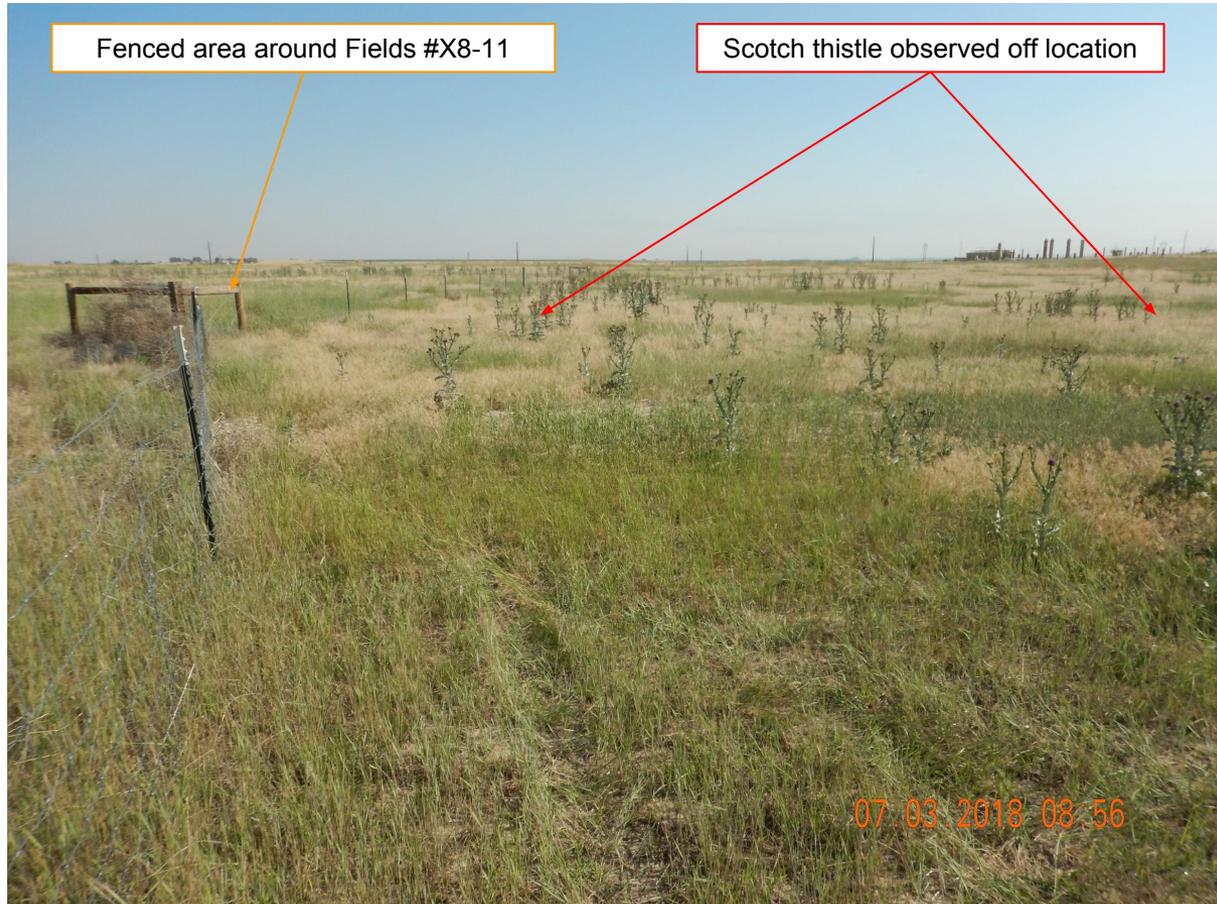
**Photo 1.** Photo taken from the southeastern fenced area, facing North. Photo illustrates Scotch thistle that has spread off location. Operator shall control and manage Scotch thistle that has spread off location. Operator shall coordinate with the surface owner using the Best Management Practices to control and manage Scotch thistle.

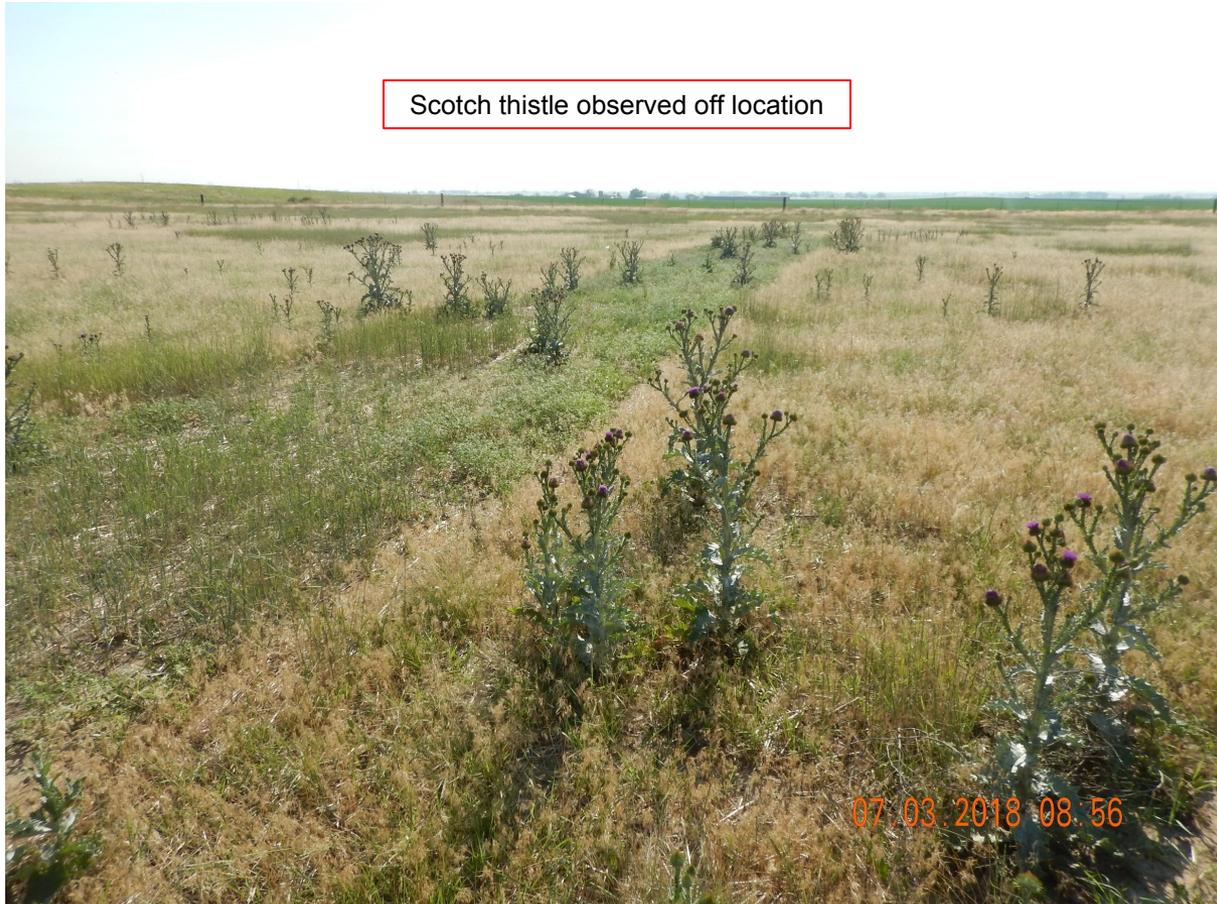
**Photo 2.** Photo taken just beyond the eastern fenced area, facing East off location. See comments under Photo 1.

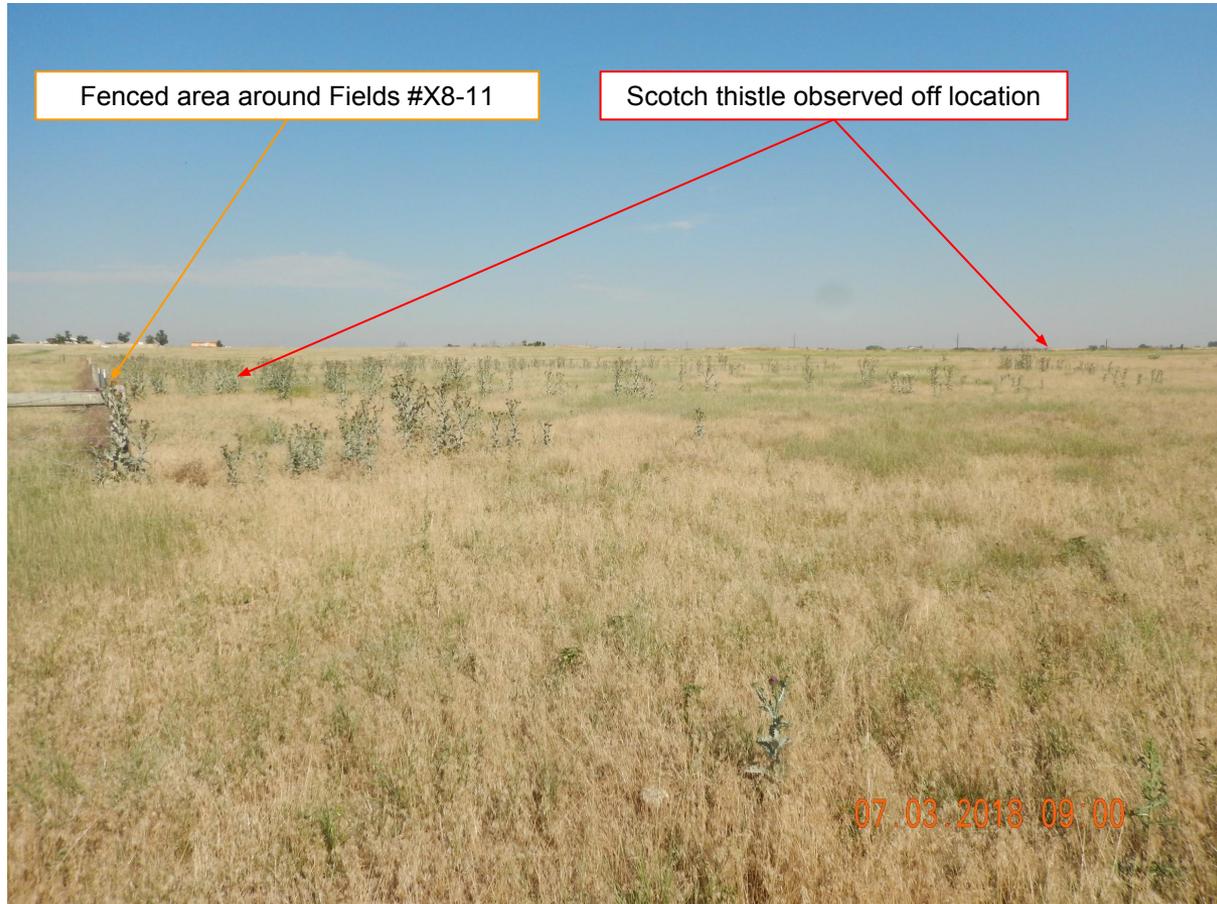
**Photo 3.** Photo taken just beyond the northeastern fenced area, facing Northwest off location. See comments under Photo 1.

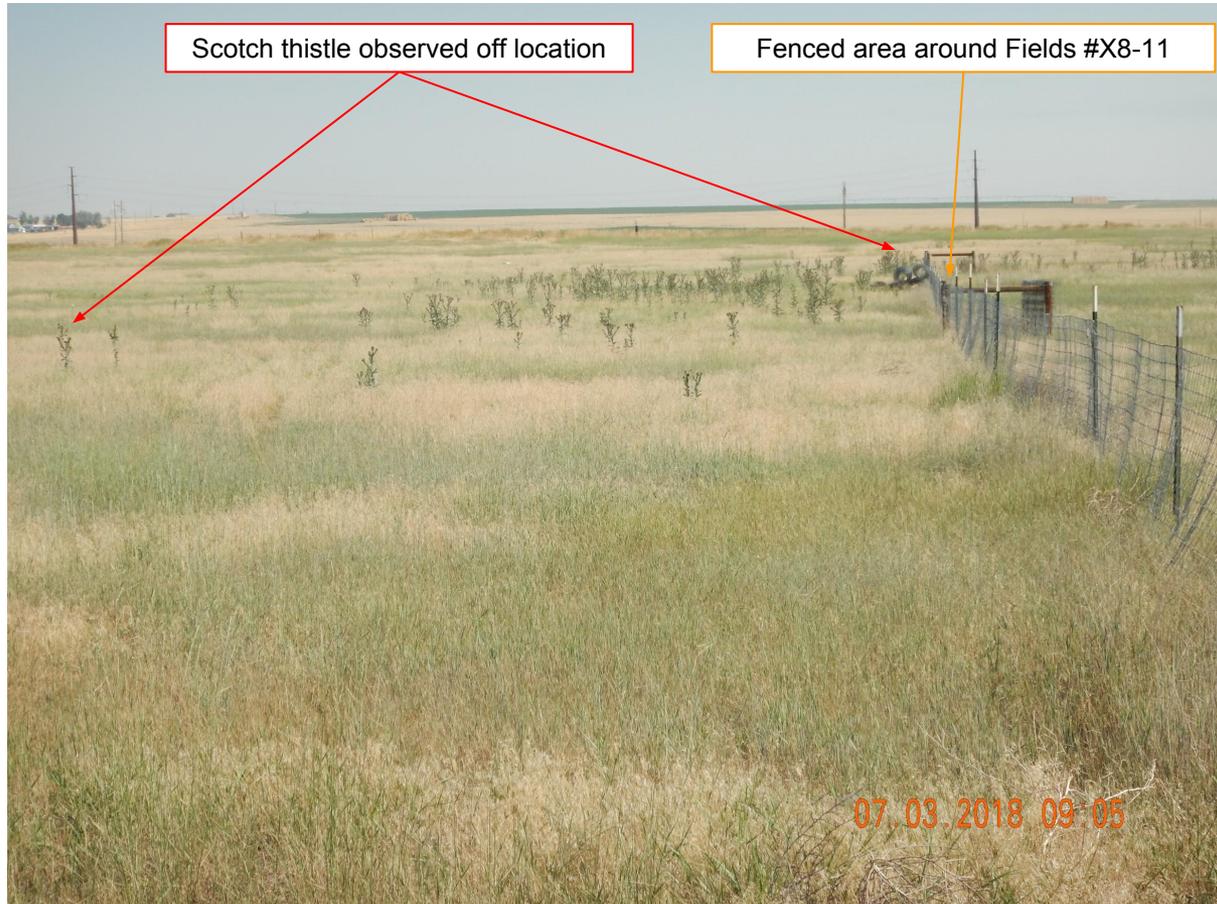
**Photo 4.** Photo taken just beyond the southwestern fenced area, facing North off location. See comments under Photo 1.

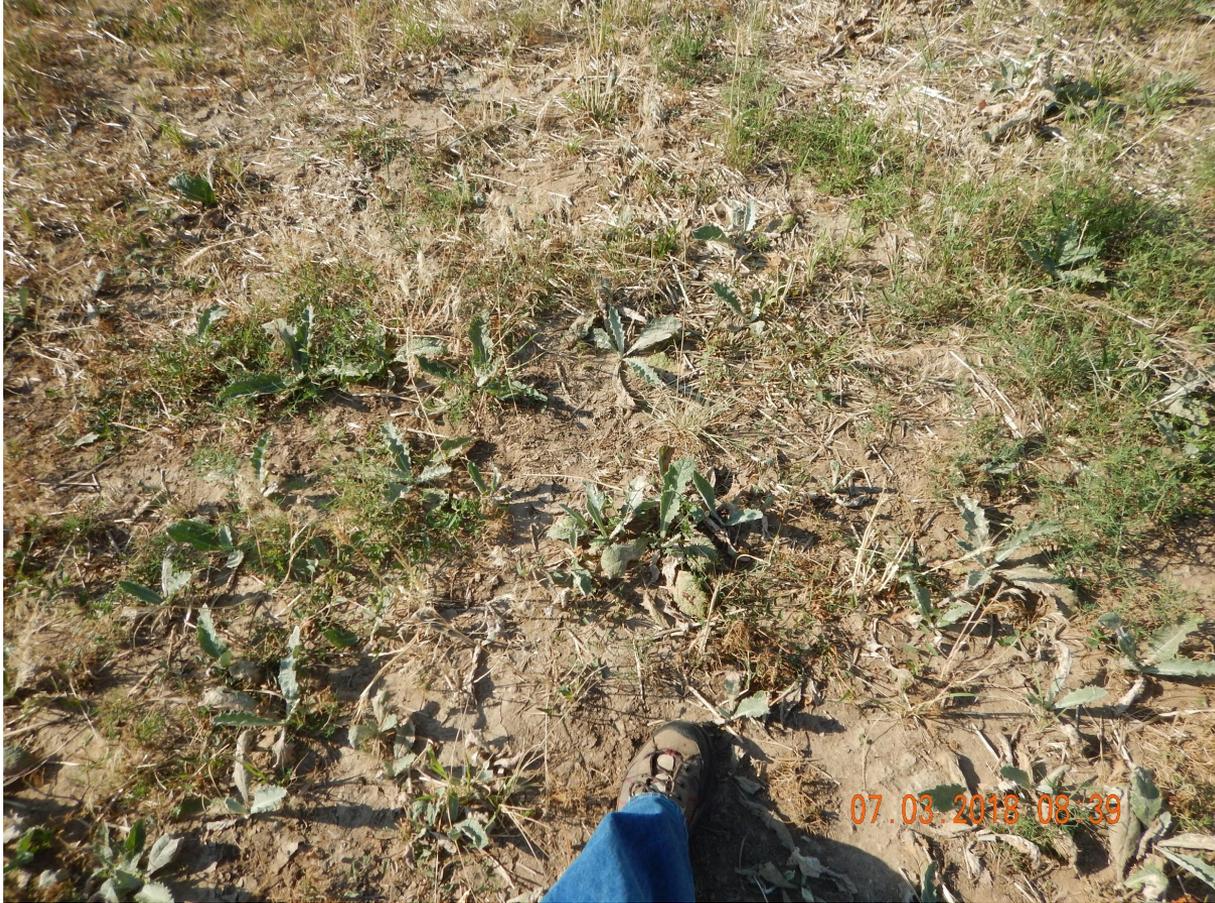
**Photo 5.** Photo taken from the northeastern location. Photo illustrates viable Scotch thistle rosettes. Operator claims that recent weed management was performed but several viable Scotch thistle rosettes were observed within the location. Operator shall coordinate with the surface owner using the Best Management Practices to control and manage Scotch thistle.

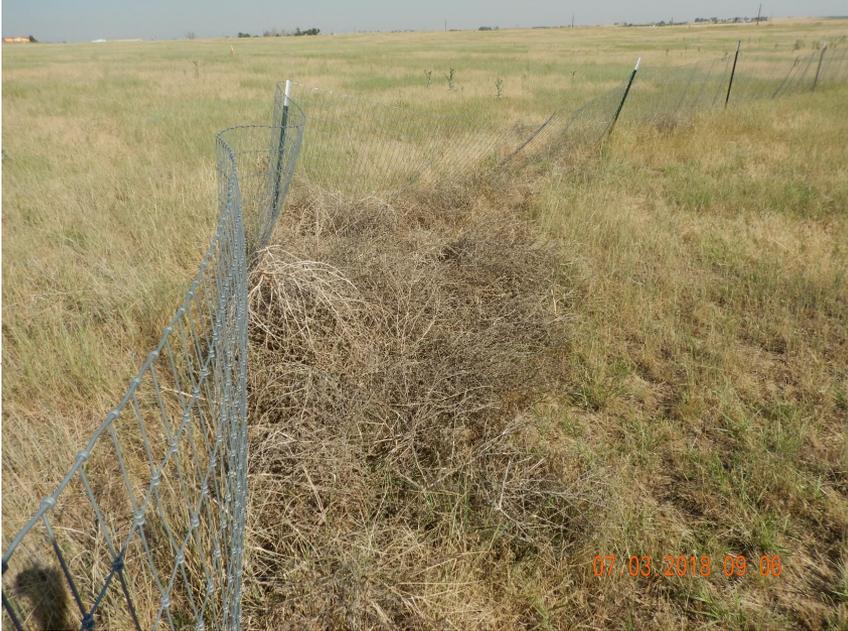
**Photo 6.** Photo taken from the southwestern location, facing Northwest. Photo illustrates Russian thistle weed debris. Per Rule 603.f., Operator shall control and manage Russian thistle weeds to prevent weed waste and to prevent the spread of dispersing seeds onto adjacent lands.

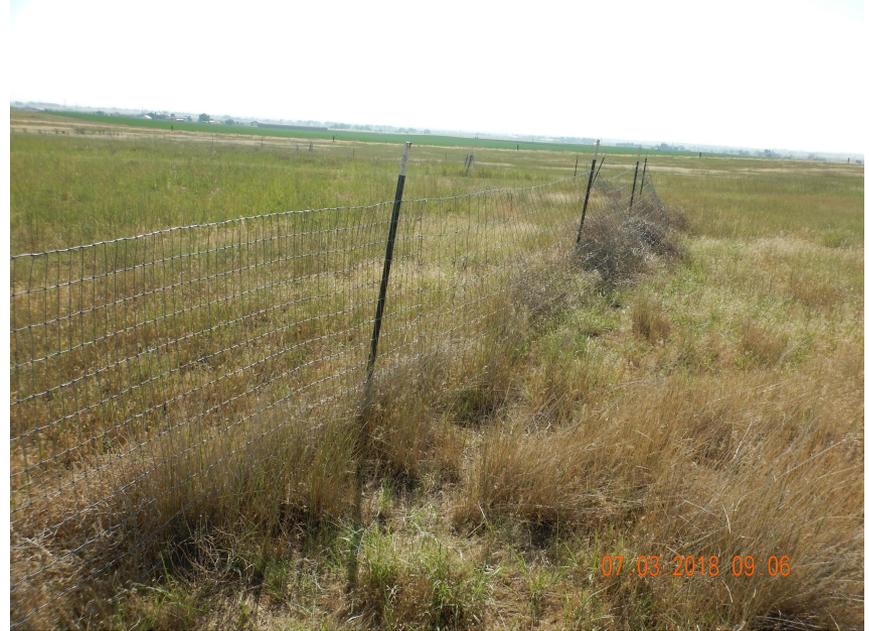
**Photo 7.** Photo taken from the southwestern location, facing East. See comments under Photo 6.
