Extraction Triple Creek Location Photos Demonstrating Compliance and Corrective Actions

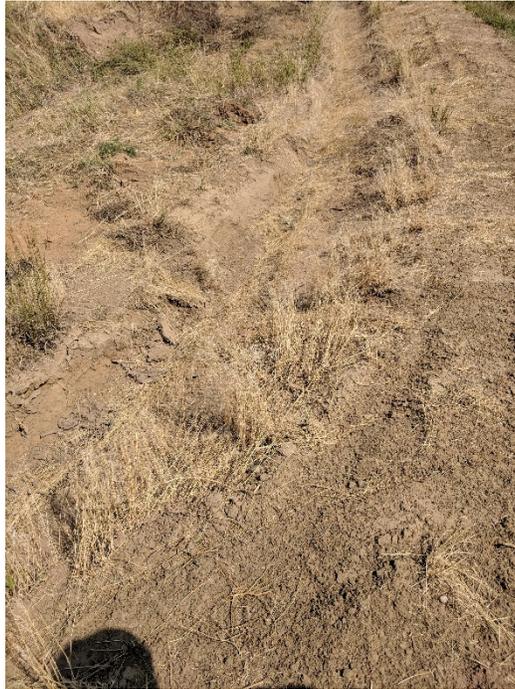
Photo #1.

This picture corresponds to COGCC Photo #13 and shows that trash has been picked up.

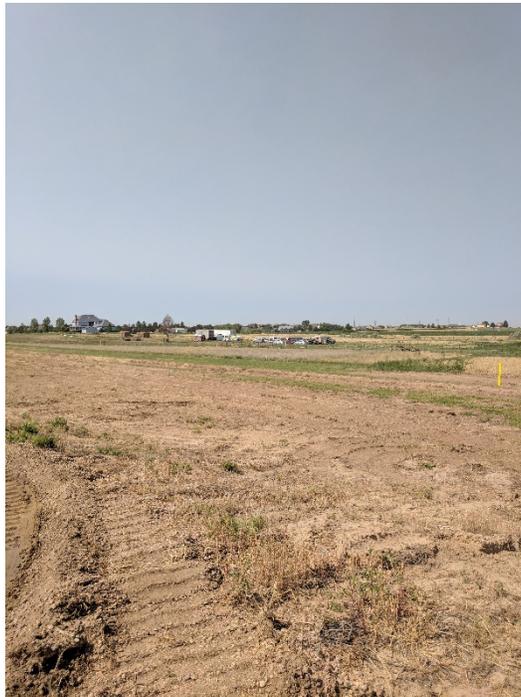
Photo #2

Adjacent landowner's junk yard/ dump that is source of trash on location.

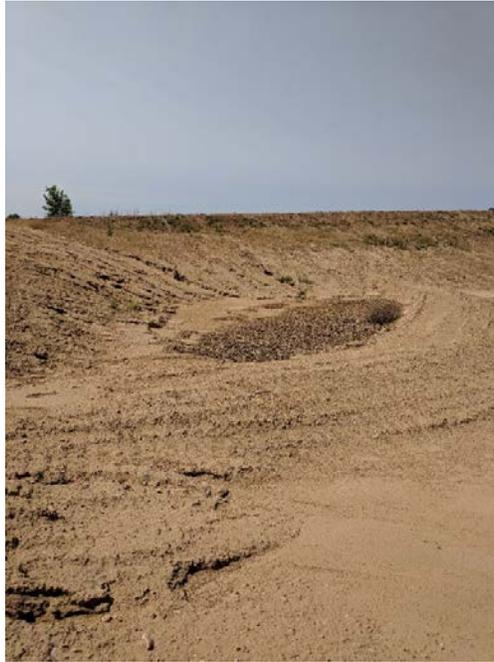
Photo #3

Temporary berms constructed below slopes. Some slopes are still too saturated and unstable to work on as of 7/9/18, but will be repaired as soon as it is feasible to do so.

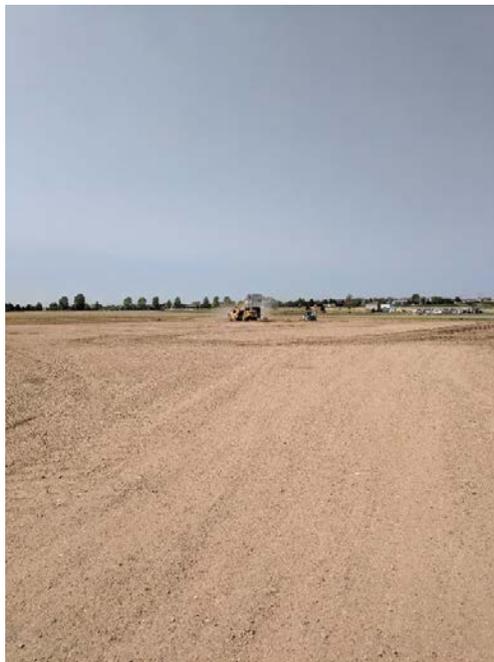
Photo #4

Scraper working dirt on uppermost area on 7/9/18.

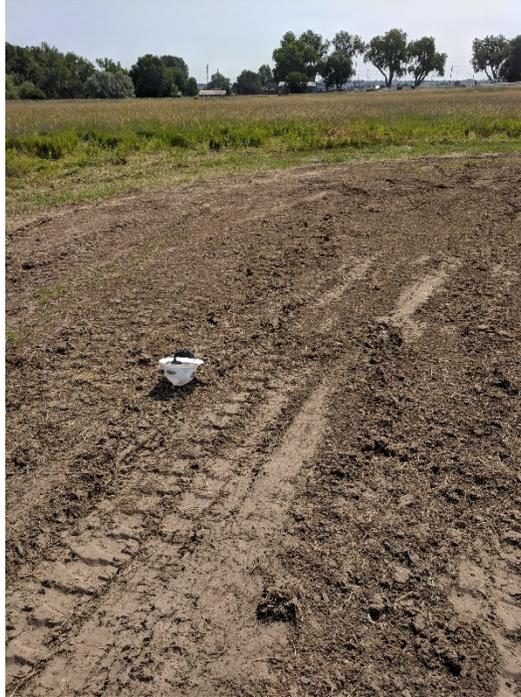
Photo #5

This picture corresponds to COGCC Photo #15 and shows the ruts have been fixed.

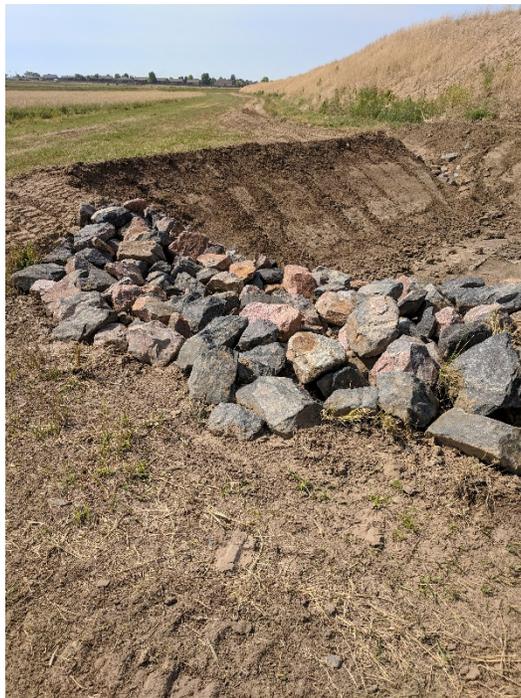
Photo #6

This picture corresponds to COGCC Photo #14 and shows that the sediment pond has been repaired and no sediment was discharged.

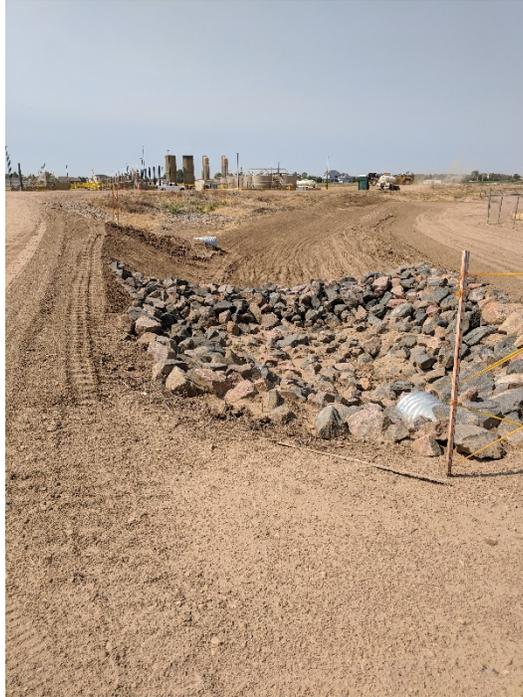
Photo #7

This picture corresponds to COGCC Photos #6 & 8 and shows that the area has been repaired.

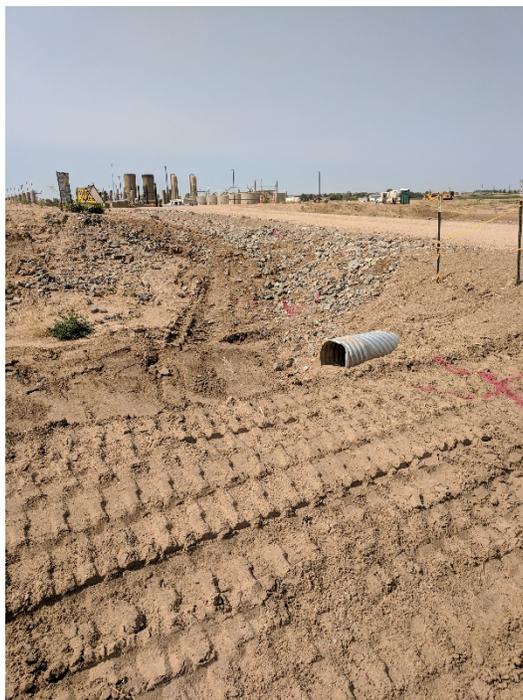
Photo #8

This picture corresponds to COGCC Photo #5 and shows that the area has been repaired.

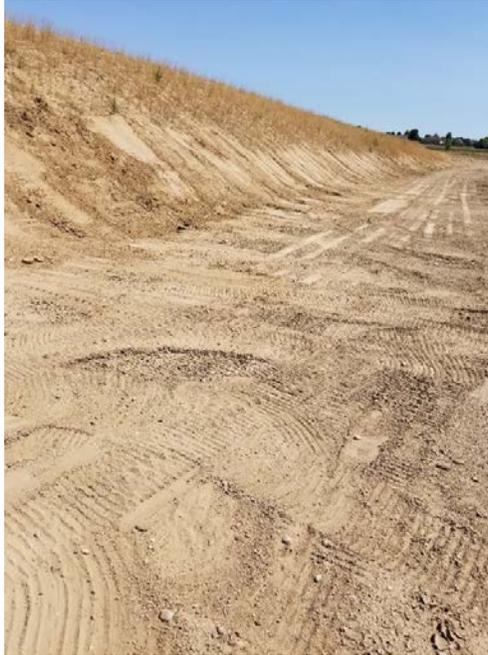
Photo #9

As shown, in part, above, repair work began on 7/9/18 to repair slopes noted in COGCC photo #s 16,17, 18, & 20. It should be noted that this work began as soon as it was practicable to work on the slopes after they had dried out.

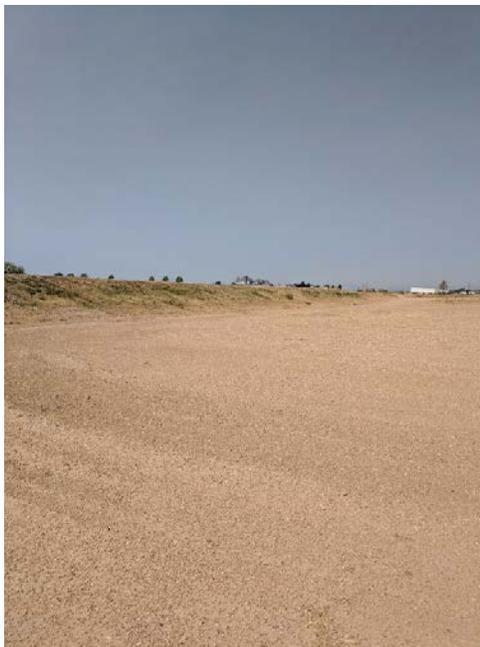
Photo #10

The above shows the topsoil slopes in greater detail. As documented here, the topsoil slopes experienced very little erosion overall, and the small area in COGCC photo #20 is in the process of being repaired as of 7/9/18.

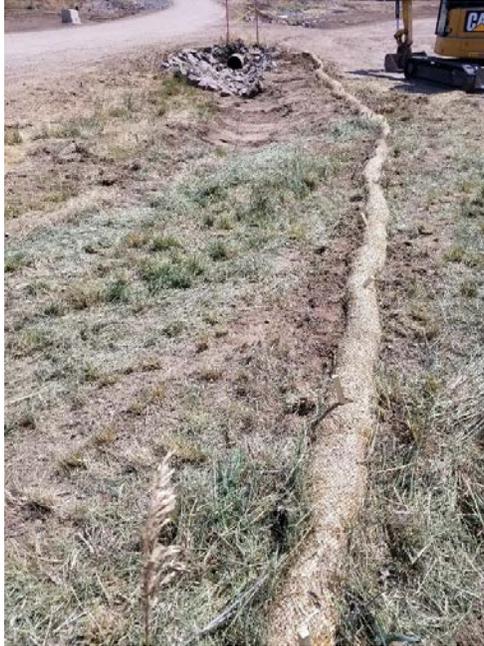
Photo #11

This picture corresponds to COGCC Photo #s 3&4 The area was repaired and BMPs were updated per Extractions internal corrective actions

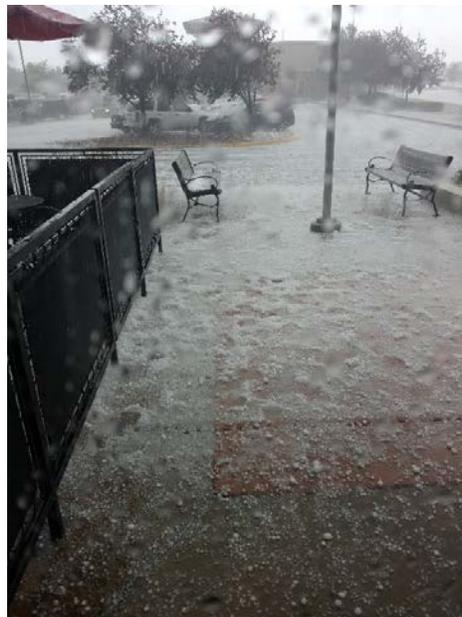
Photo #12

Example of the flooding event on 6/19 from a restaurant 1 ½ miles to the east of Triple Creek Location. This storm was the first in a series of microburst hail storms that hit the Triple Creek Location through 6/24.

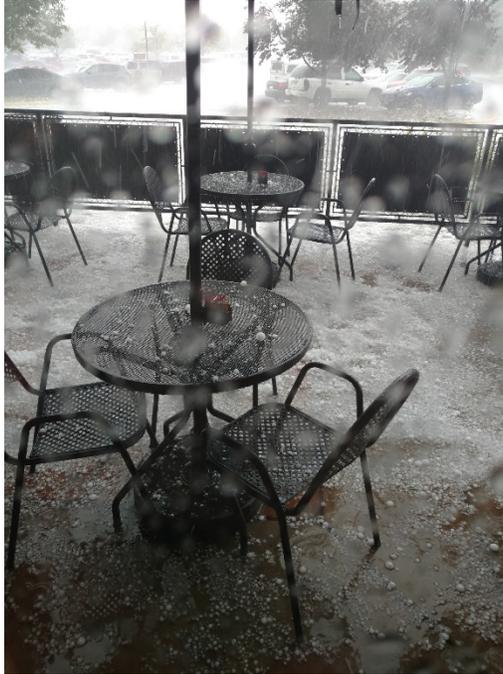
Photo #13

Golf ball sized hail to the east of Triple Creek (same location as above). This was a photo from the 6/19 storm that was the first in a series of microburst downpours that hit the location thru 6/24.

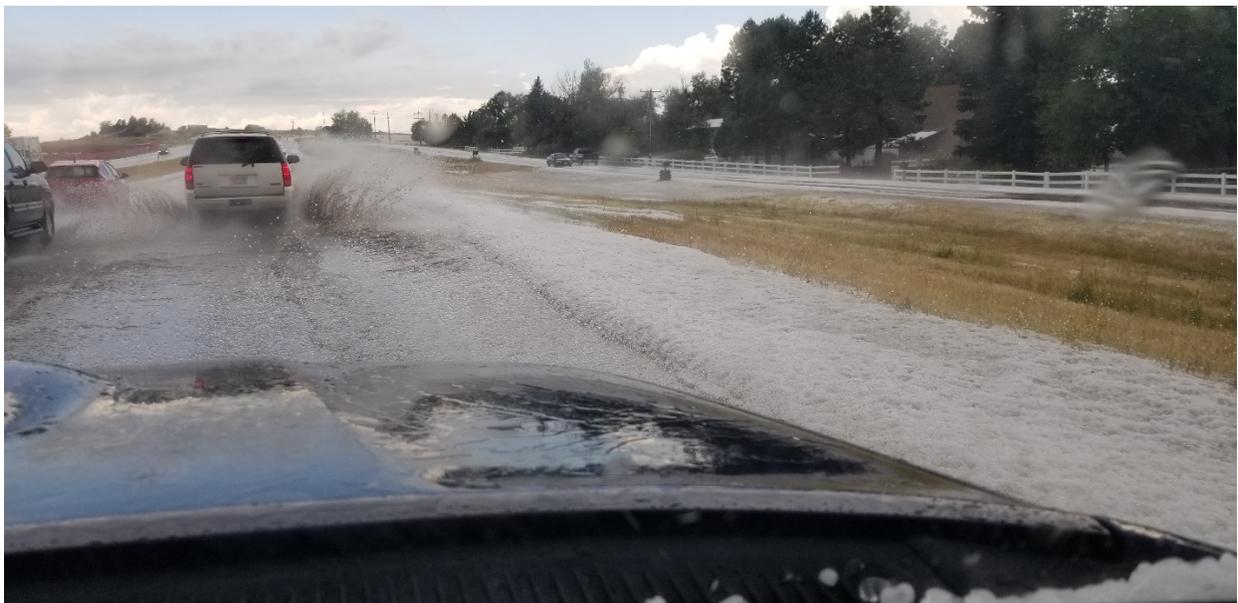
Photo #14

HWY 34 just to the north of the Triple Creek location showing the flooding as a result of a microburst. This was from the 6/19 storm, which was the first in a series of microbursts that hit the location, the last of which was on 6/24.
