Inspection Photos

Operator: FOUNDATION ENERGY
MANAGEMENT LLC - 10112

Location ID: 331849

Inspection Doc. Number: 682503566
Weld County, CO

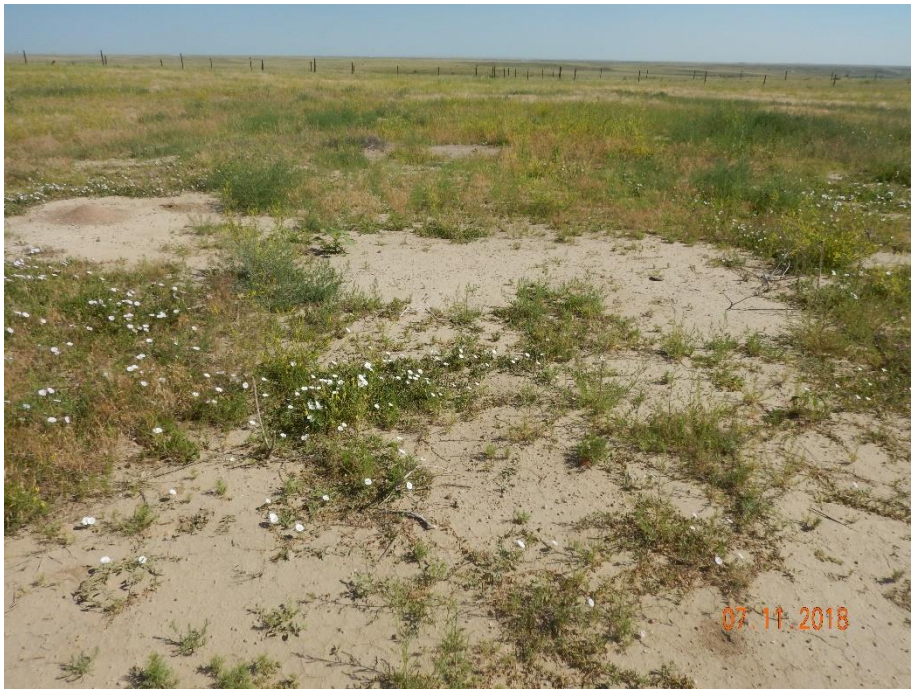
Photo 1: Photo taken from the location, facing north. Previous inspection required reclamation activities to be conducted on location and access road. Photo shows location remains predominantly bare and exposed soil. Unable to find evidence of reclamation.

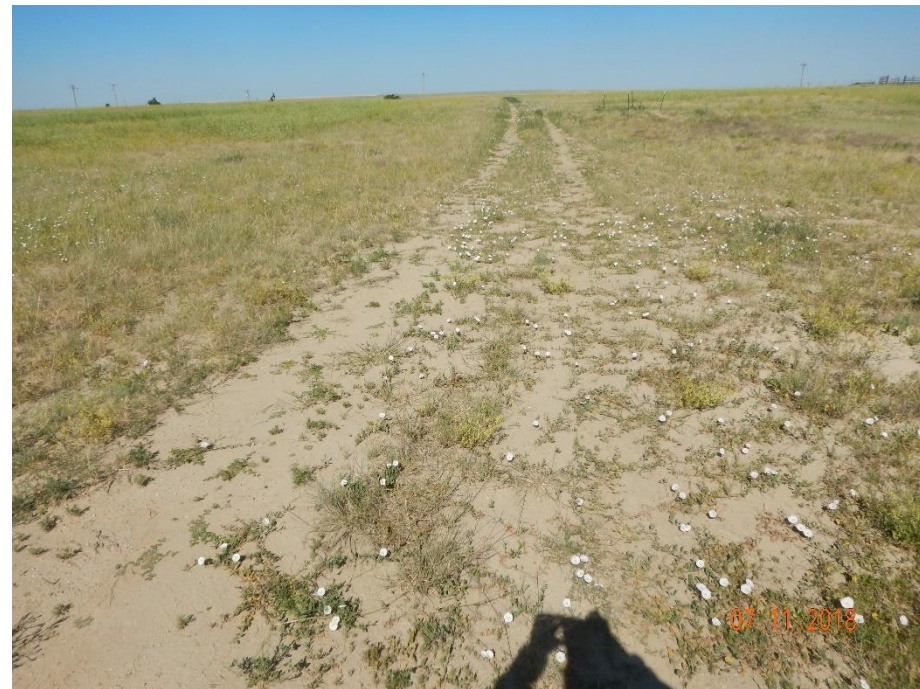
Photo 2: Photo taken from the location, facing west. Previous inspection required reclamation activities to be conducted on location and access road. Photo shows location remains predominantly bare and exposed soil. Unable to find evidence of reclamation.

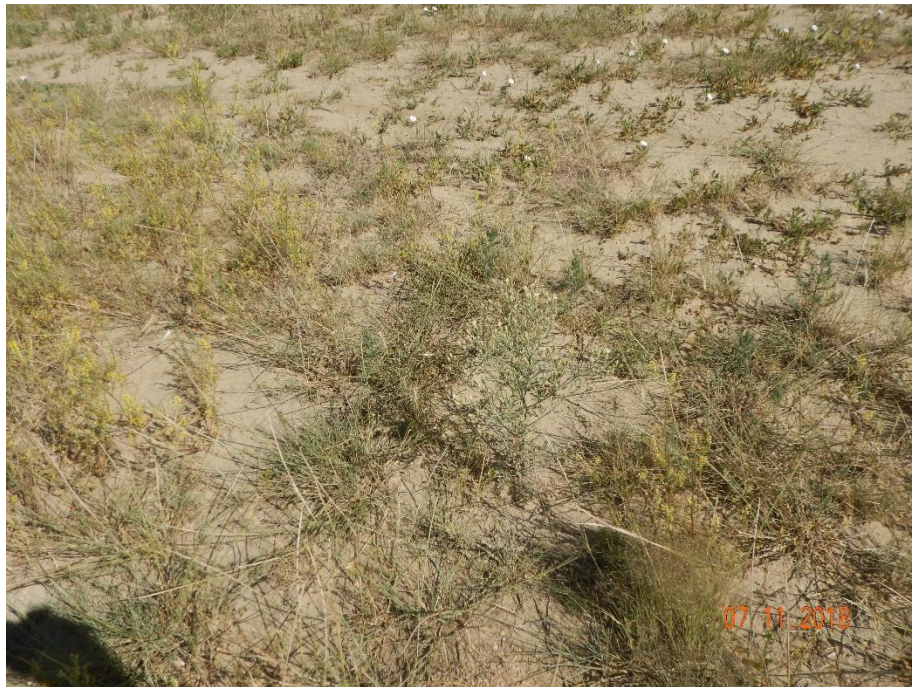
Photo 3: Photo taken from the south end of the location. Previous inspection required management and removal of noxious weeds.

Photo shows Diffuse Knapweed (lighter, grey-green plants, white colored flowers) remains prevalent on location and have not been managed/removed. Plants are flowering or have matured and are preparing to seed.

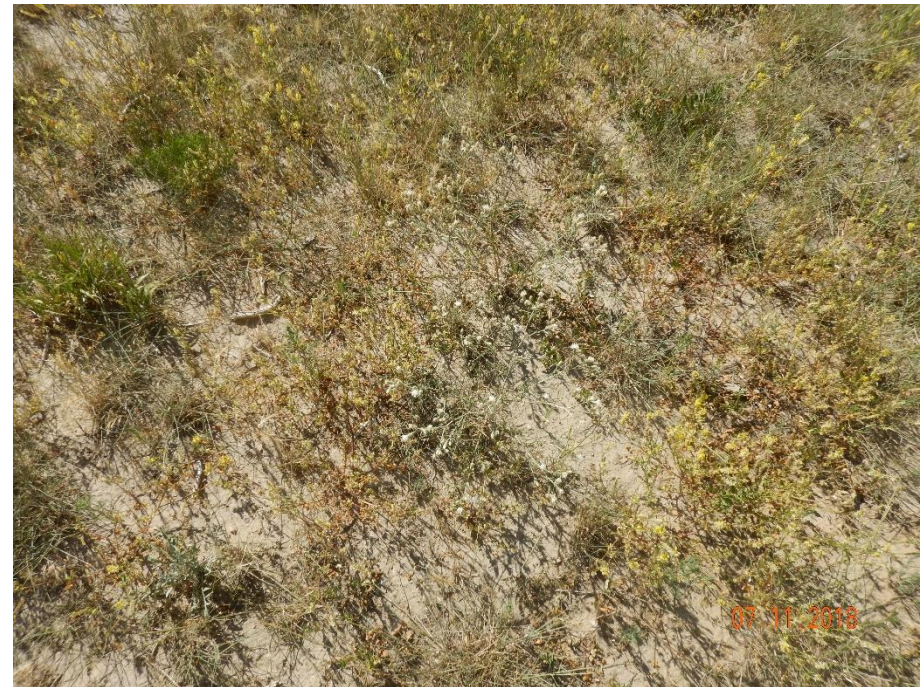
Photo 4: Photo taken from the south end of the location. Previous inspection required management and removal of noxious weeds.

Photo shows Diffuse Knapweed (lighter, grey-green plants, white colored flowers) remains prevalent on location and have not been managed/removed. Plants are flowering or have matured and are preparing to seed.
