Inspection Photos

Operator: FOUNDATION ENERGY
MANAGEMENT LLC - 10112

Location ID: 327558

Inspection Doc. Number: 682503576
Weld County, CO

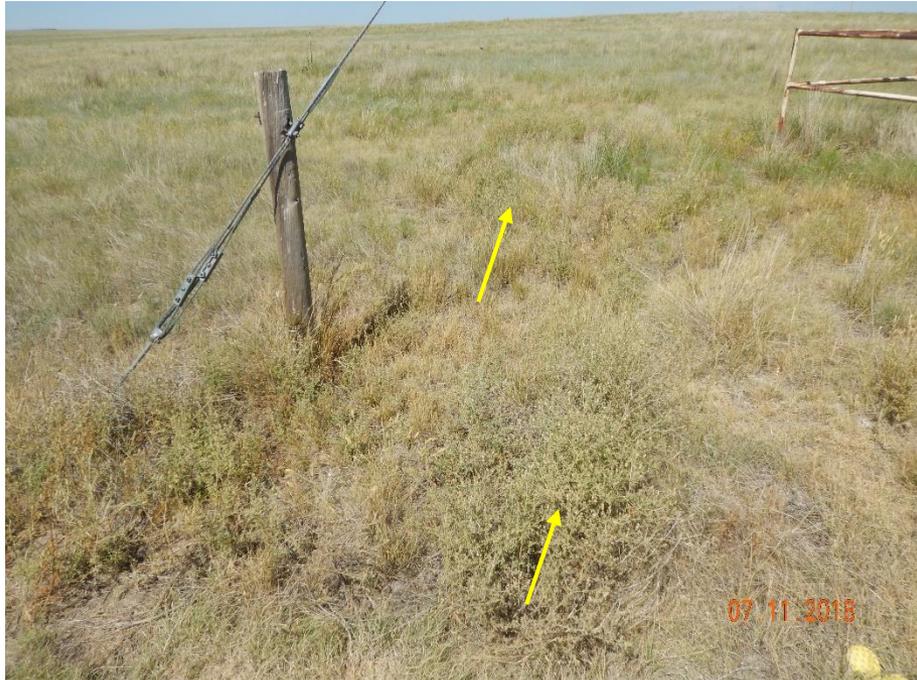
Photo 1: Photo taken from the western interim areas of the location, facing west.. Previous inspection required management and removal of noxious weeds.

Photo shows Diffuse Knapweed (lighter, grey-green plants, white colored flowers) remains prevalent on location and access roads. Though there is evidence of herbicide, spraying does not appear to have been sufficient as many plants appear to be viable and have continued to mature/flower

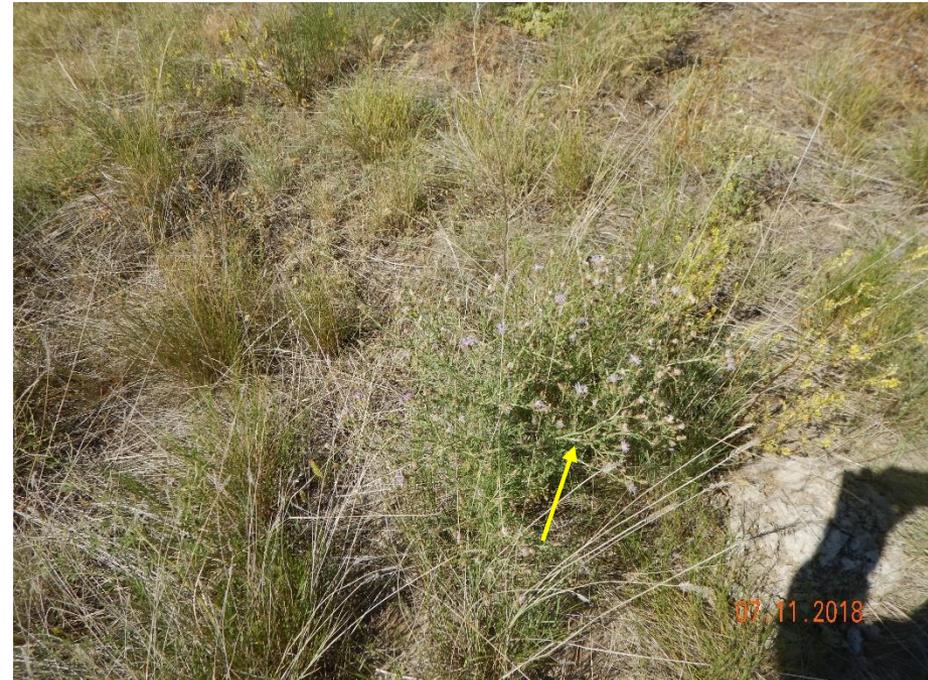
Photo 2: See comments under photo 1.

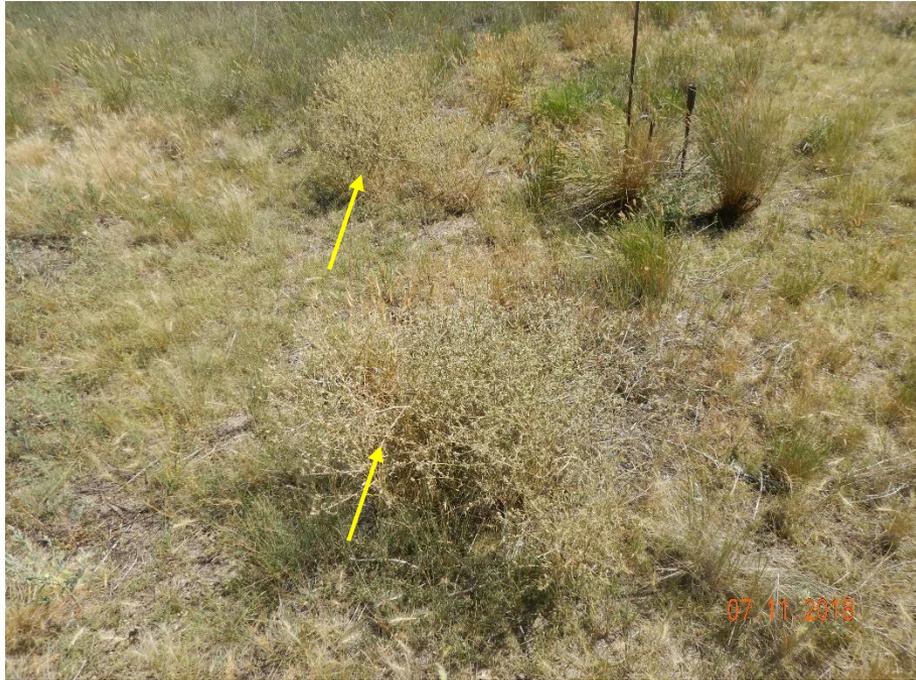
Photo 3: Photo taken from the eastern interim areas of the location. Previous inspection required management and removal of noxious weeds.

Photo shows Diffuse Knapweed (lighter, grey-green plants, white colored flowers) remains prevalent on location and access roads. Though there is evidence of herbicide, spraying does not appear to have been sufficient as many plants appear to be viable and have continued to mature/flower

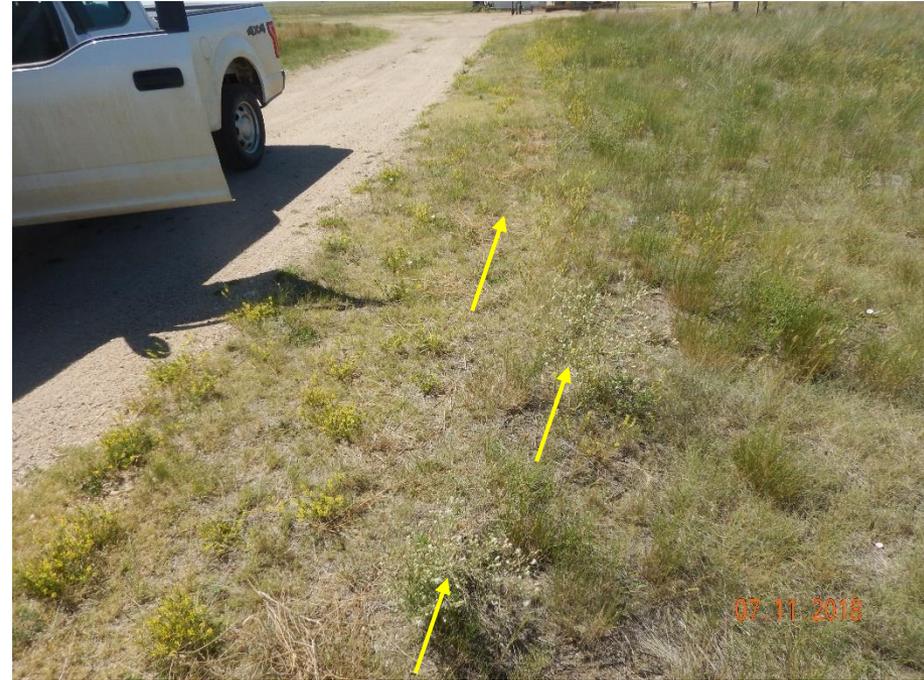
Photo 4: Photo taken from the access road, facing south. See comments under photo 1.
