Inspection Photos

Operator: FOUNDATION ENERGY
MANAGEMENT LLC - 10112

Location ID: 429227

Inspection Doc. Number: 682503638
Weld County, CO

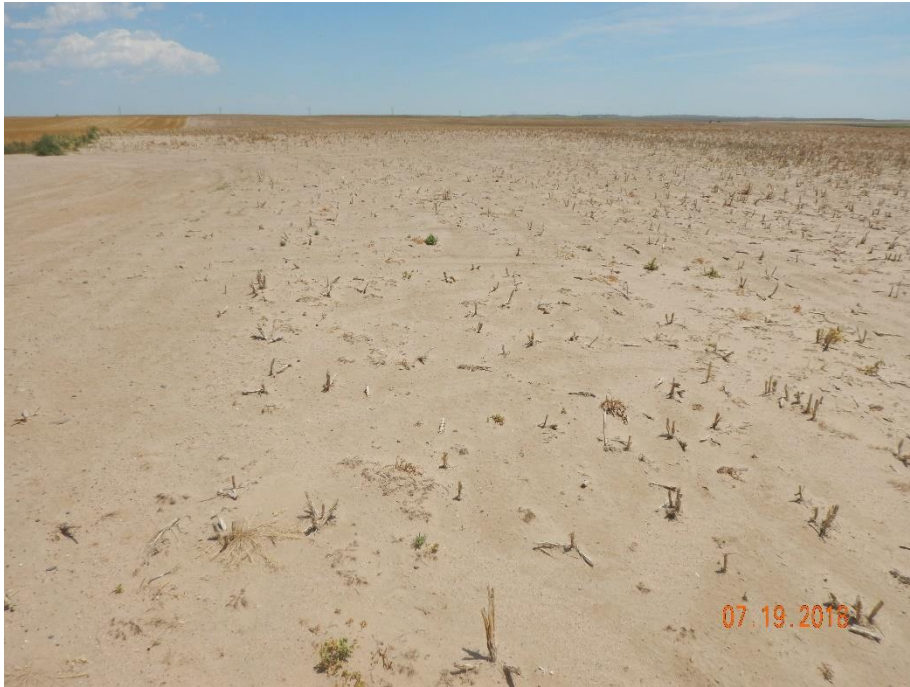
Photo 1: Photo taken from the southwest corner of the location, facing east. Photo shows portions of the interim area that consists of sparse vegetation and/or exposed soil, and may require additional decompaction, seeding and stabilization to pass reclamation. A follow-up inspections will be conducted in a future growing season to evaluate compliance with reclamation standards. Additionally wind erosion transporting sediment from the pad may be hindering reclamation here.

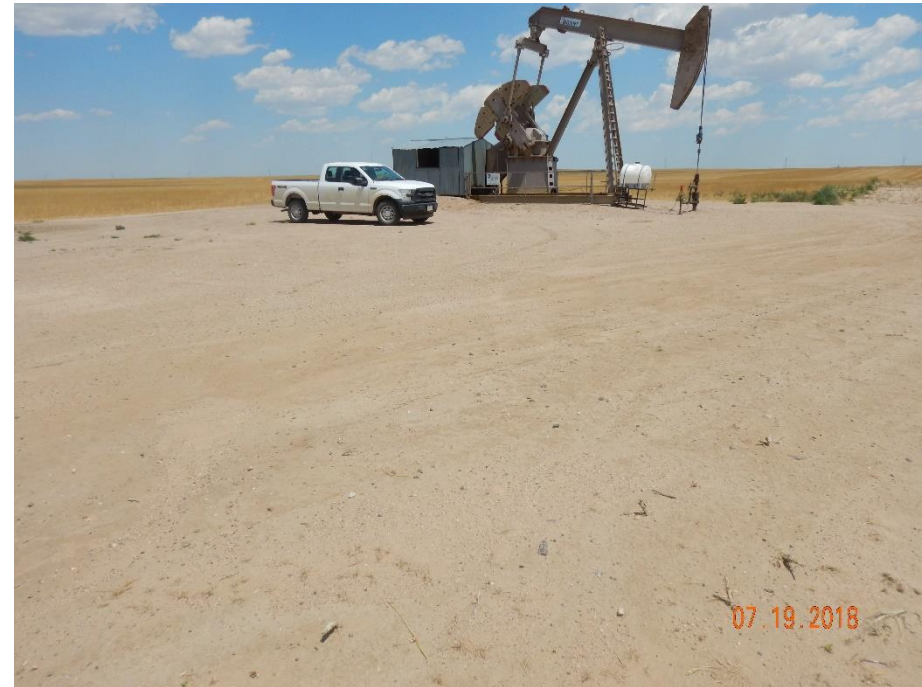
Photo 2: Photo taken from the southwest corner of the location, facing northeast. Photo shows overview of the production area.
