# Inspection Photos

Operator: PAR PACIFIC HOLDINGS INC - 16800

Location ID: 404554

Inspection Doc. Number: 682503668

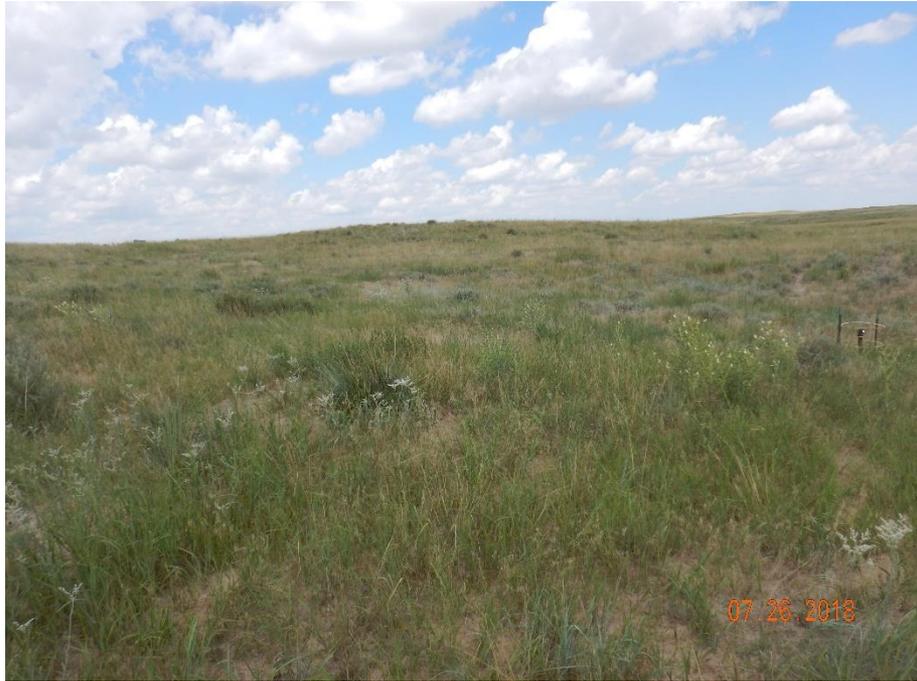
**Photo 1:** Photo taken from the west end of the location, facing northeast. Photos 1-3 provide an overview of the location and the vegetation over the reclamation area from northeast, east, to southeast. . Vegetation appears to have achieved sufficient uniform desirable perennial vegetative cover reflective of the reference.

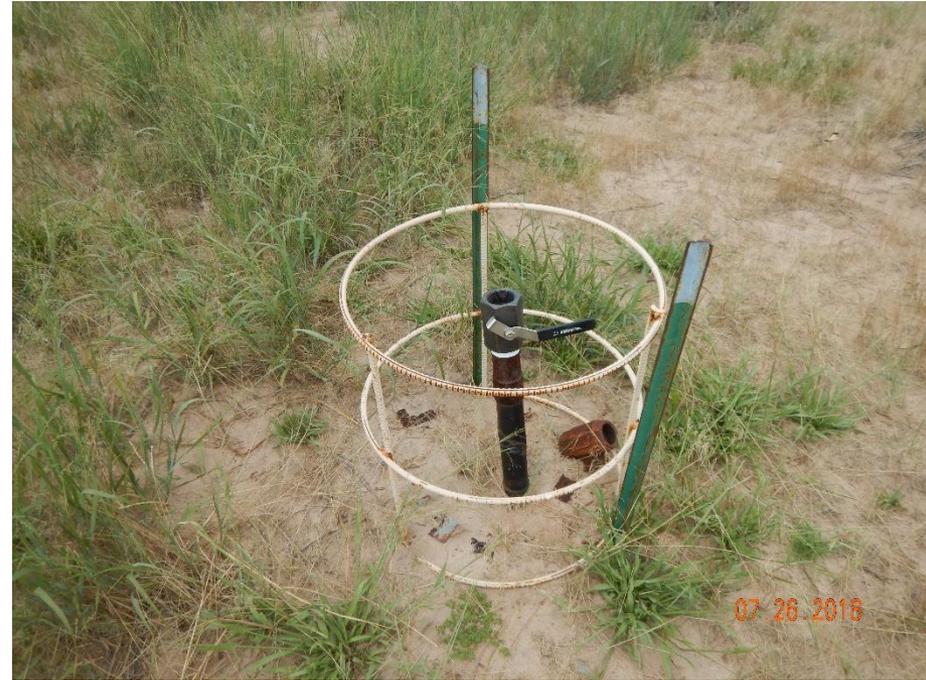
**Photo 4:** Photo taken from the west end of the location. Photo shows pipe riser remaining on location. Riser needs to be removed in accordance to 1004.a

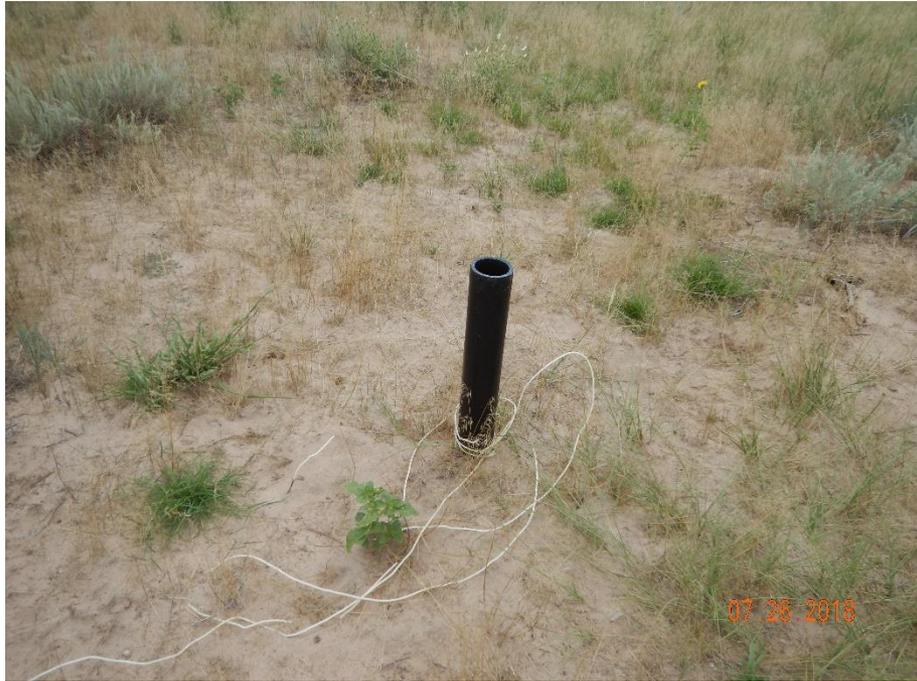
**Photo 5:** Photo taken from the west end of the location. Photo shows pipe riser remaining on location. Riser needs to be removed in accordance to 1004.a

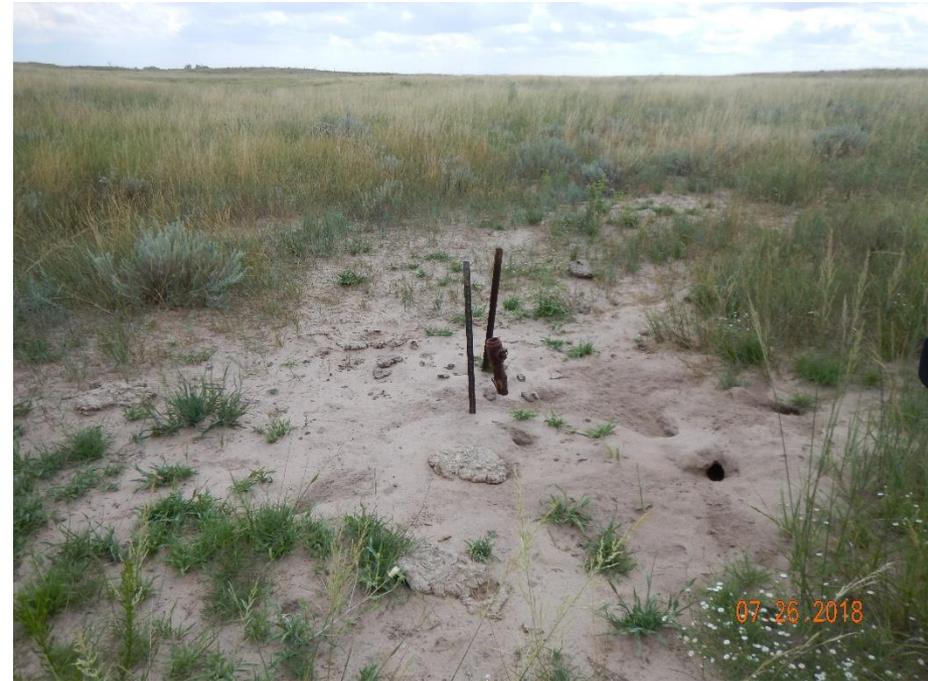
**Photo 6:** Photo taken from the access road, west of the location (GPS coordinates 39.77372/-102.88281). Photo shows pipe riser equipment remaining. Riser needs to be removed in accordance to 1004.a
