# Inspection Photos

Operator: WESTERN OPERATING COMPANY -  
95620

Location ID: 319759

Inspection Doc. Number: 682503698  
Adams County, CO

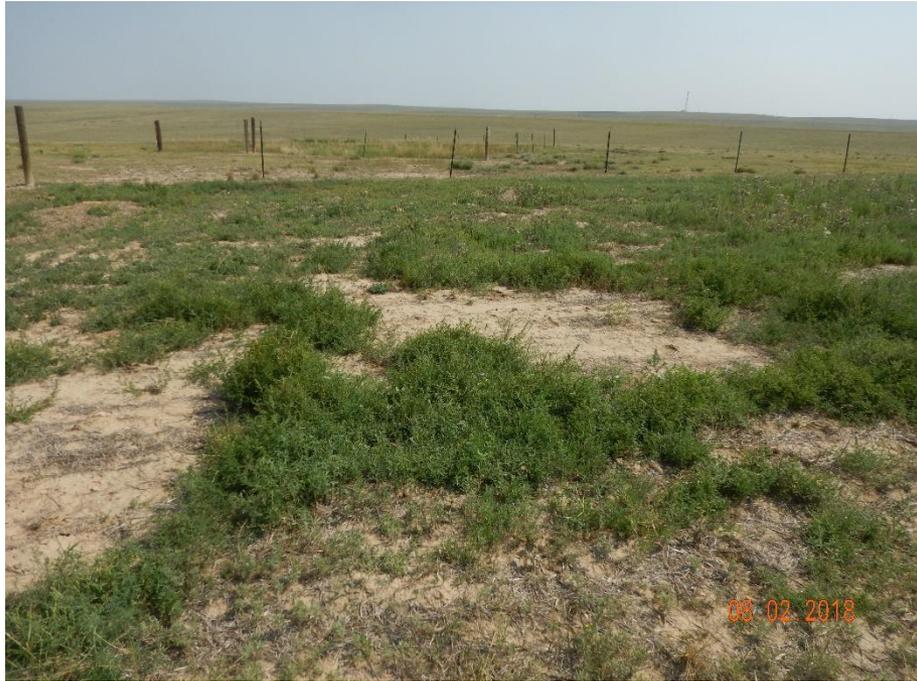
**Photo 1:** Photo taken from the southwest corner of the former battery location, facing north. Photo shows battery location remains predominantly undesirable weedy plant species such as Kochia and Russian thistle, as well as noxious weeds such as Canada Thistle. Very little desirable perennial vegetative germination and establishment is evident.

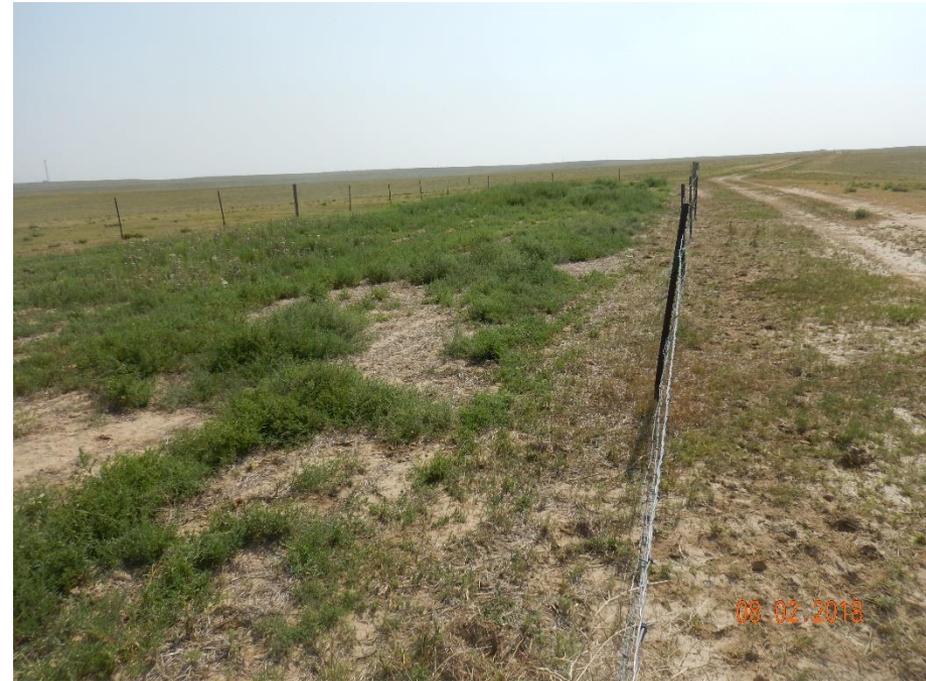
**Photo 2:** Photo taken from the southwest corner of the former battery location, facing east. Photo shows battery location remains predominantly undesirable weedy plant species such as Kochia and Russian thistle, as well as noxious weeds such as Canada Thistle. Very little desirable perennial vegetative germination and establishment is evident.

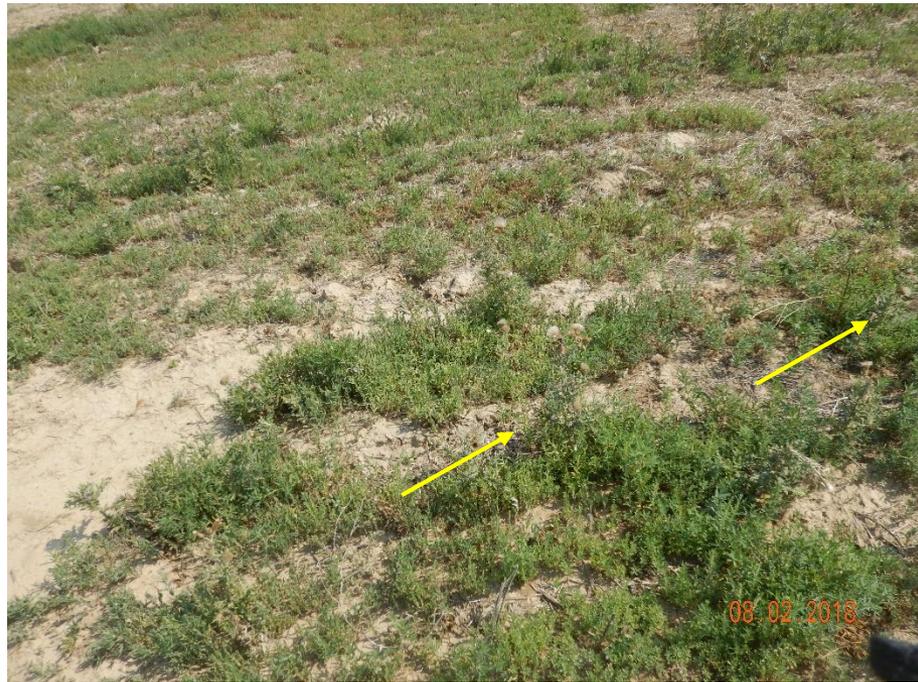
**Photo 3:** Photo taken from within the former battery location. Photo shows battery location remains predominantly undesirable weedy plant species such as Kochia and Russian thistle, as well as noxious weeds such as Canada Thistle (yellow arrow). Very little desirable perennial vegetative germination and establishment is evident.

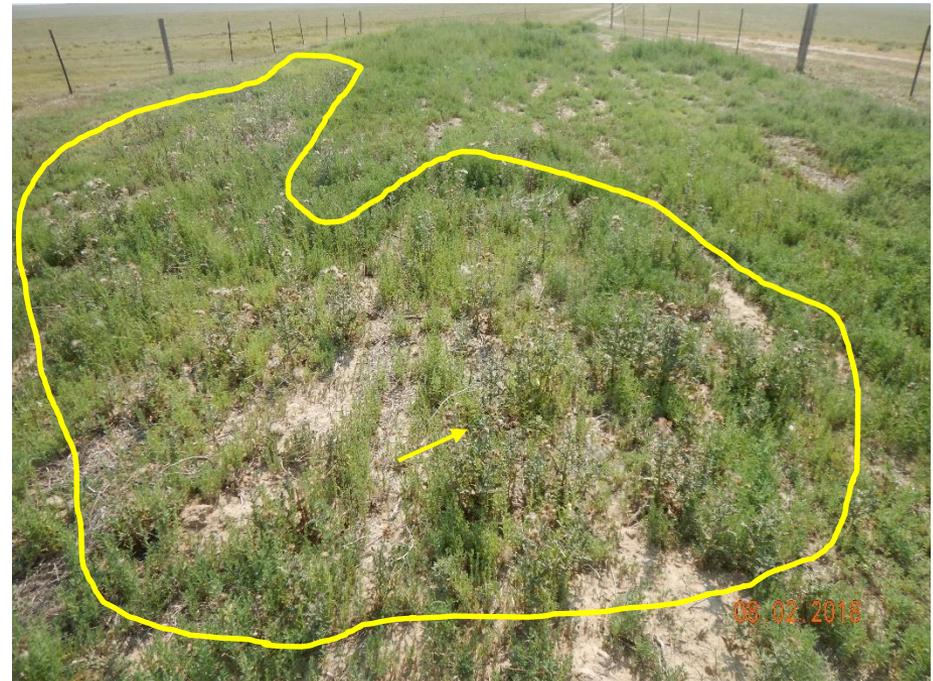
**Photo 4:** Photo taken from the west end of the former battery location, facing east. Photo shows battery location remains predominantly undesirable weedy plant species such as Kochia and Russian thistle, as well as noxious weeds such as Canada Thistle (yellow arrow). Very little desirable perennial vegetative germination and establishment is evident.
