Reclamation and Stormwater Inspection

Operator: EXTRACTION OIL & GAS INC - #10459

Location ID: 455340

Inspection Photos
Location Name: Rinn Valley West
Location ID: 455340

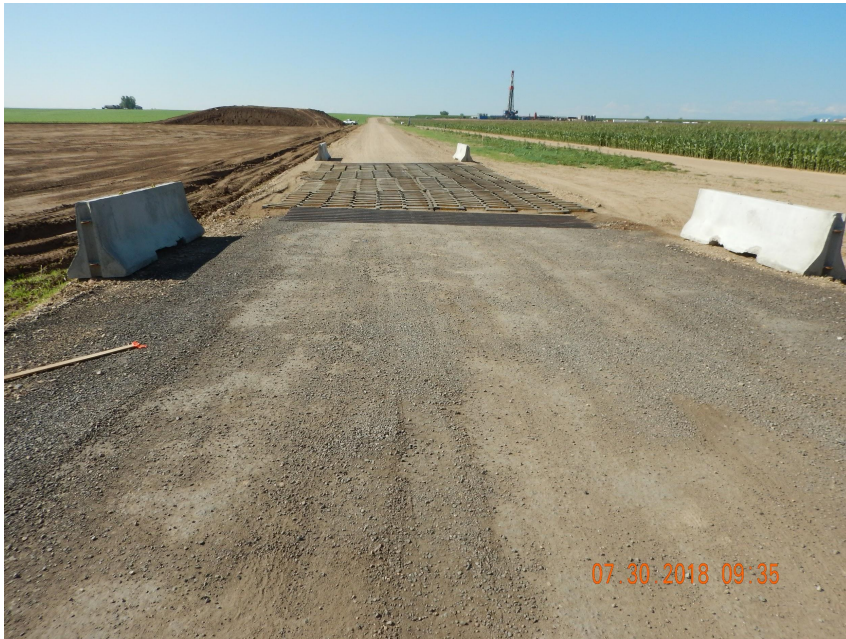
Photo 1. Photo taken from the entrance of location off CR 20.5, facing South. Operator has installed tracking device BMPs and appears to be in proper functioning condition.

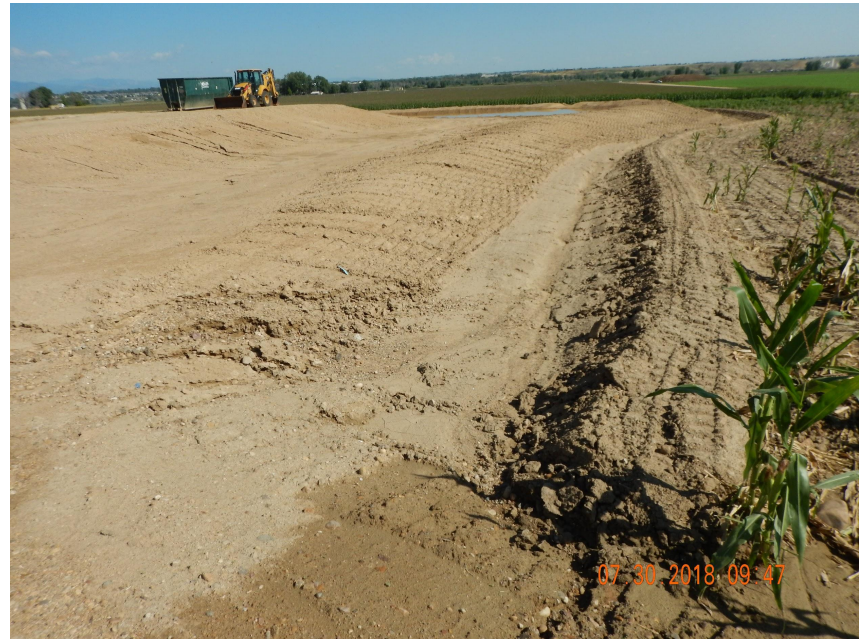
Photo 2. Photo taken from the entrance of location, facing North. Ditch and berm BMP has been installed around the entire perimeter of the location.

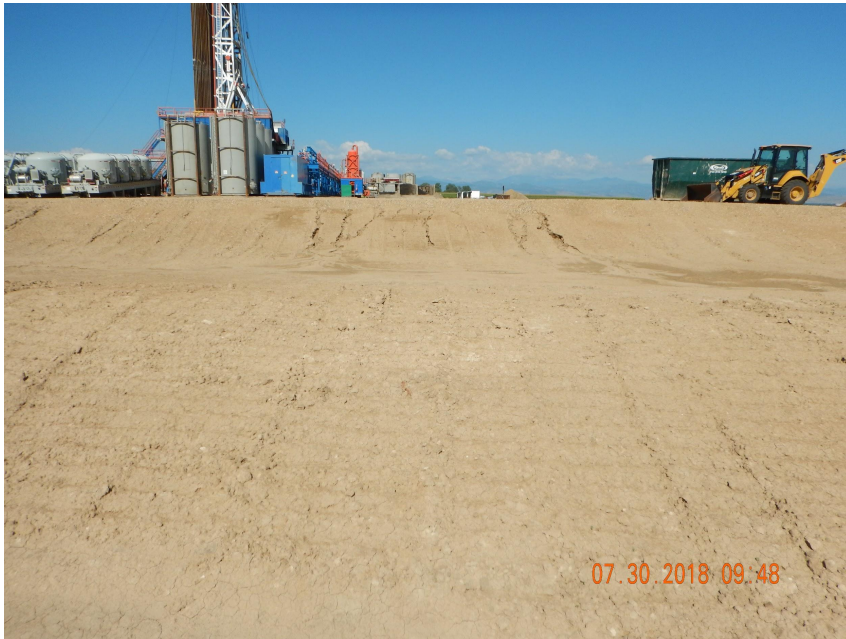
Photo 3. Photo taken of the eastern fill slope, facing West. Photo illustrates rill erosion. Operator shall stabilize fill slopes to minimize site degradation.

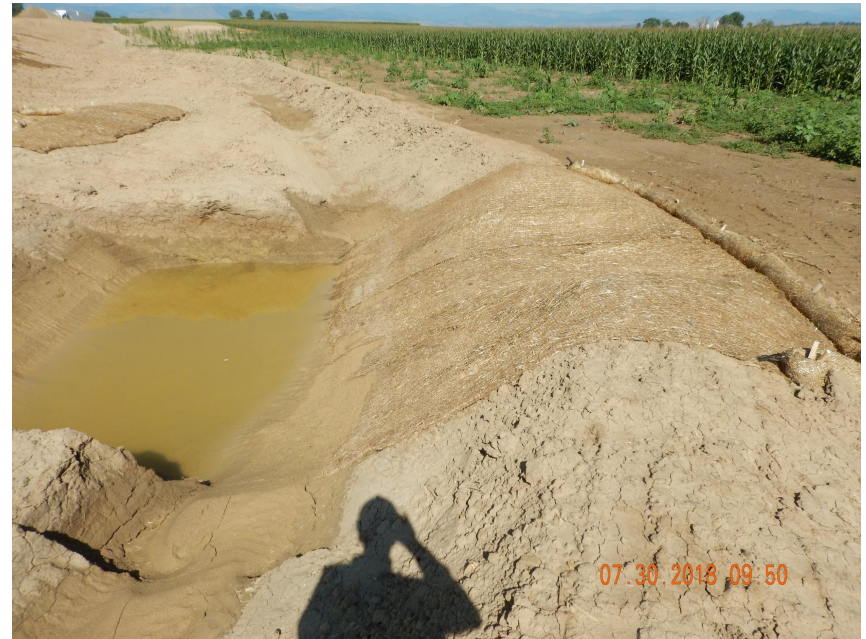
Photo 4. Photo taken from the outlet area of the northeast sediment trap, facing West. No sediment discharge was observed. Operator also has a retention area, not shown in this photo, upslope from this sediment trap.

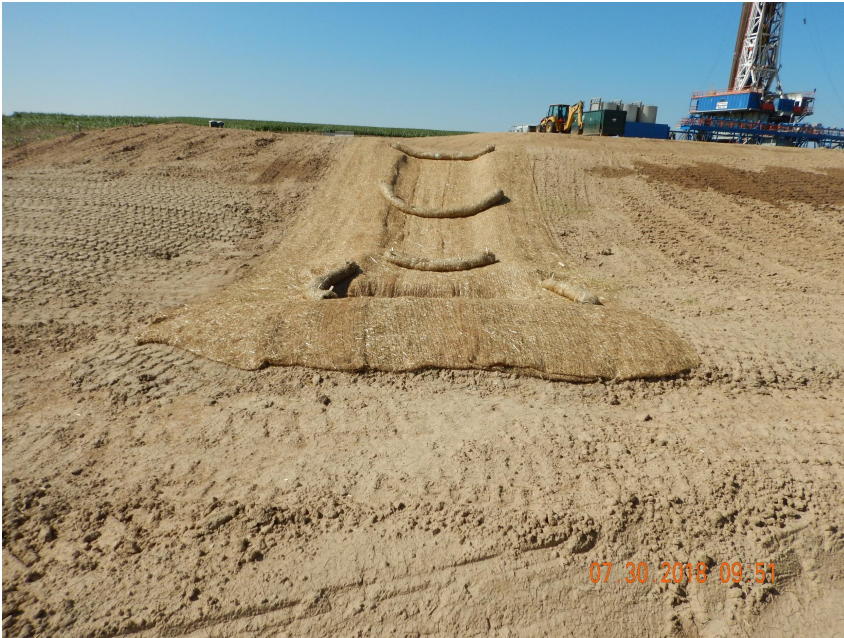
Photo 5. Photo taken from the northeast perimeter of the location, facing South. Photo illustrates a stabilized outfall from the retention pond which is directed to the sediment trap previously shown in Photo 4.

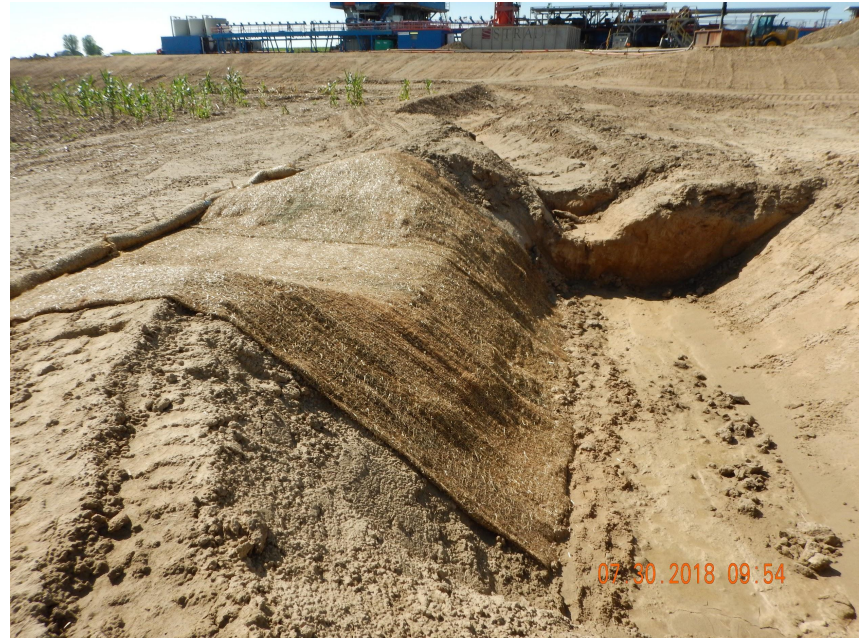
Photo 6. Photo taken from the northern sediment trap, facing South. No sediment discharge was observed.

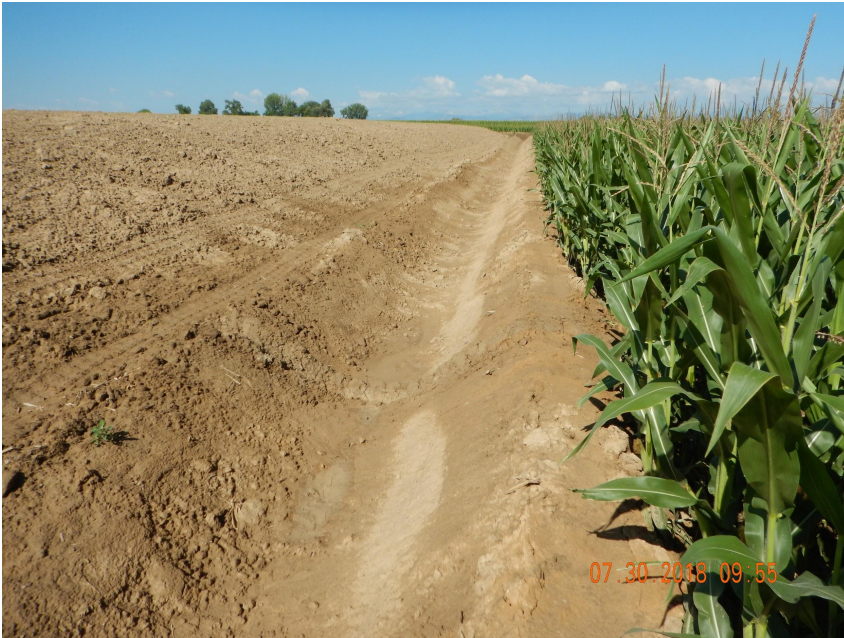
Photo 7. Photo taken from the northern perimeter of the location, facing West. Photo illustrates a ditch and berm BMP and the topsoil stockpile.

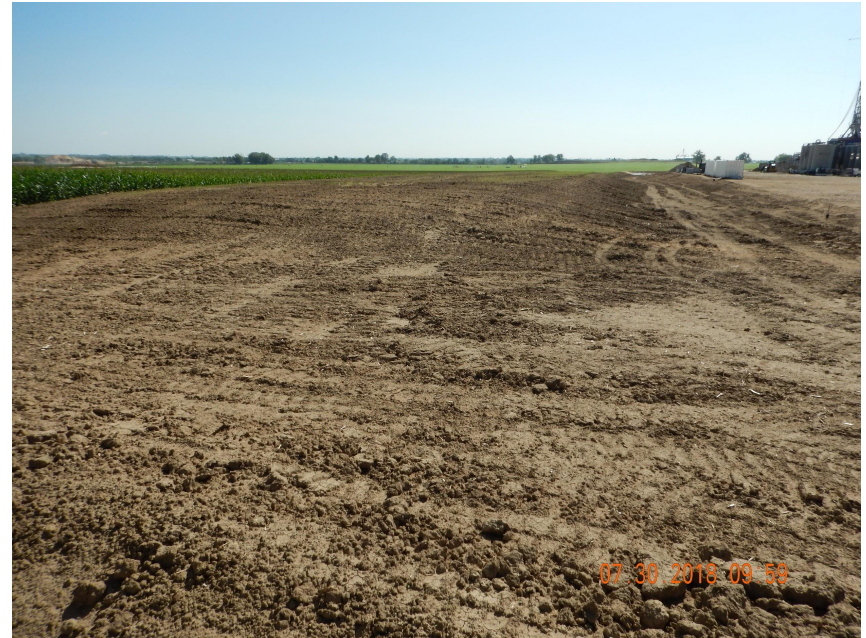
Photo 8. Photo taken from the northwestern perimeter of the location, facing East. Topsoil stockpile has been stabilized with equipment tracking and appears to be seeded. Germination was observed along portions of the topsoil stockpile.

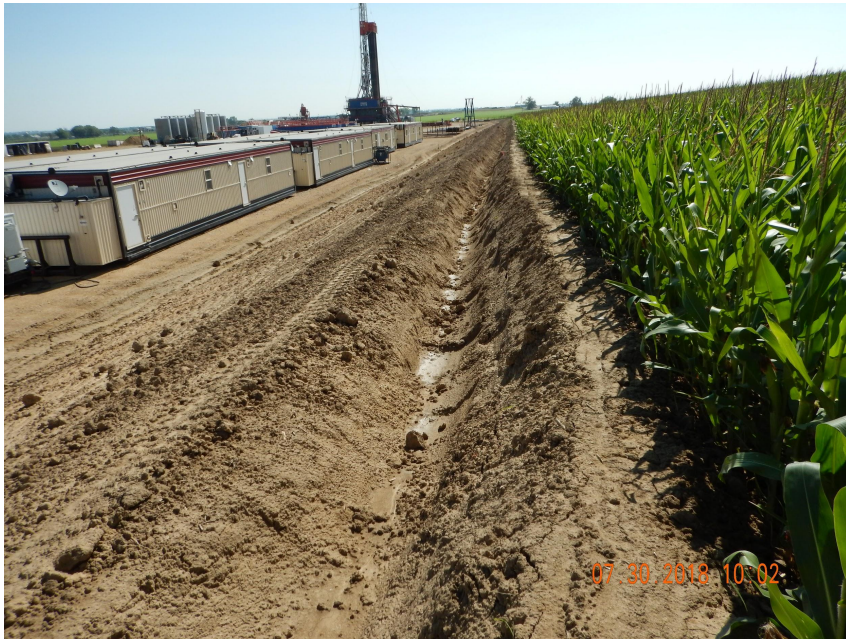
Photo 9. Photo taken from the southwestern perimeter of the location, facing East. See comments under Photo 2.

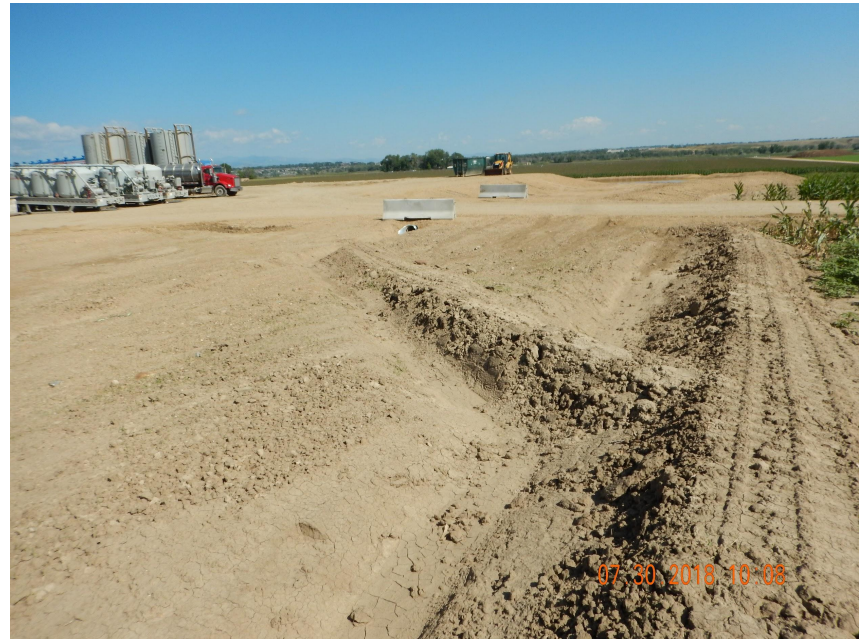
Photo 10. Photo taken from the southeast perimeter of the location, facing North. See comments under Photo 2.
