Inspection Photos

API#045-06376

Operator: Maralex

Inspection Number: 692400002

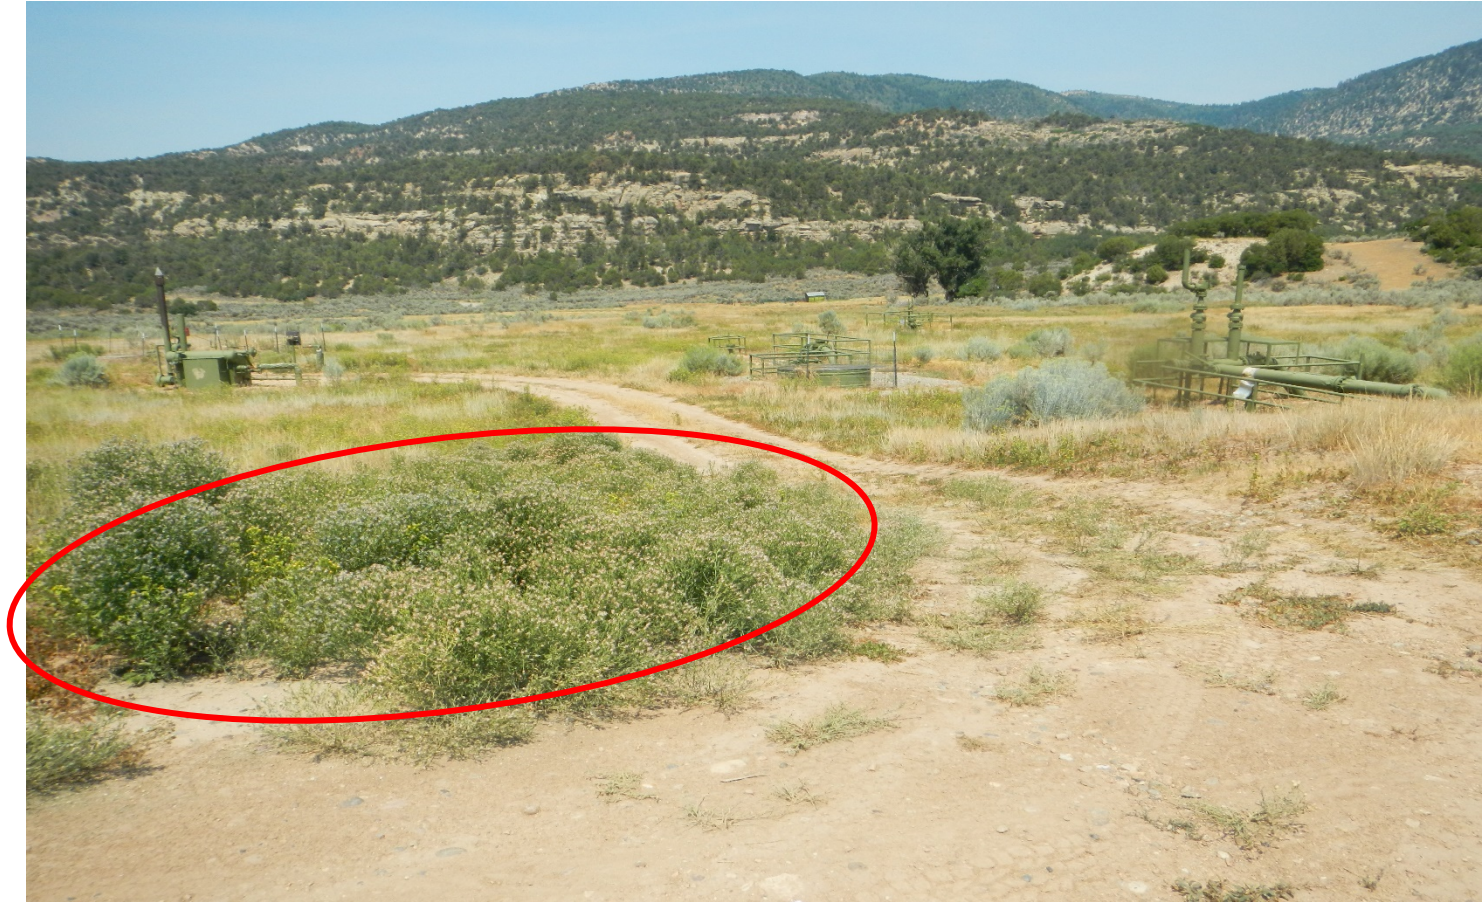
Photo#1:
Overview of Location from entry to West. Note Knapweed circled in red.

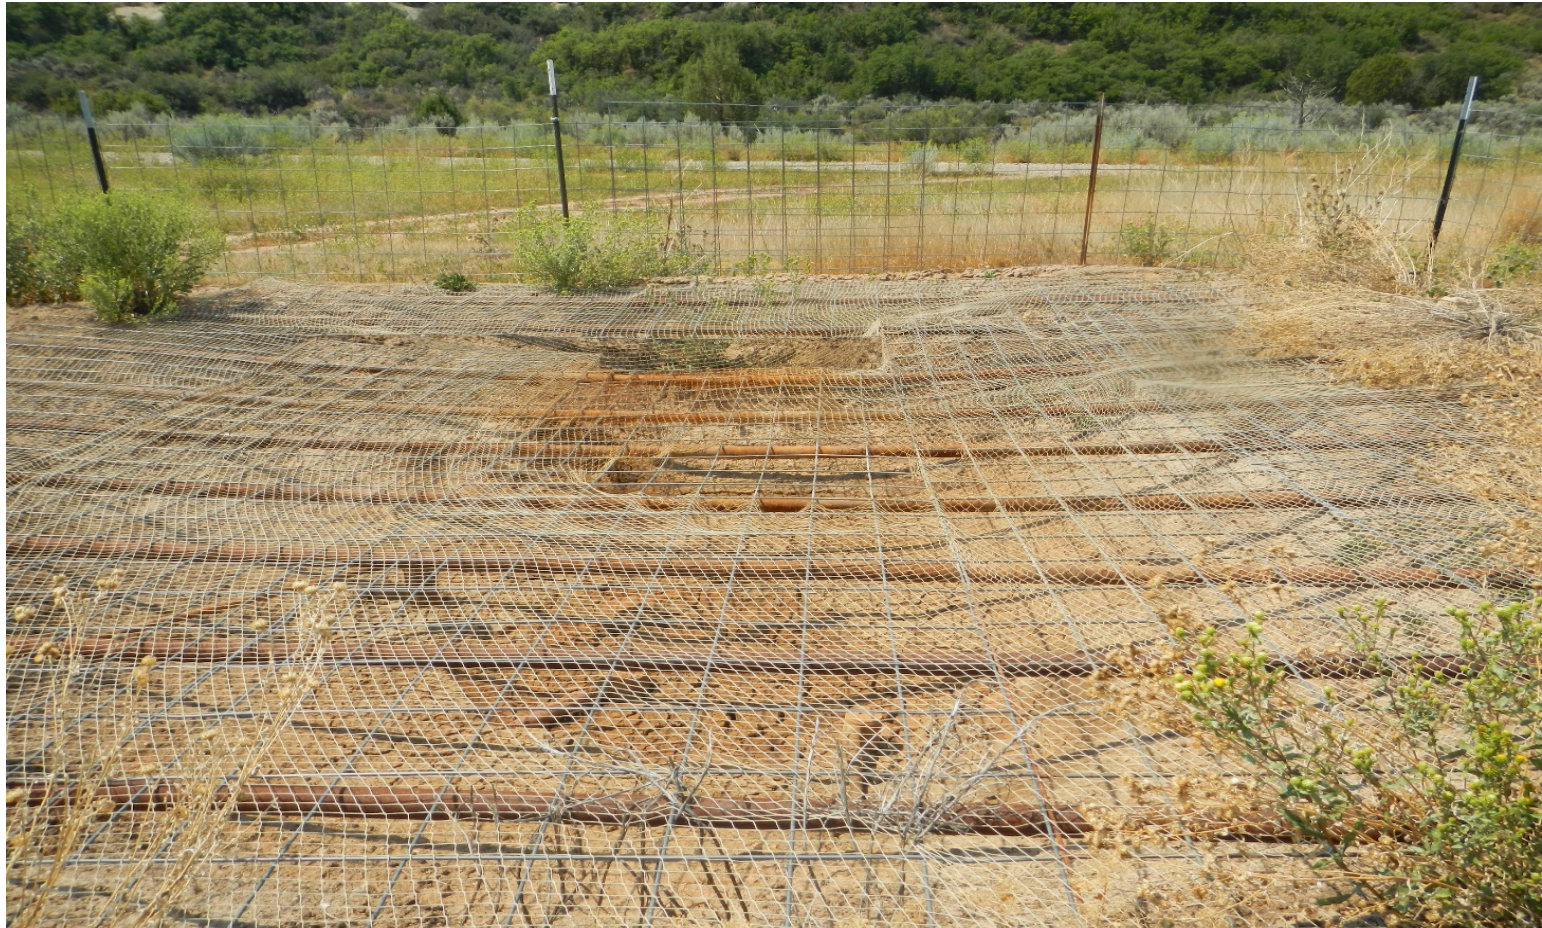
Photo#2:

There are holes in netting that is layered on panels, allowing ingress of smaller Wildlife, who even though Pit is dry at this time would not be able to find egress.

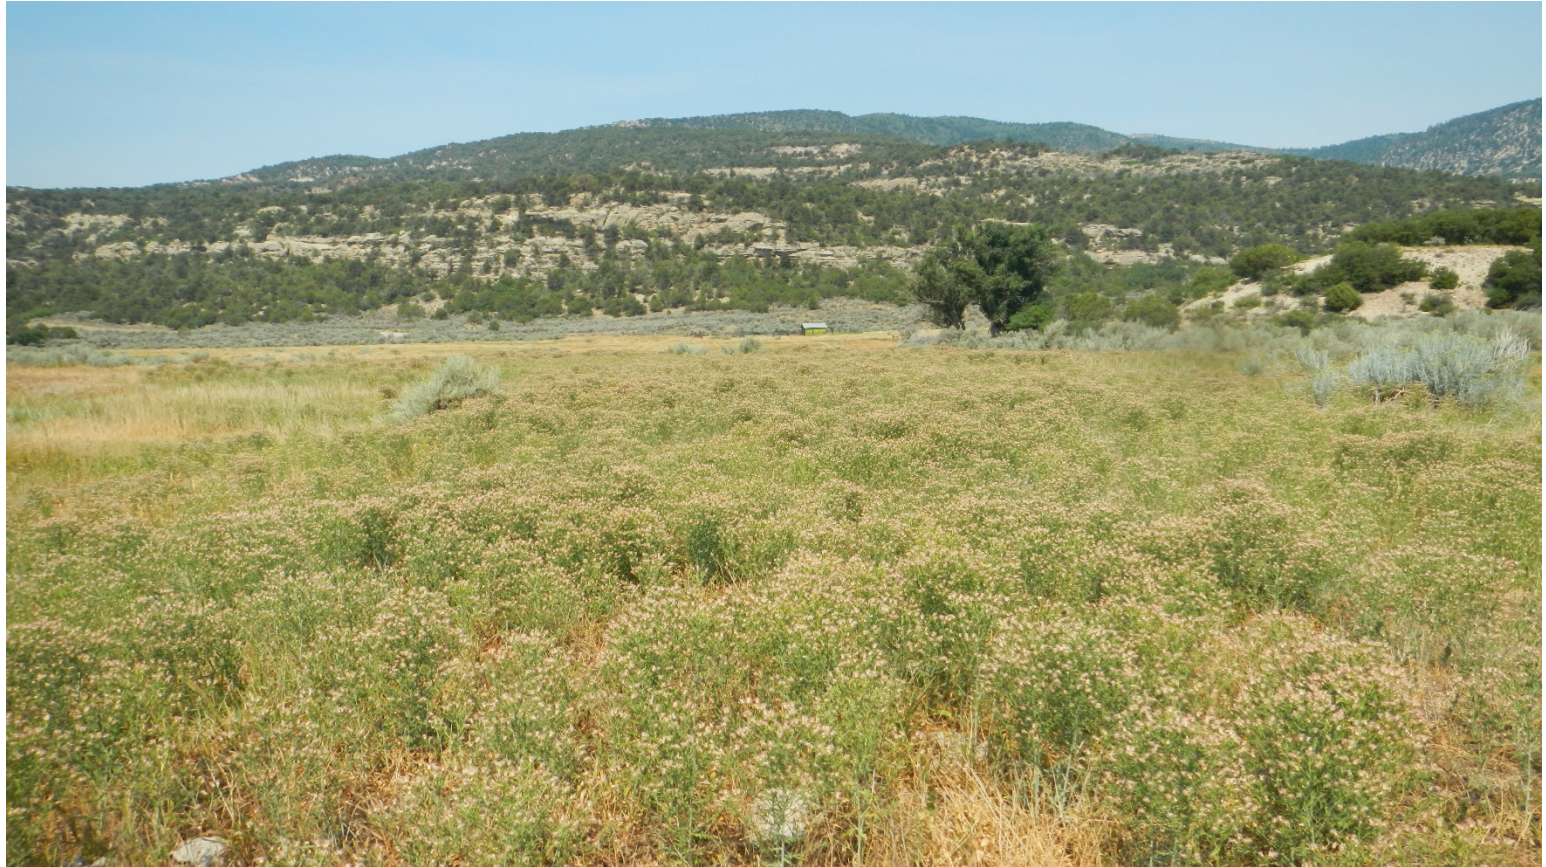
Photo#3:

In Interim reclamation, areas of original disturbance and invading into adjacent lands is an established mono-culture of Knapweed.
