# *Inspection Photos*

*API#045-06239*

*Operator: Maralex*

*Inspection Number: 692400018*

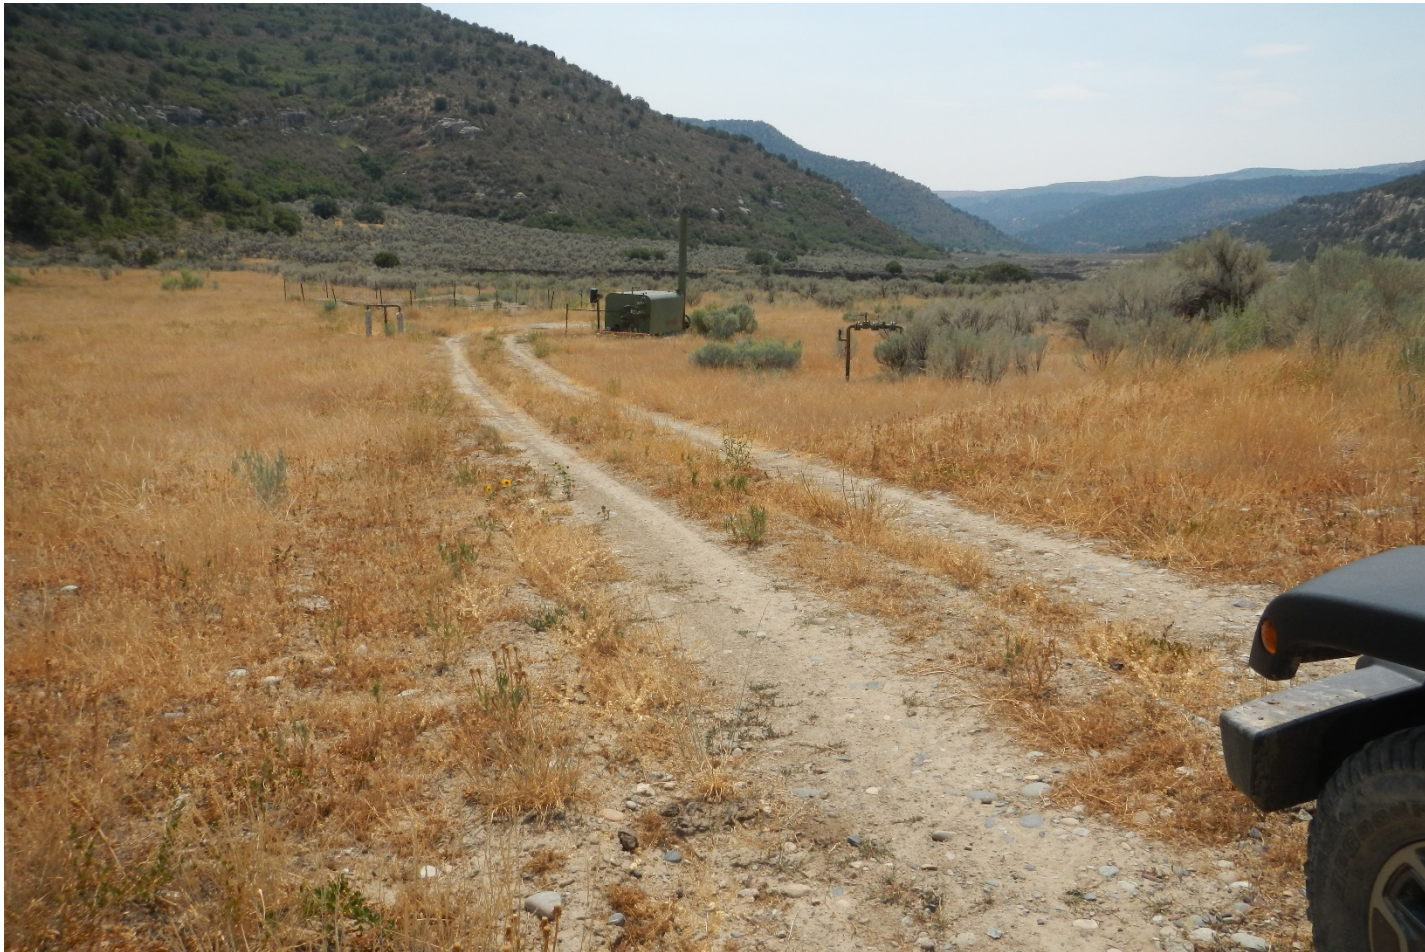
Photo#1:  
Overview of Location from entry to Southwest.

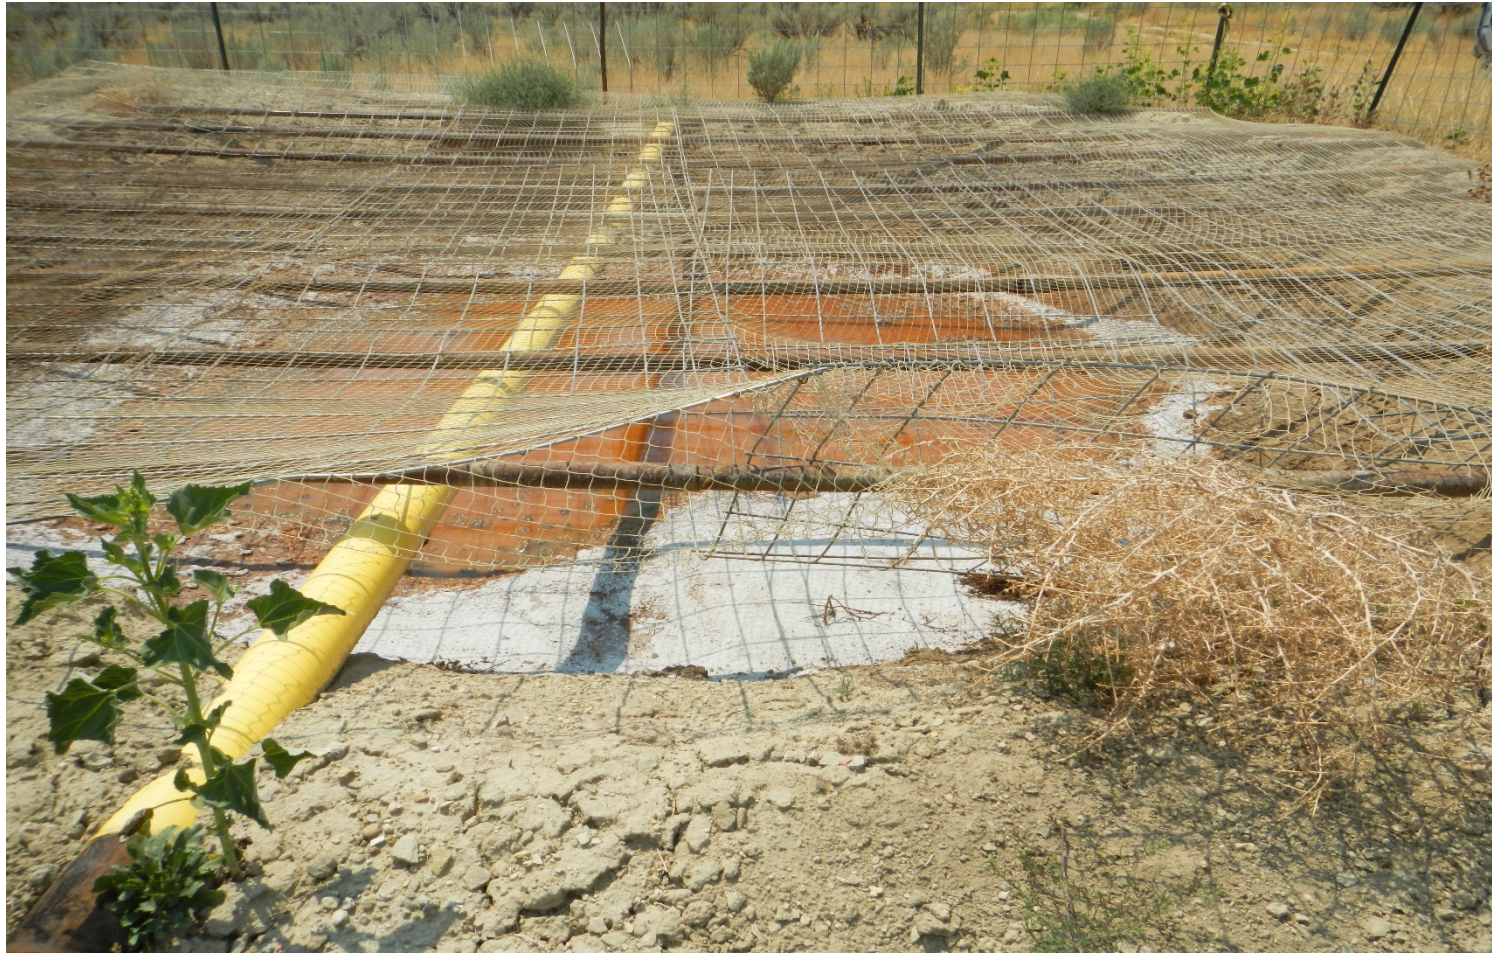
Photo#2:

One area of Panels upon which netting is layered has been damaged, allowing ingress of smaller Wildlife, who even though Pit is dry at this time would not be able to find egress.
