Construction and Stormwater Inspection

August 10, 2018

Operator: BURLINGTON RESOURCES OIL & GAS LP- #26580

Location ID: 455750

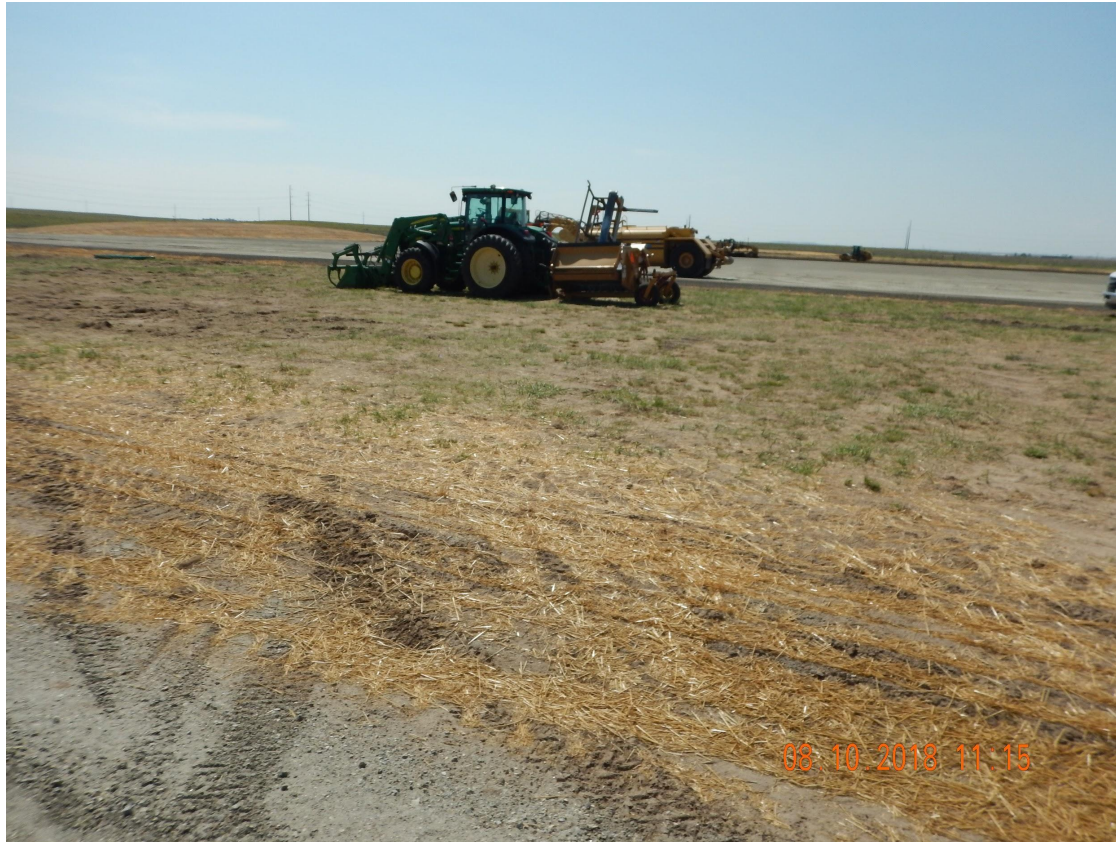
Photo 1. Photo taken from the access road, facing South. Operator has disturbed a section of land between the access road and the location. Operator is responsible for all future reclamation throughout any portion of land that was disturbed.

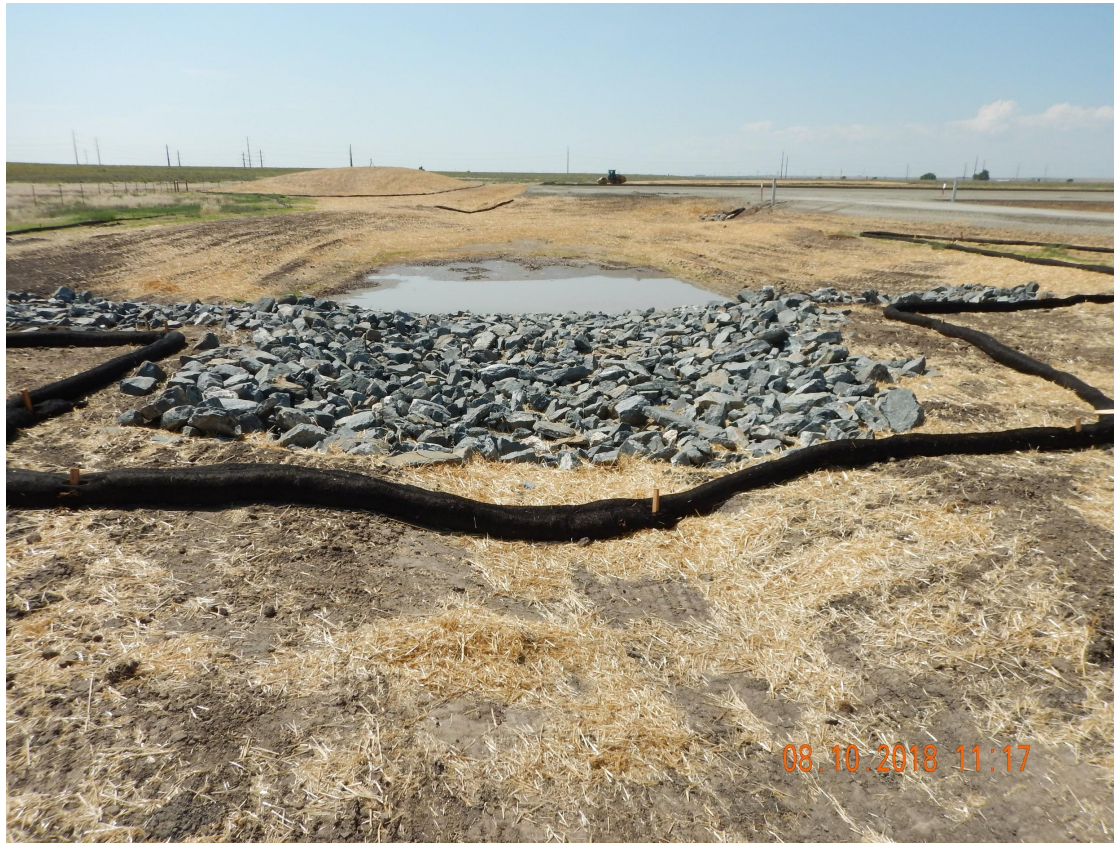
Photo 2. Photo taken from the northeastern perimeter of the location, facing South. Photo illustrates a sediment basin that appears to be in proper functioning condition. Operator has installed a ditch that continues north of the sediment basin. Operator will be responsible for that ditch disturbance (contouring and vegetation standards).

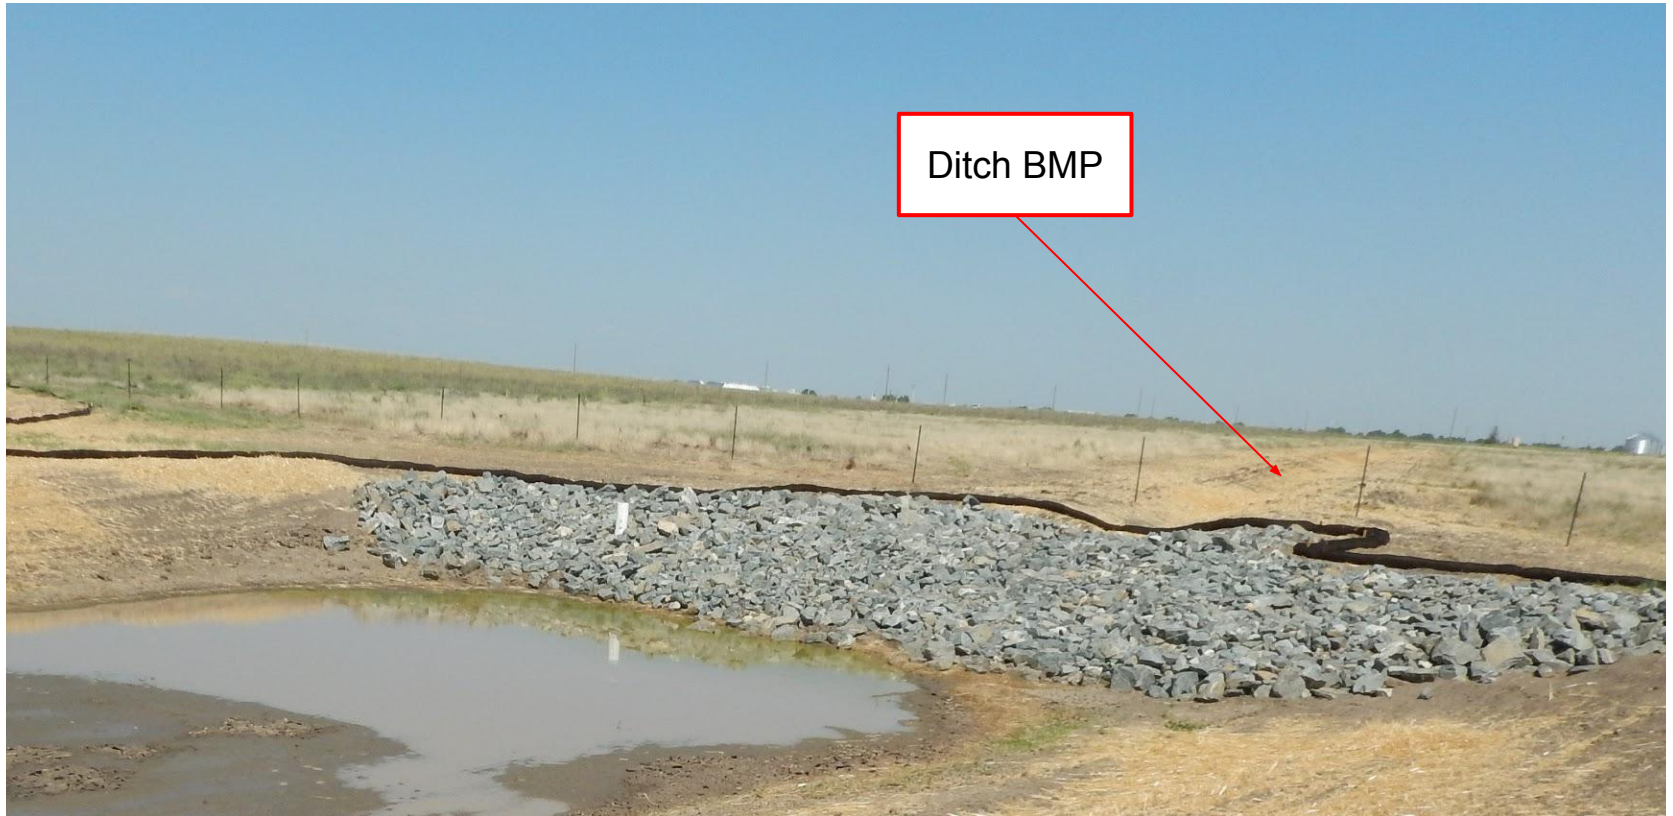
Photo 3. Photo taken from the northeastern perimeter of the location, facing North. Photo illustrates the previously mentioned ditch that continue north of the sediment basin.

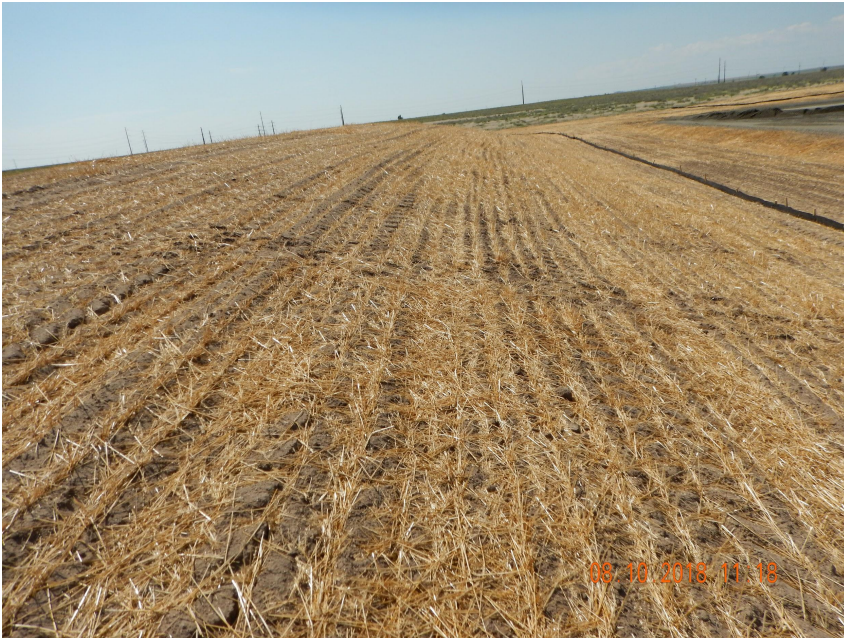
Photo 4. Photo taken from the eastern soil stockpile, facing South. Soil stockpiles have been seeded and crimped with filtrex wattles along the base.

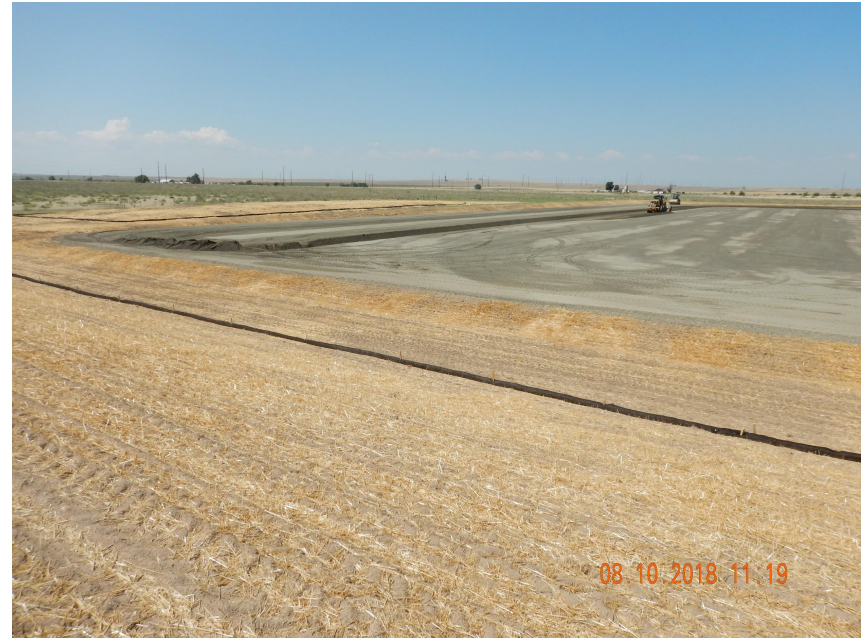
Photo 5. Photo taken from the eastern soil stockpile, facing Southwest. Photo illustrates the Operator stabilizing the location.

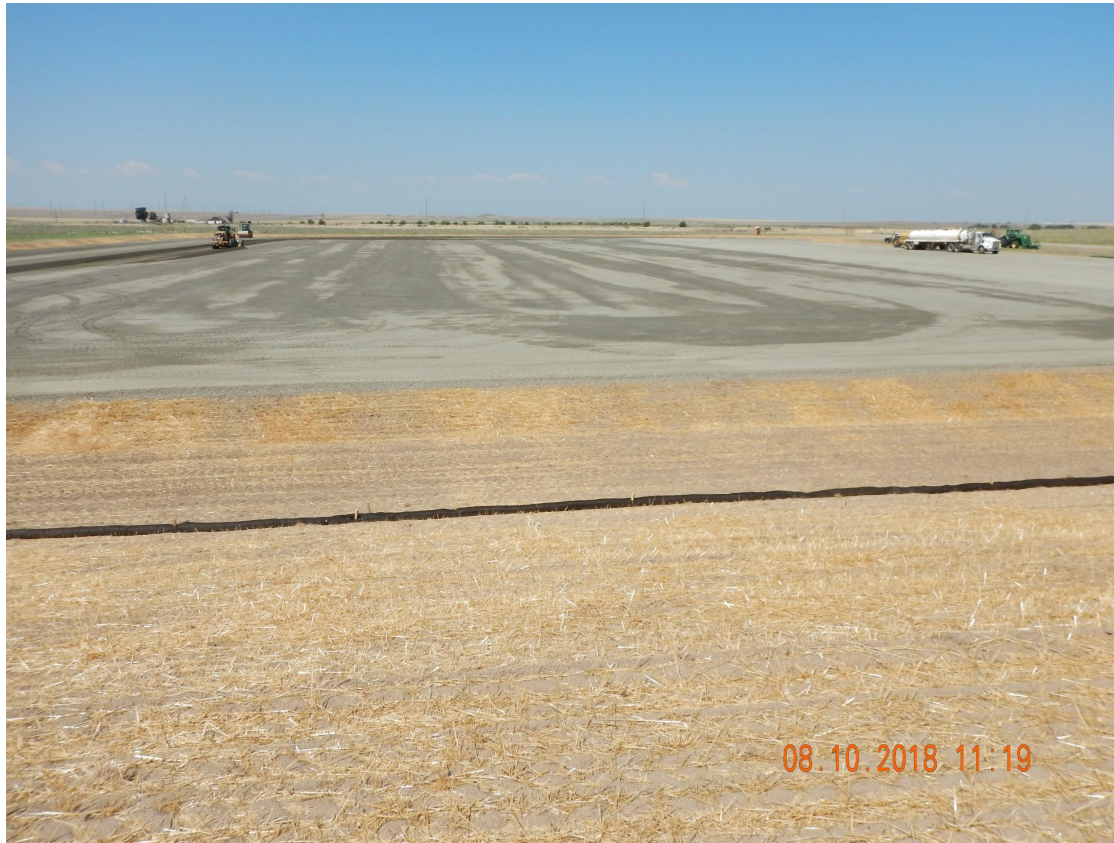
Photo 6. Photo taken from the eastern soil stockpile, facing West. See comments under Photo 5.
