Final Reclamation Inspection

Operator: PDC ENERGY INC - 69175

API: 05-123-19814

Inspection Photos
Location Name: SUCCO #24-20
API: 05-123-19814

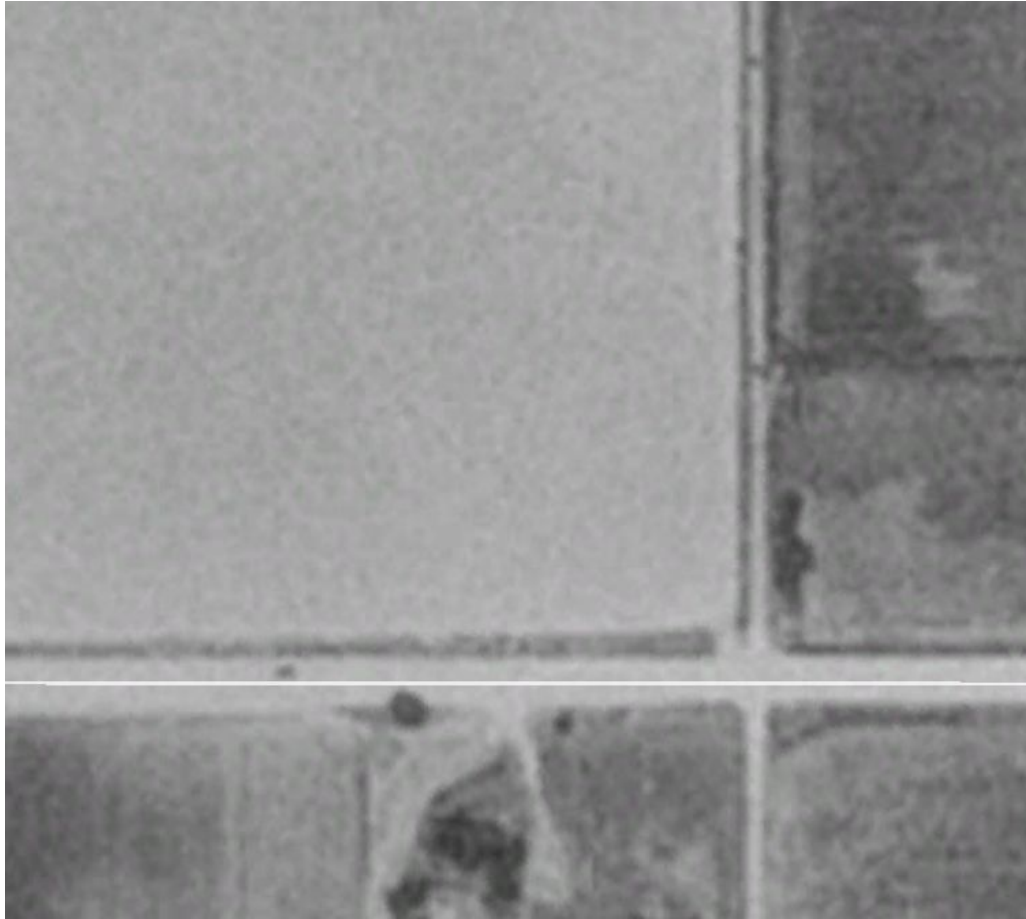
Aerial imagery from 1993 illustrates the tank battery location was not pre-existing.

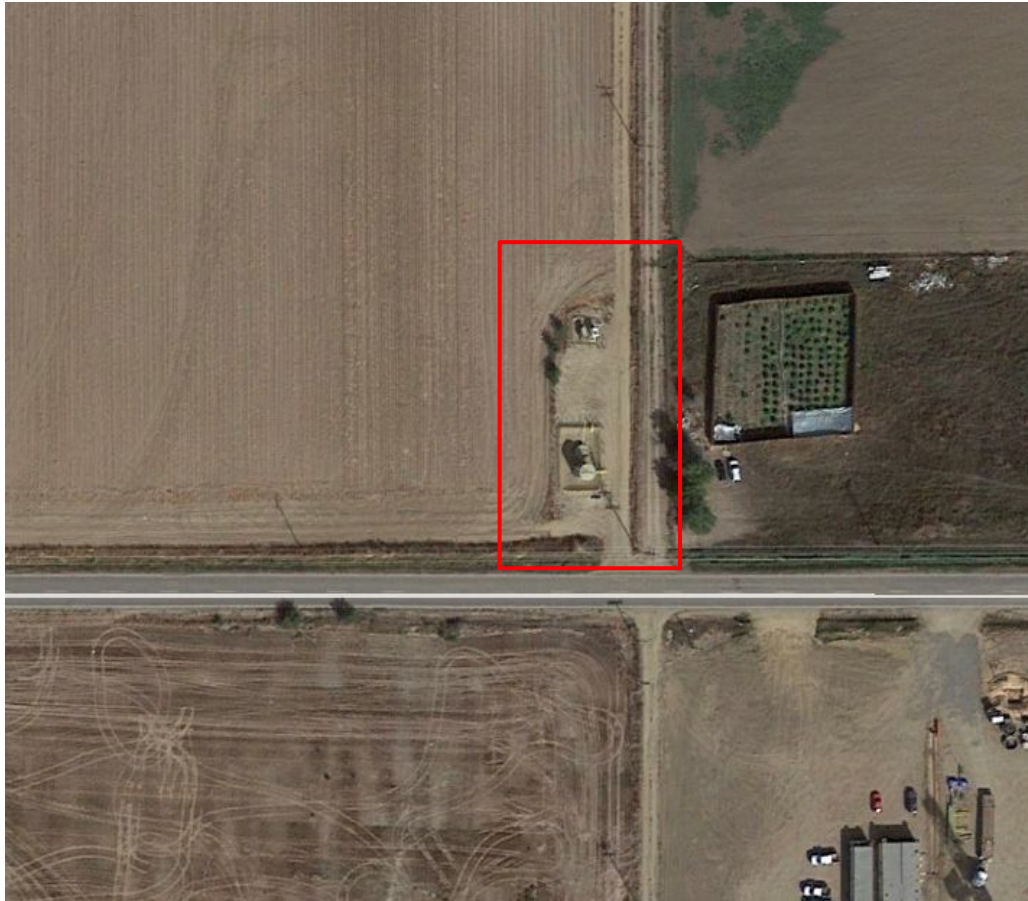
Aerial imagery from 2017 illustrates the Succo Gas Unit during active operations. Access road and tank battery location have not been reclaimed per Rule 1004.

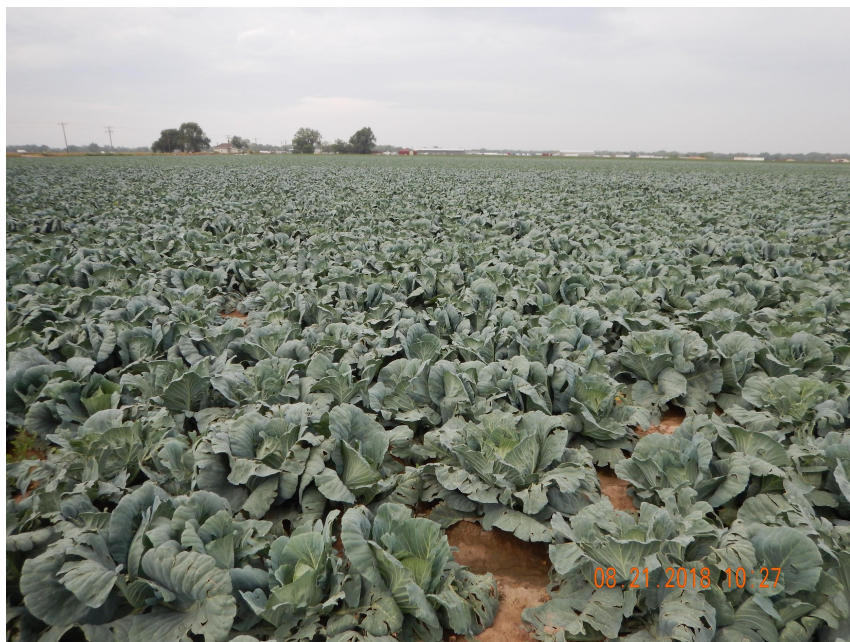
Photo 1. Photo taken from the well location, facing West. Appears the well location and well access road meet Rule 1004 standards. Unable to find evidence of oil and gas activities and/or disturbances. Well location and access road appear reflective of reference crop areas.

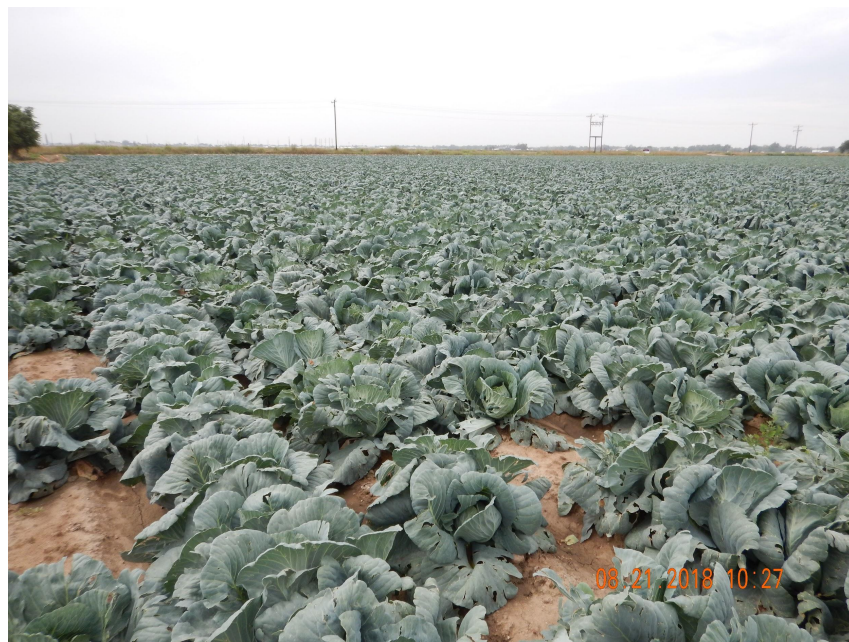
Photo 2. Reference photo taken east of the well location, facing South. See comments under Photo 1.

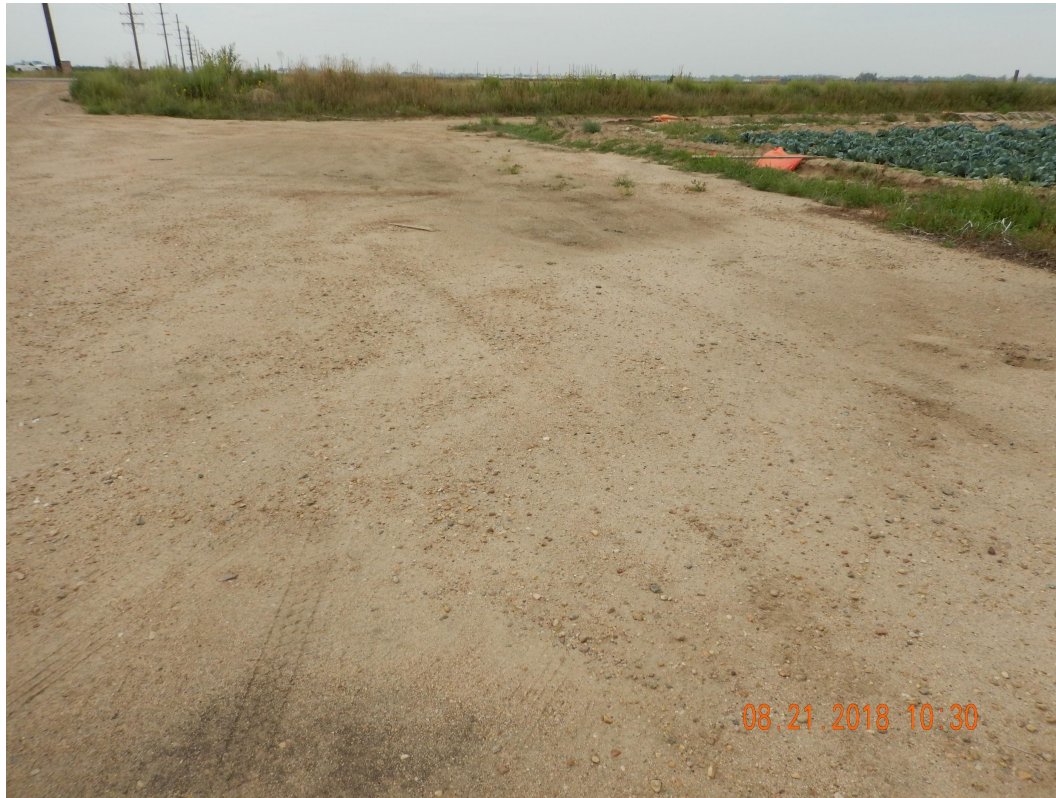
Photo 3. Photo taken from the tank battery location, facing South. Operator has failed to perform final reclamation at the tank battery location.
