# Interim Reclamation and Stormwater Inspection

Operator: NGL WATER SOLUTIONS DJ LLC- #10373

Location ID: 440281

Inspection Document #: 682403913

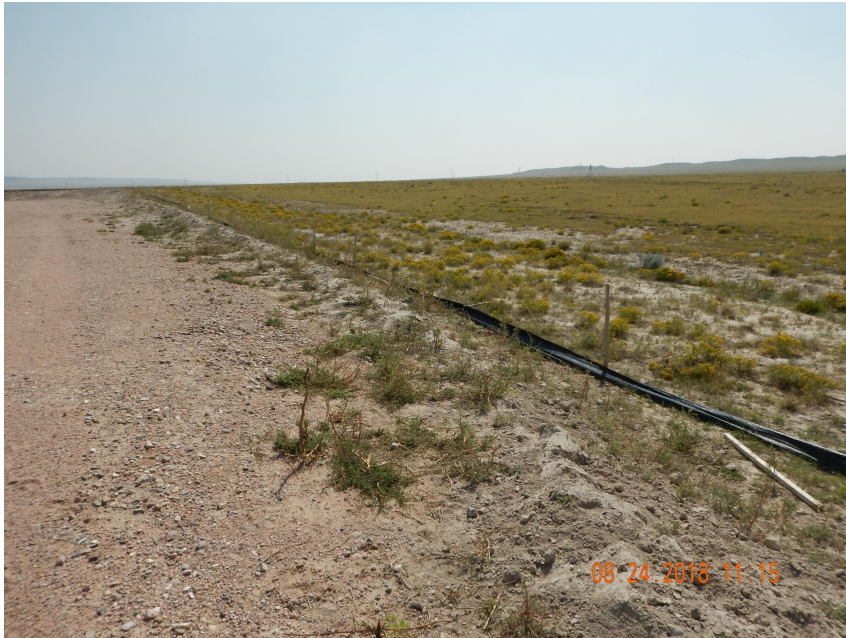
**Photo 1.** Photo taken from the southwestern location, facing East. Operator has not maintained the installed stormwater BMP (silt fence). Rill erosion was observed along portions of the perimeter of the location.

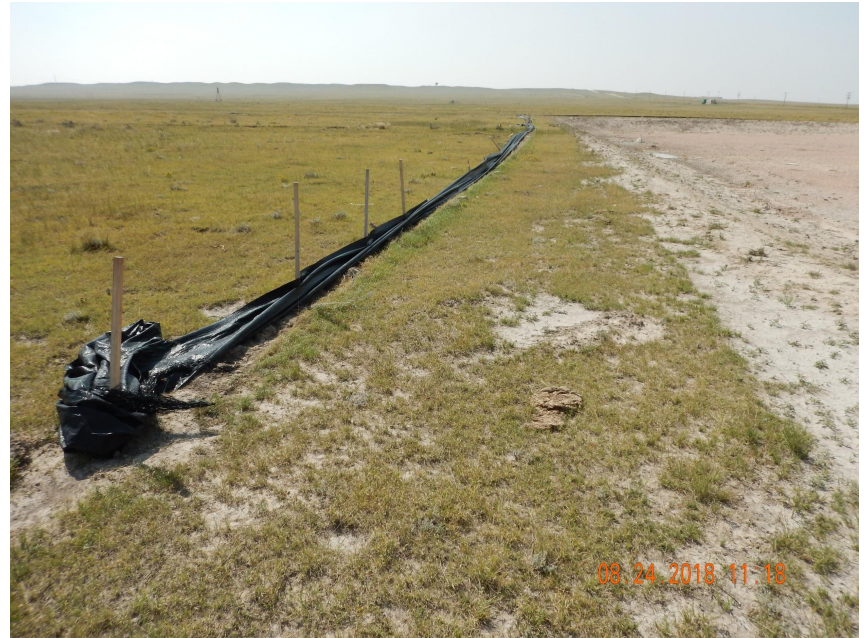
**Photo 2.** Photo taken from the eastern location, facing South. See comments under Photo 1.

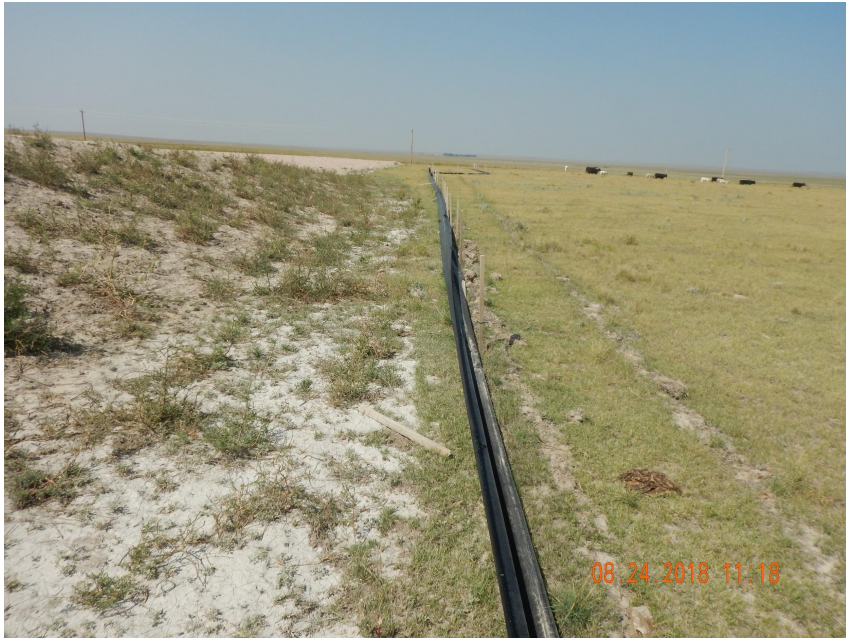
**Photo 3.** Photo taken from the northeastern location, facing West. See comments under Photo 1.

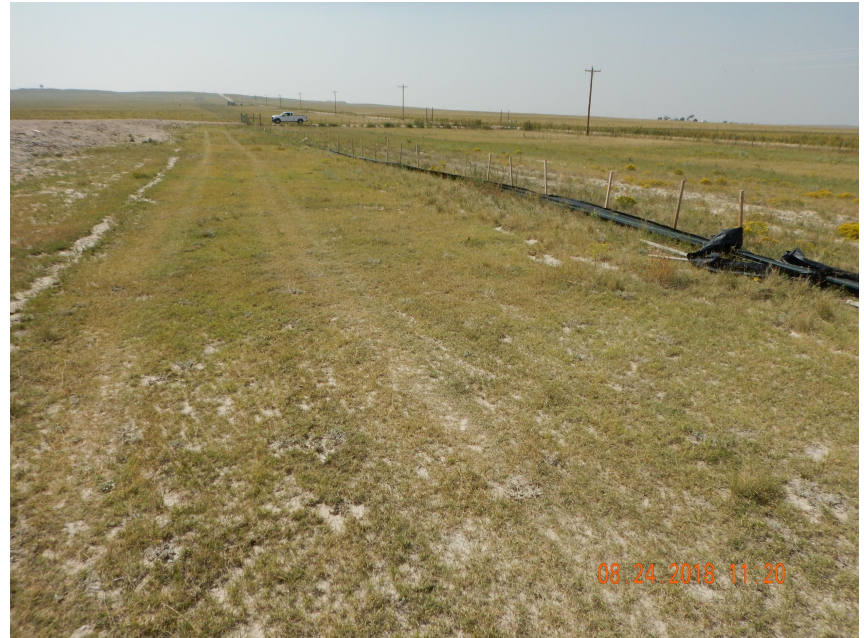
**Photo 4.** Photo taken from the western location, facing South. See comments under Photo 1.

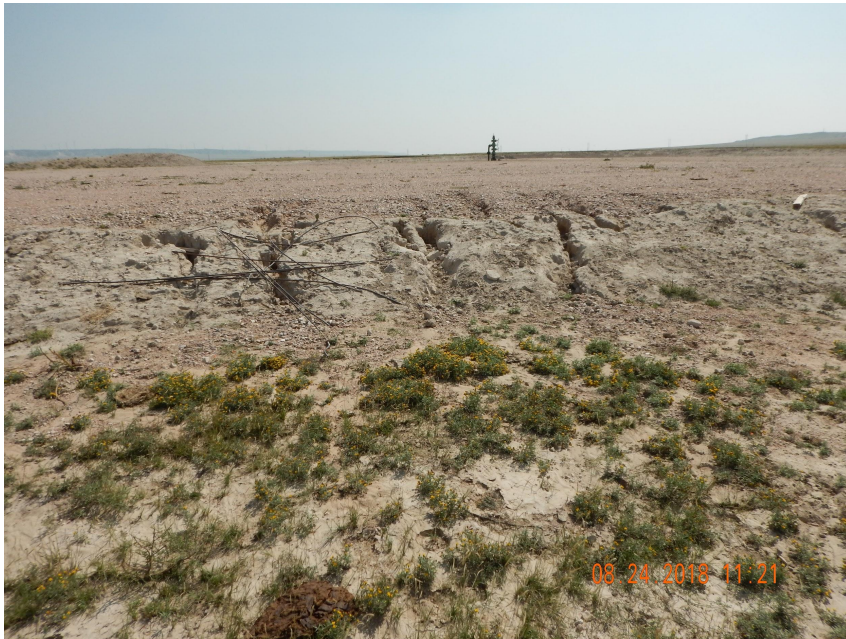
**Photo 5.** Photo taken from the western location, facing East. Fill slopes are not adequately stabilized to minimize erosion, transport of sediment offsite, and site degradation.

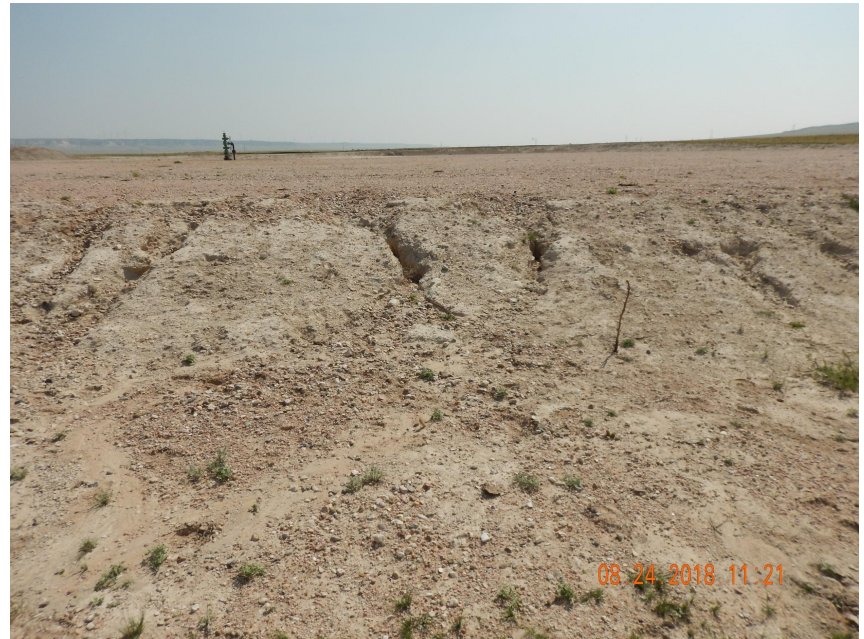
**Photo 6.** Photo taken from the western location, facing East. See comments under Photo 5.

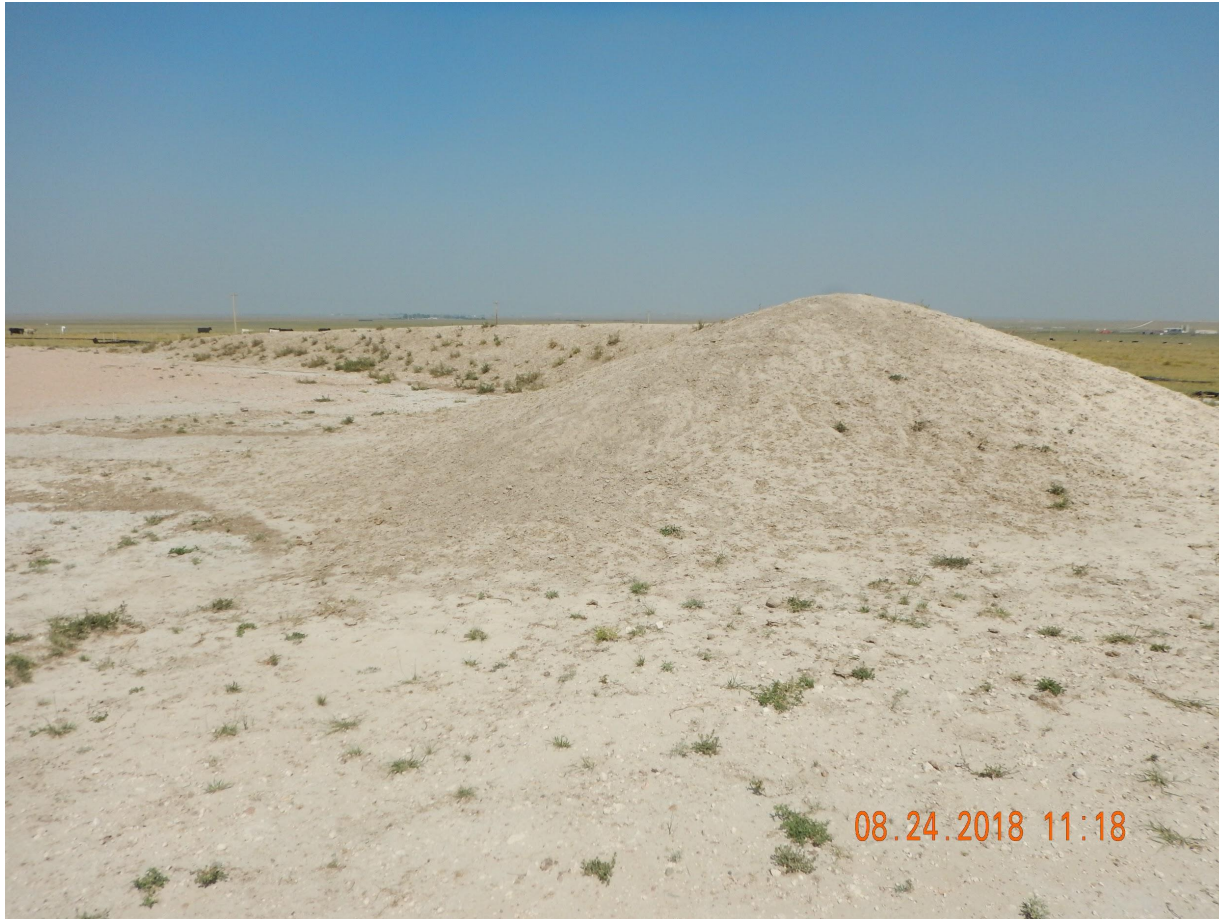
**Photo 7.** Photo taken from the northeastern location, facing North. Does not appear the Operator has salvaged a sufficient amount of topsoil. Also, Operator has failed to properly protect the topsoil from degradation due to erosion and failed to prevent weed establishment. Appears cattle have also degraded the topsoil.

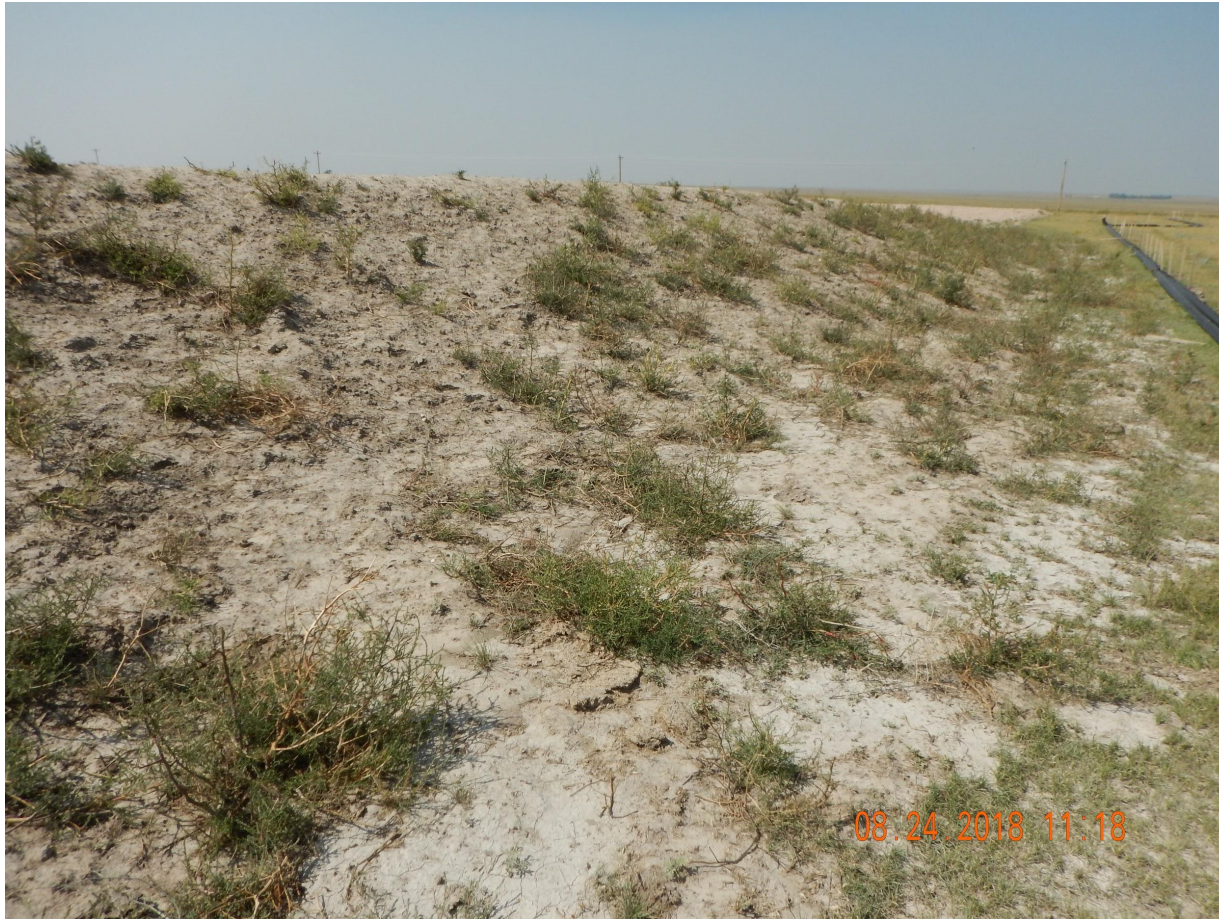
**Photo 8.** Photo taken from the northern topsoil stockpile, facing West. Photo illustrates weed establishment, erosion and degraded topsoil from cattle disturbance.
