# Final Reclamation Inspection

Operator: PETROSHARE CORPORATION- 10454

Location ID: 319769

Location Name: TSUZUKI #1

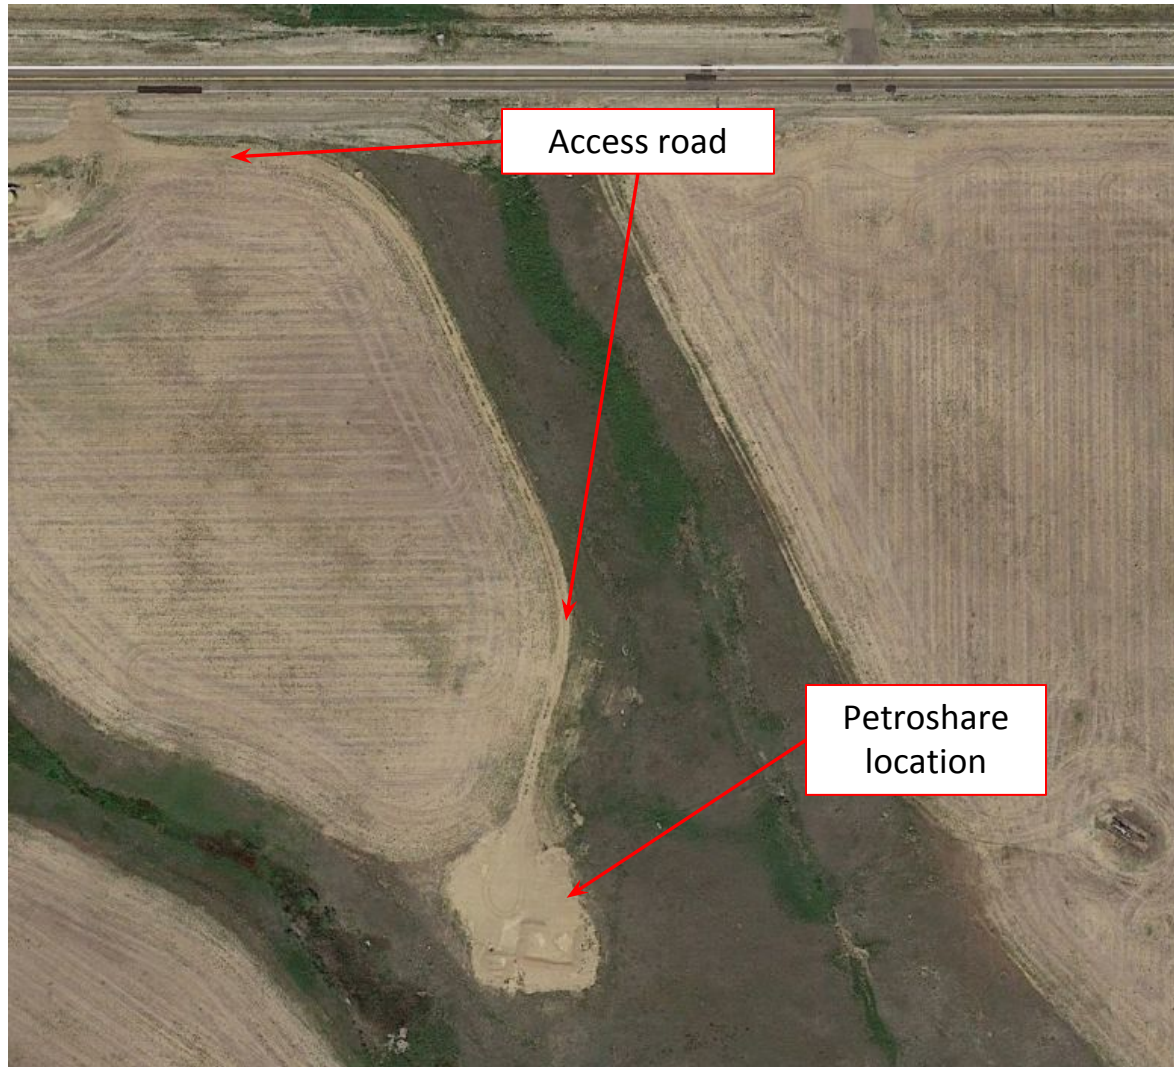
Google Earth aerial imagery taken 6/7/2017 illustrating the well and battery location, and access road post plugging and abandonment. Operator has failed to reclaim the access road and location per Rule 1004 and failed to respond to the previous corrective action inspection.

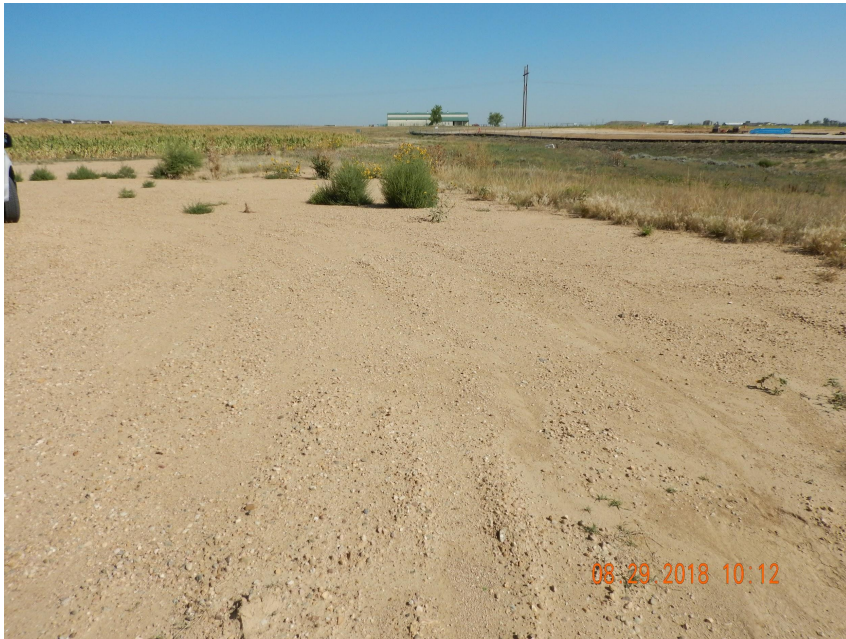
**Photo 1.** Photo taken from the southern well/battery location, facing North. Operator has not reclaimed the well/battery location and access road per Rule 1004 standards and failed to respond to the previous corrective action inspection. Also, weeds were observed along portions of the location.

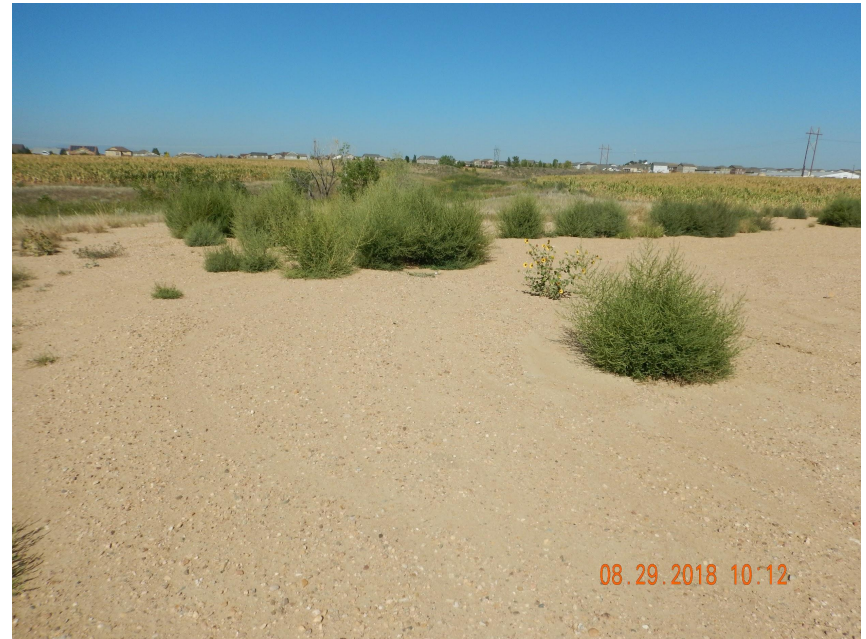
**Photo 2.** Photo taken from the southern well/battery location, facing Northwest. See comments under Photo 2.

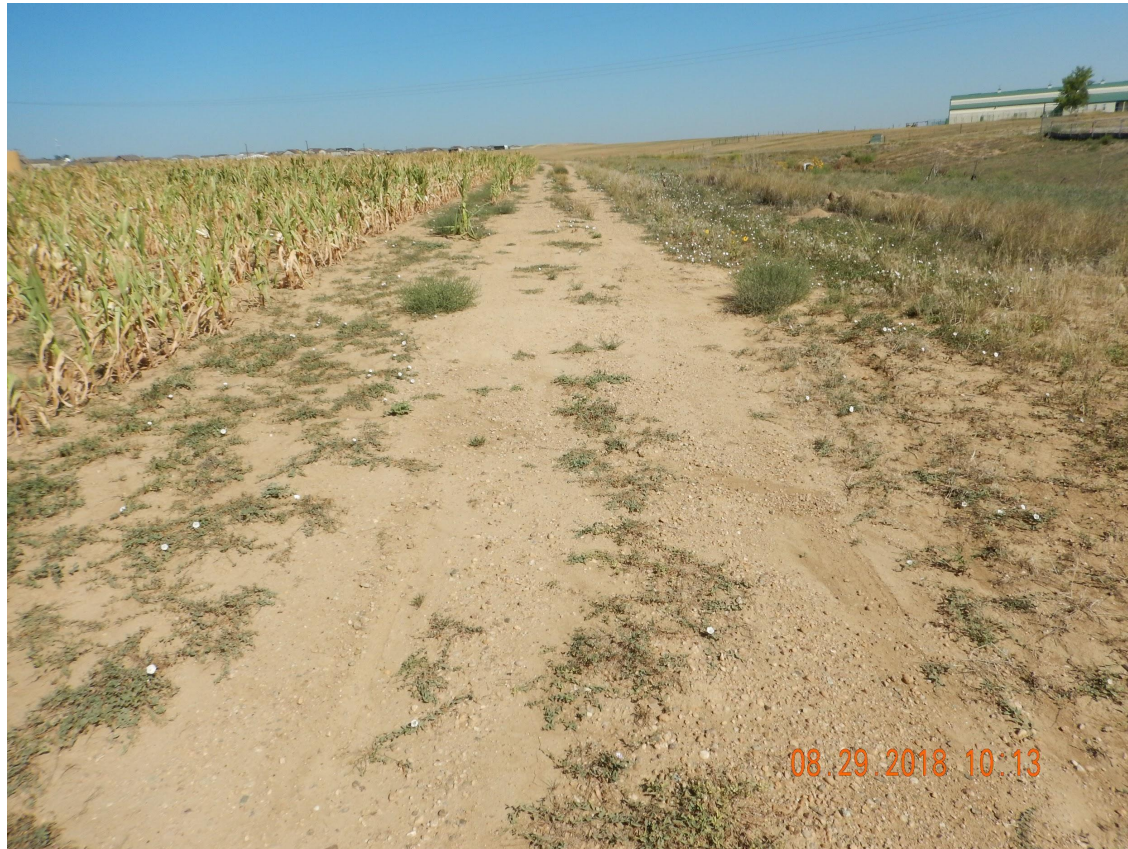
**Photo 3.** Photo taken along a portion of the access road, facing North. See comments under Photo 2.
