Construction and Stormwater Inspection

Operator: CRESTONE PEAK RESOURCES OPERATING LLC - #10633

Location ID: 332117

Inspection Photos
Location Name: Cosslett /22H-B168
Location ID: 332117

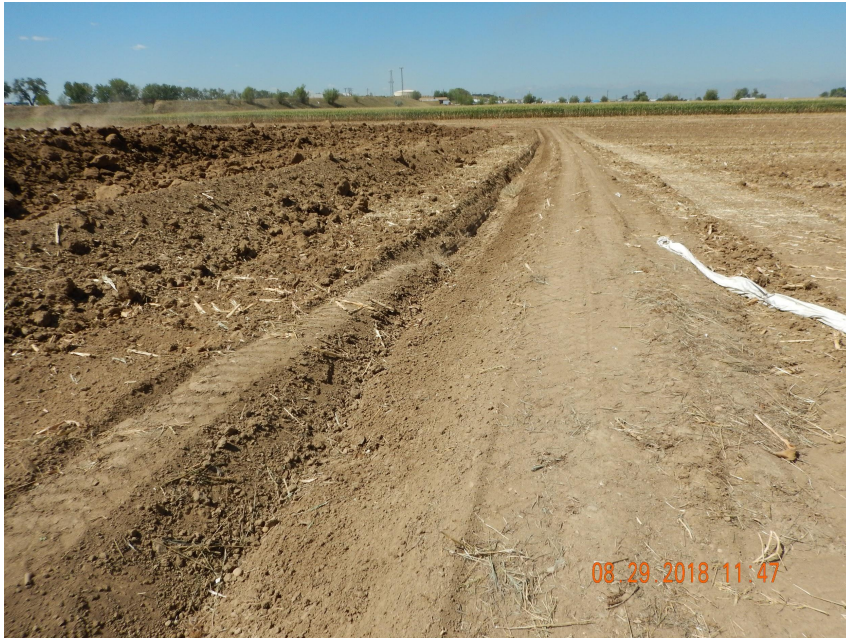
Photo 1. Photo taken from the northern perimeter of the location, facing West. Ditch and berm BMP has been installed along the entire perimeter of the location.

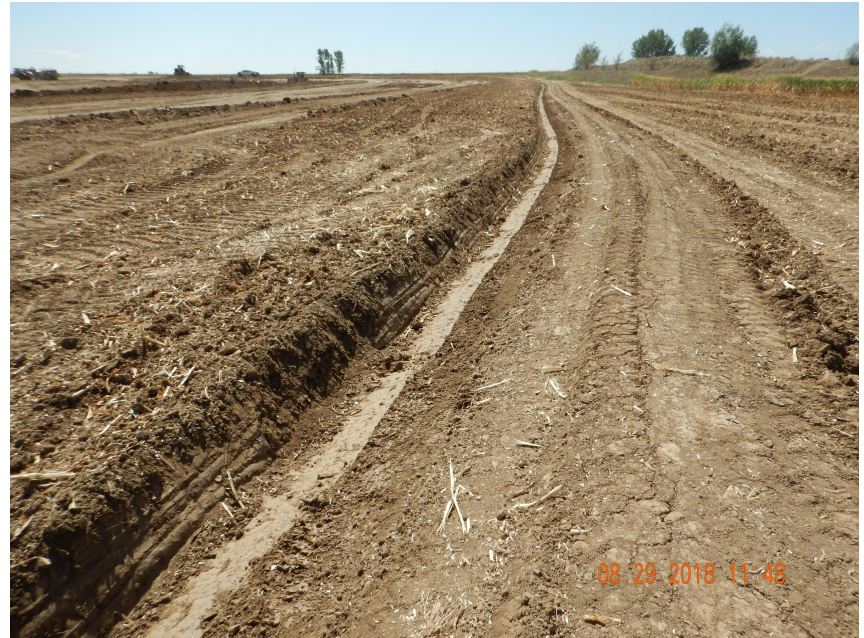
Photo 2. Photo taken from the northwest perimeter of the location, facing South. See comments under Photo 1.

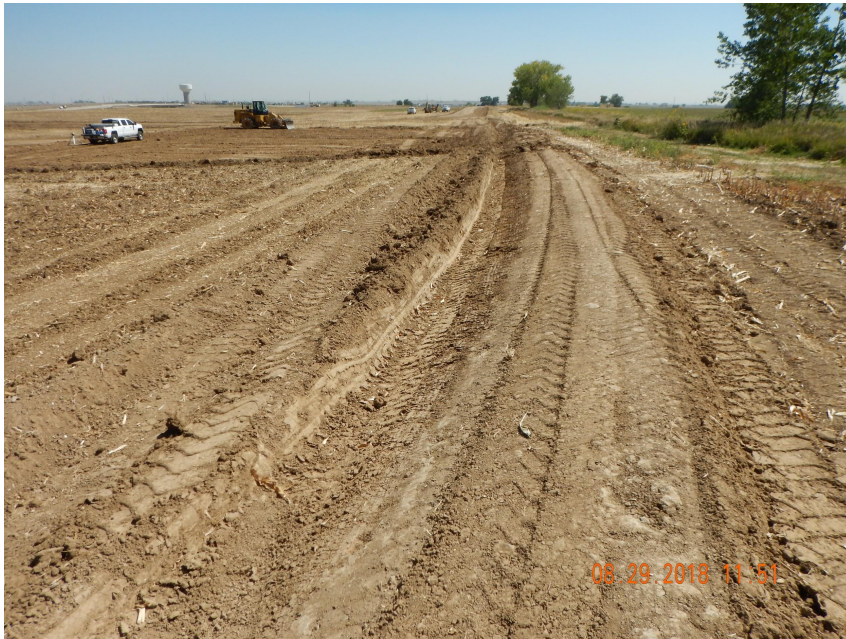
Photo 3. Photo taken from the southwestern perimeter of the location, facing East. See comments under Photo 1.

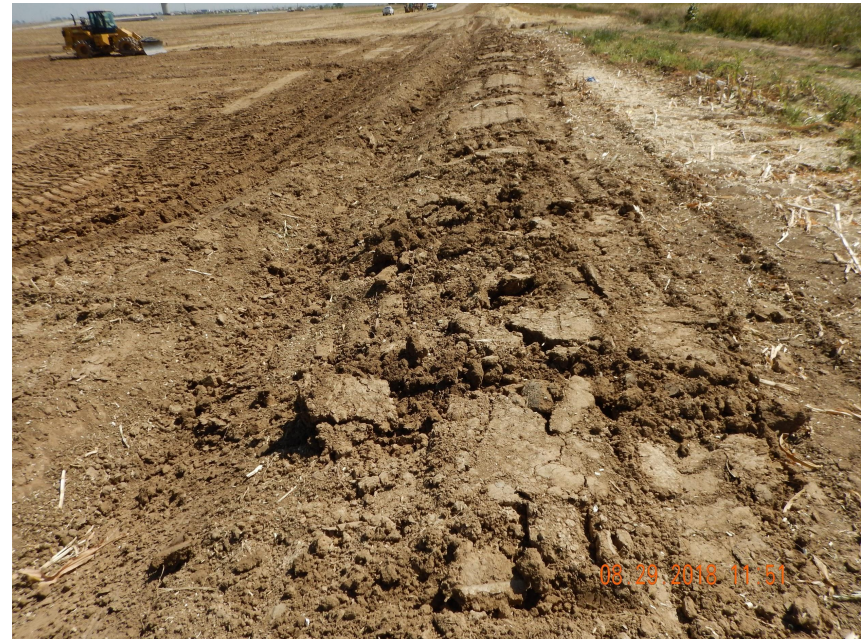
Photo 4. Photo taken from the southern perimeter of the location, facing East. Equipment traffic has damaged a portion of the stormwater BMP. BMPs shall be in proper functioning condition and shall be repaired.

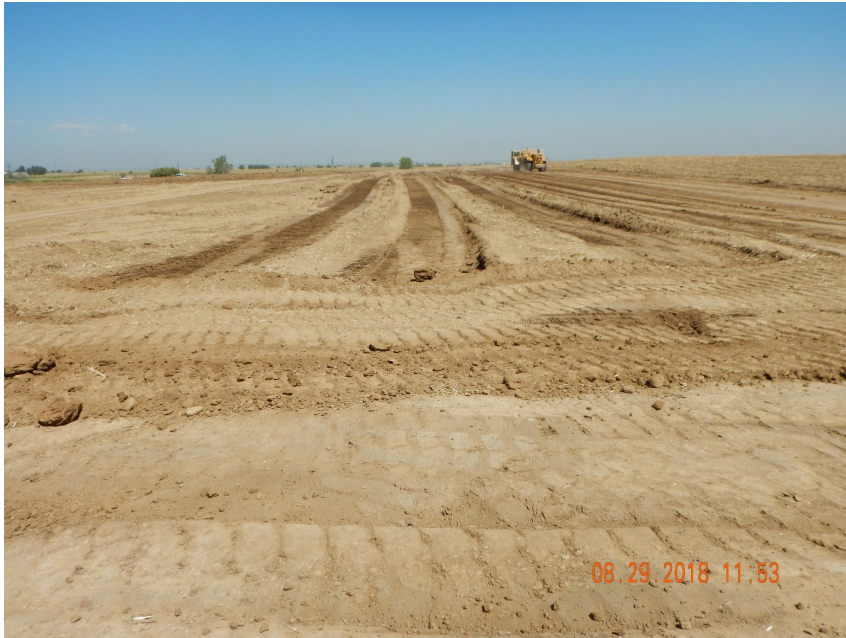
Photo 5. Photo taken from the southern perimeter of the location, facing North. Photo illustrates topsoil salvage operations are underway.

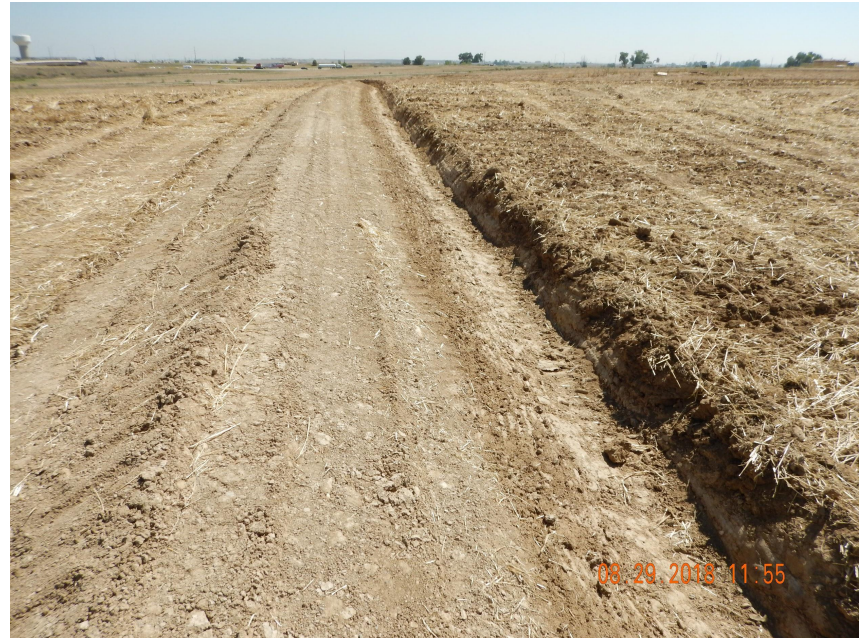
Photo 6. Photo taken from the northeastern perimeter of the location, facing East. See comments under Photo 1.
