Inspection Photos

Operator: WHITING OIL & GAS CORPORATION -
96155

Location ID: 437030

Inspection Doc. Number: 682503792
Weld County, CO

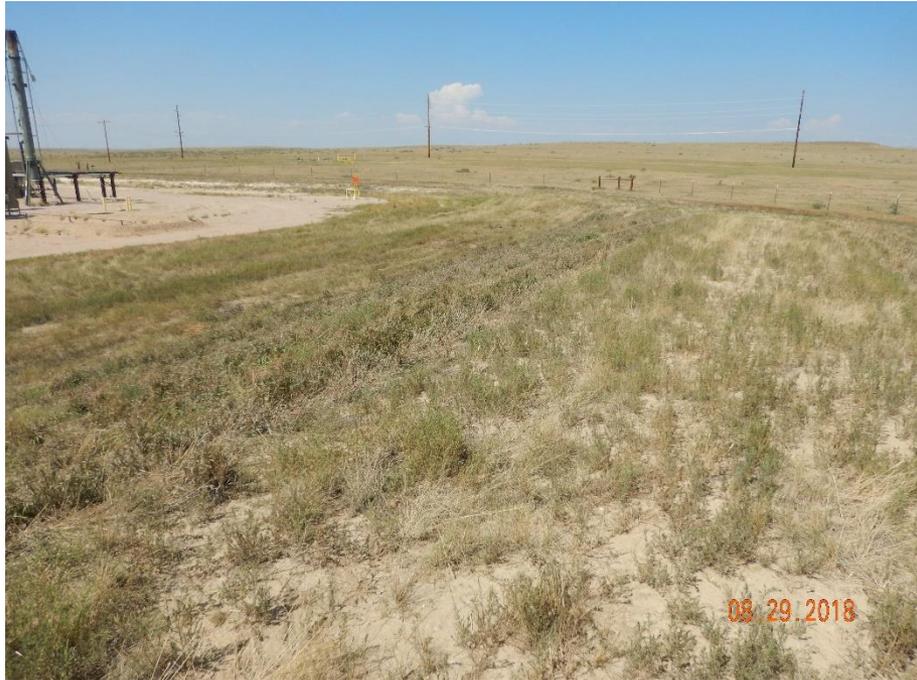
Photo 1: Photo taken from the west end of the location, facing north. Photos 1-4 provide an overview of the location from north, to west, to south.

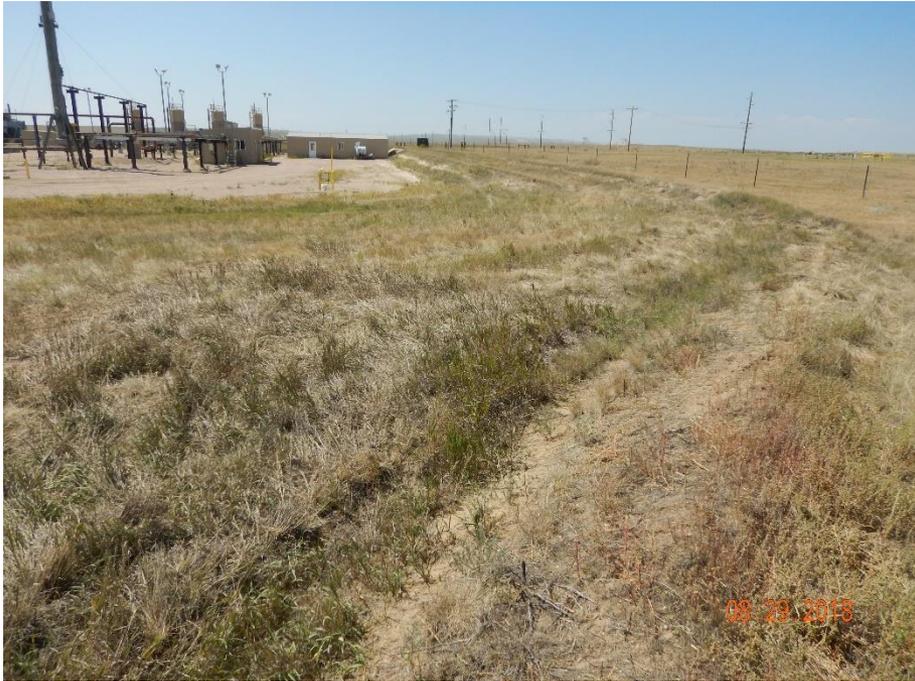
Photo 5: Photo taken from the northwest corner of the location. Facing west. Photo shows interim reclamation in process. Photo also shows stormwater ditch along perimeter.

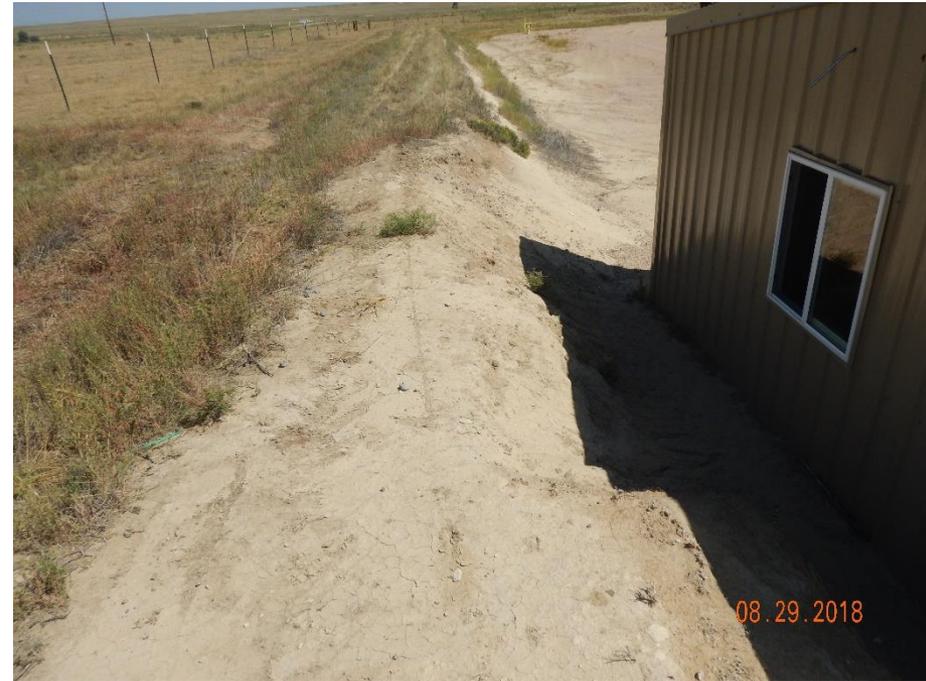
Photo 6: Photo taken from the north end of the location. Photo shows area where the ditch appears to have filled in over time and erosion degradation is beginning to occur. Advise maintenance to mitigate any additional disturbances.

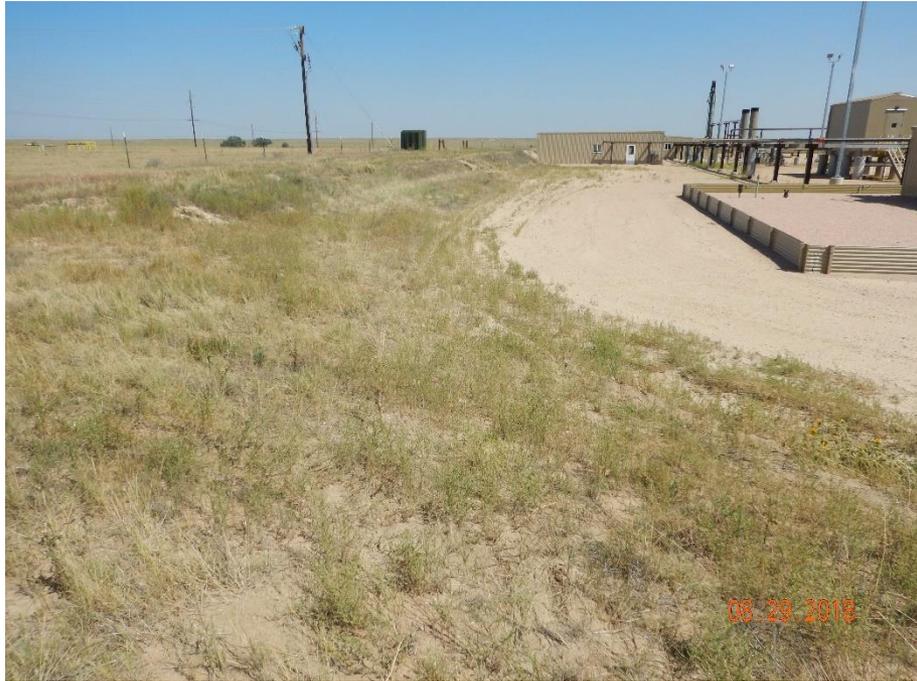
Photo 7: Photo taken from the northwest end of the location, facing east.

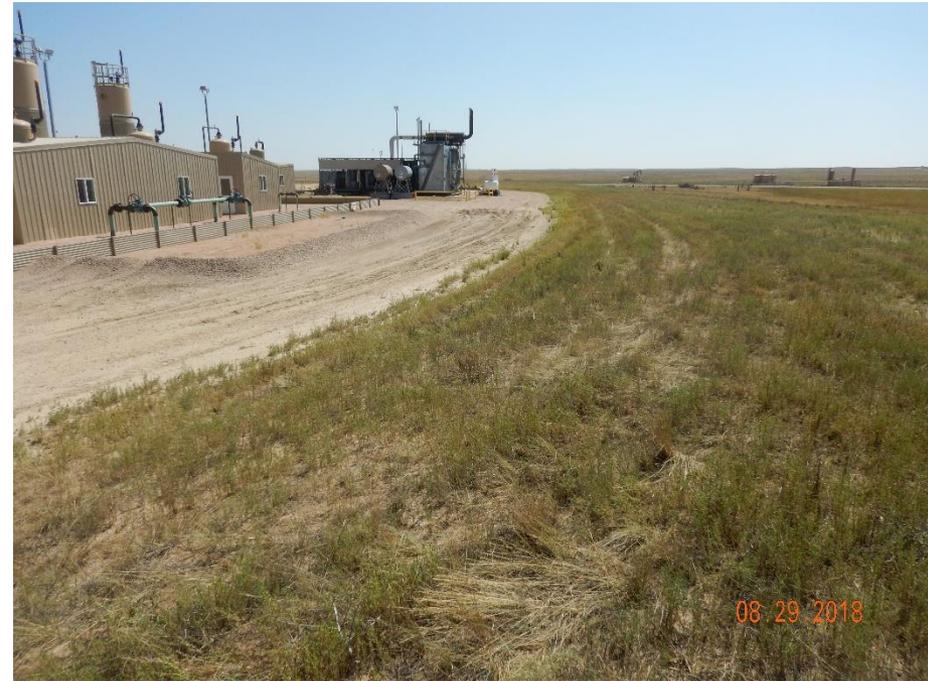
Photo 8: Photo taken from the northwest end of the location, facing south. Photo shows interim reclamation in process.

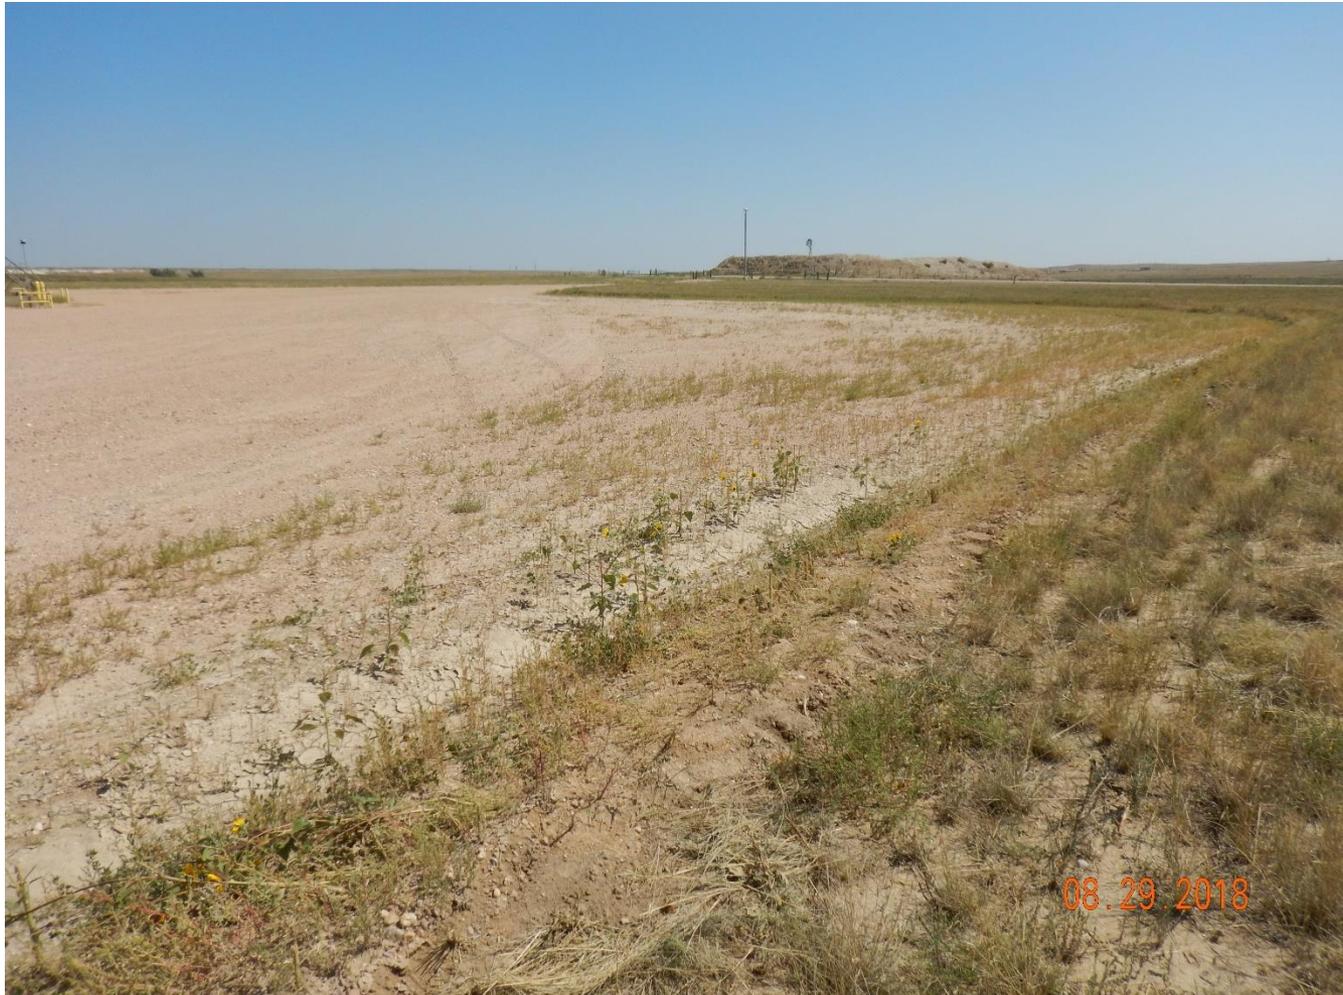
Photo 9: Photo taken from the western end of the location, facing southeast. Photo shows areas of the pad that do not appear to be reasonably needed for production. These areas need to be reclaimed.
