Construction and Stormwater Inspection

Operator: SRC ENERGY INC- #10311

Location ID: 454405

Inspection Photos
Location Name: Bluff Federal State /40-1
Pad
Location ID: 454405

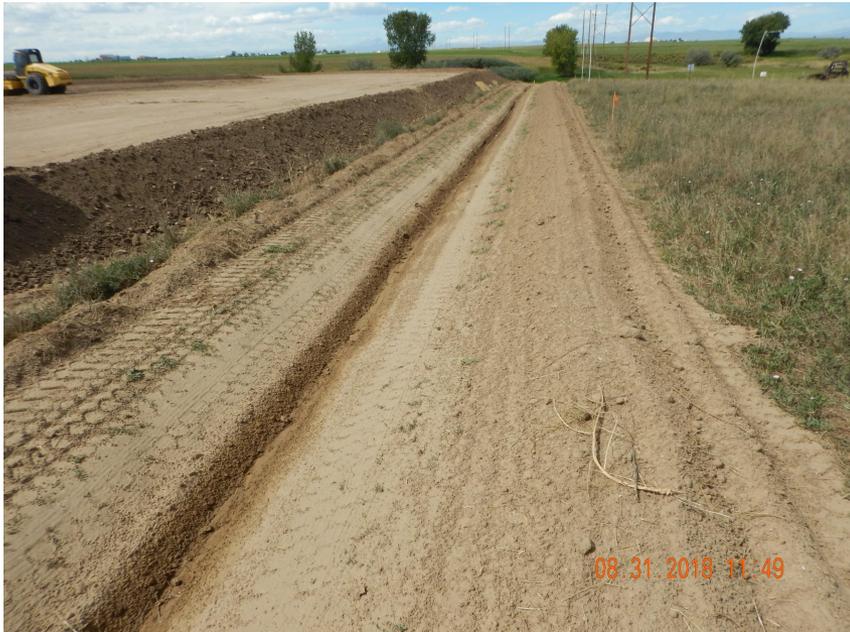
Photo 1. Photo taken from the northeast perimeter of the location, facing West. Ditch and berm BMP has been installed around the entire perimeter of the location. Culverts are needed and were staged on location.

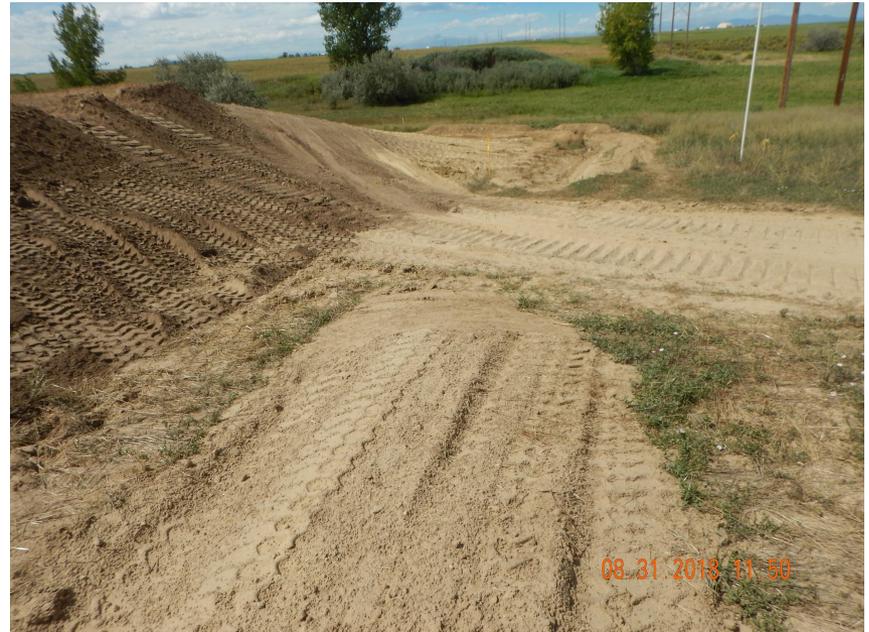
Photo 2. Photo taken from the northwestern perimeter of the location, facing West. Photo illustrates where a culvert is needed in conjunction with the ditch and berm BMP.

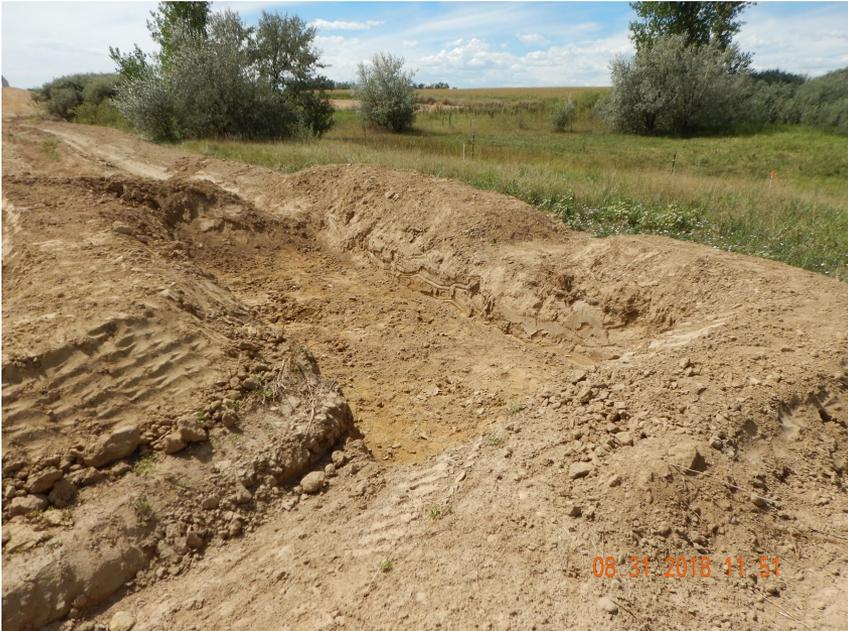
Photo 3. Photo taken from the northwest perimeter of the location, facing Southwest. Sediment trap is IN-PROCESS of being constructed. Sediment trap lacks both inlet and outlet protection devices.

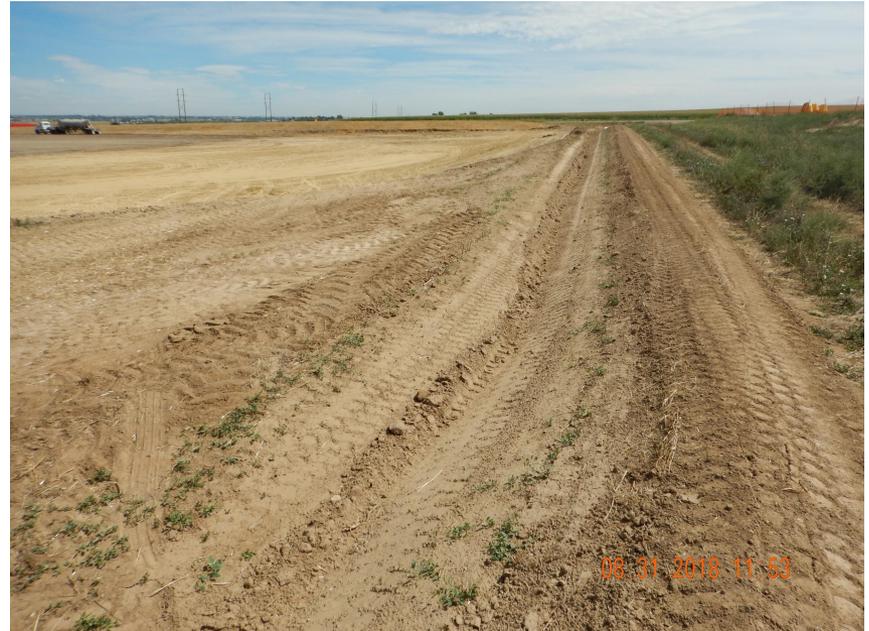
Photo 4. Photo taken from the northwestern perimeter of the location, facing South. See comments under Photo 1.

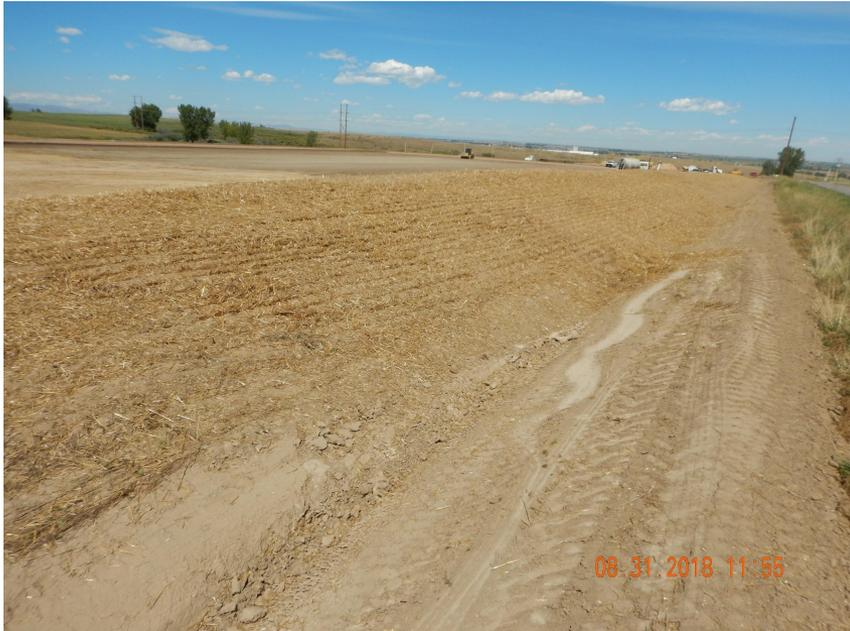
Photo 5. Photo taken from the southeastern perimeter of the location, facing North. Topsoil has been salvaged and stored along the western and eastern perimeter of the location. Topsoil has been seeded, straw mulched and crimped.

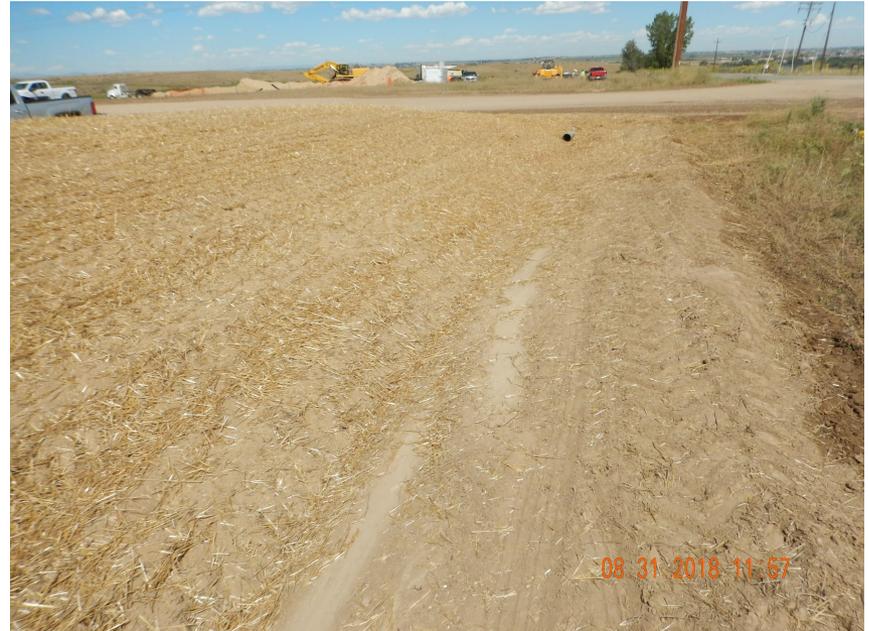
Photo 6. Photo taken from the northeastern perimeter of the location, facing North. See comments under Photo 5.
