Interim Reclamation and Stormwater Inspection

Operator: KERR MCGEE OIL & GAS ONSHORE LP- #47120

Location ID: 302901

Inspection Photos
Location Name: PAVISTMA #4-22
Location ID: 302901

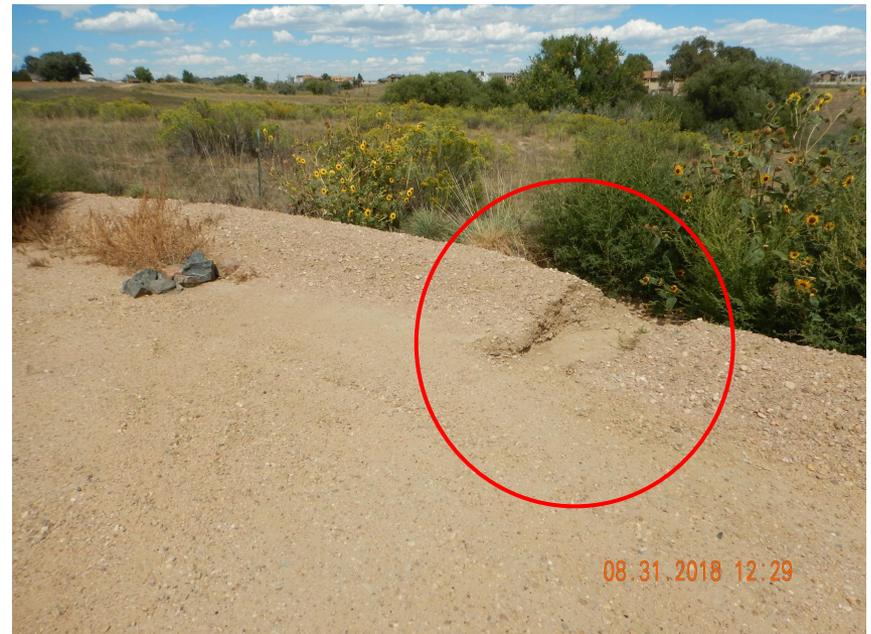
Photo 2. Photo taken of the northern battery location, facing North. Berm BMP in need of repair. Sediment discharge was observed off location.

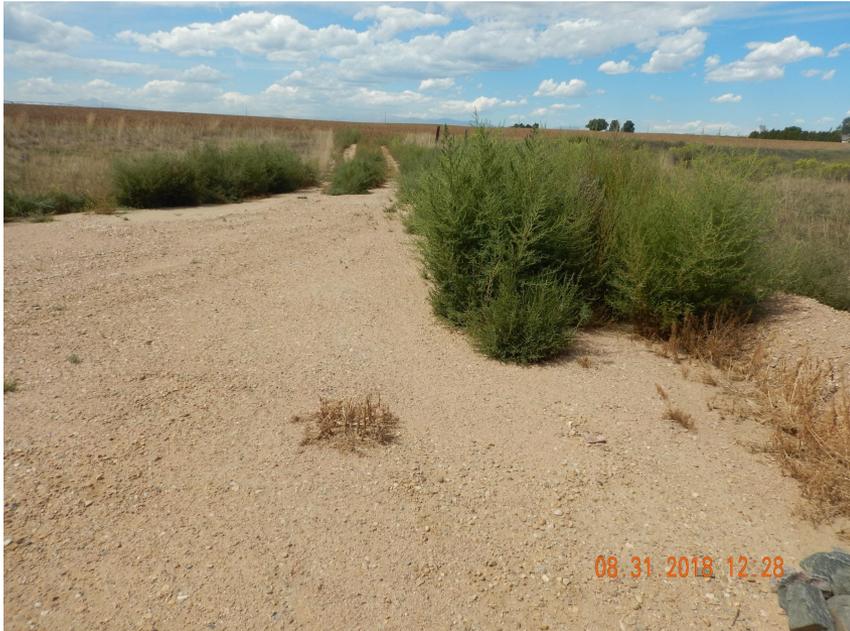
Photo 3. Photo taken from the northern entrance to the battery location, facing West. Kochia and Musk thistle weeds observed along portions of the battery location.

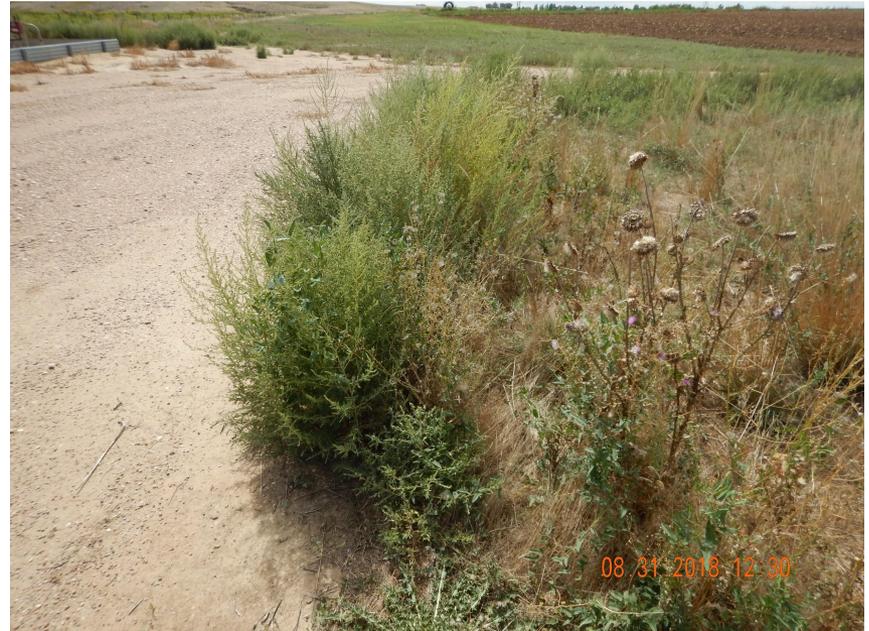
Photo 4. Photo taken from the western battery location, facing South. Photo illustrates Kochia and Musk thistle. See comments under Photo 1.
