Inspection Photos
Operator: GRAND MESA OPERATING CO - 35080
Location ID: 456610

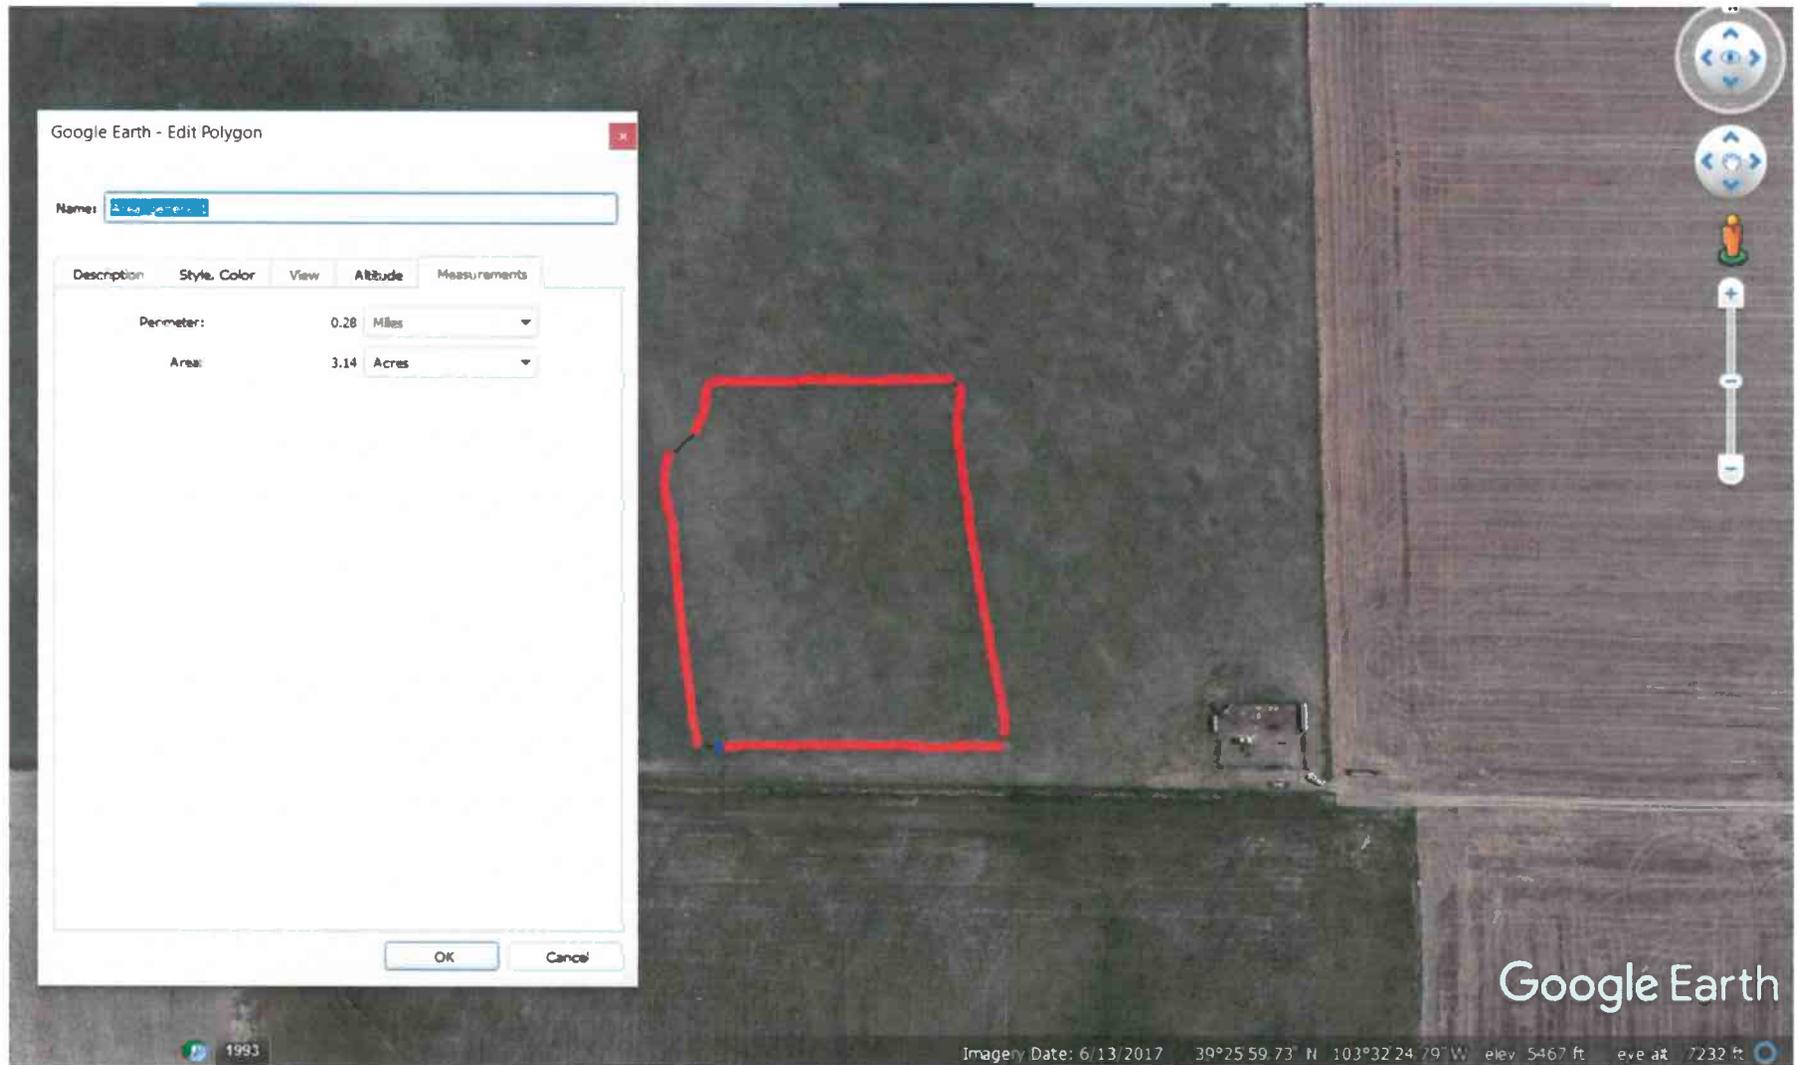
Photo 12: 2017 Google Earth aerial imagery. 2A doc. #401665224 states size of disturbance area during construction will be 2.5 acres in size. GPS measurements were conducted indicating that the disturbance area, not including the fence line, is 3.14 acres in size.
