Final Reclamation Inspection

Operator: TOP OPERATING COMPANY - 39560

API: 05-123-07899

SWNW Section 23 T2N R67W

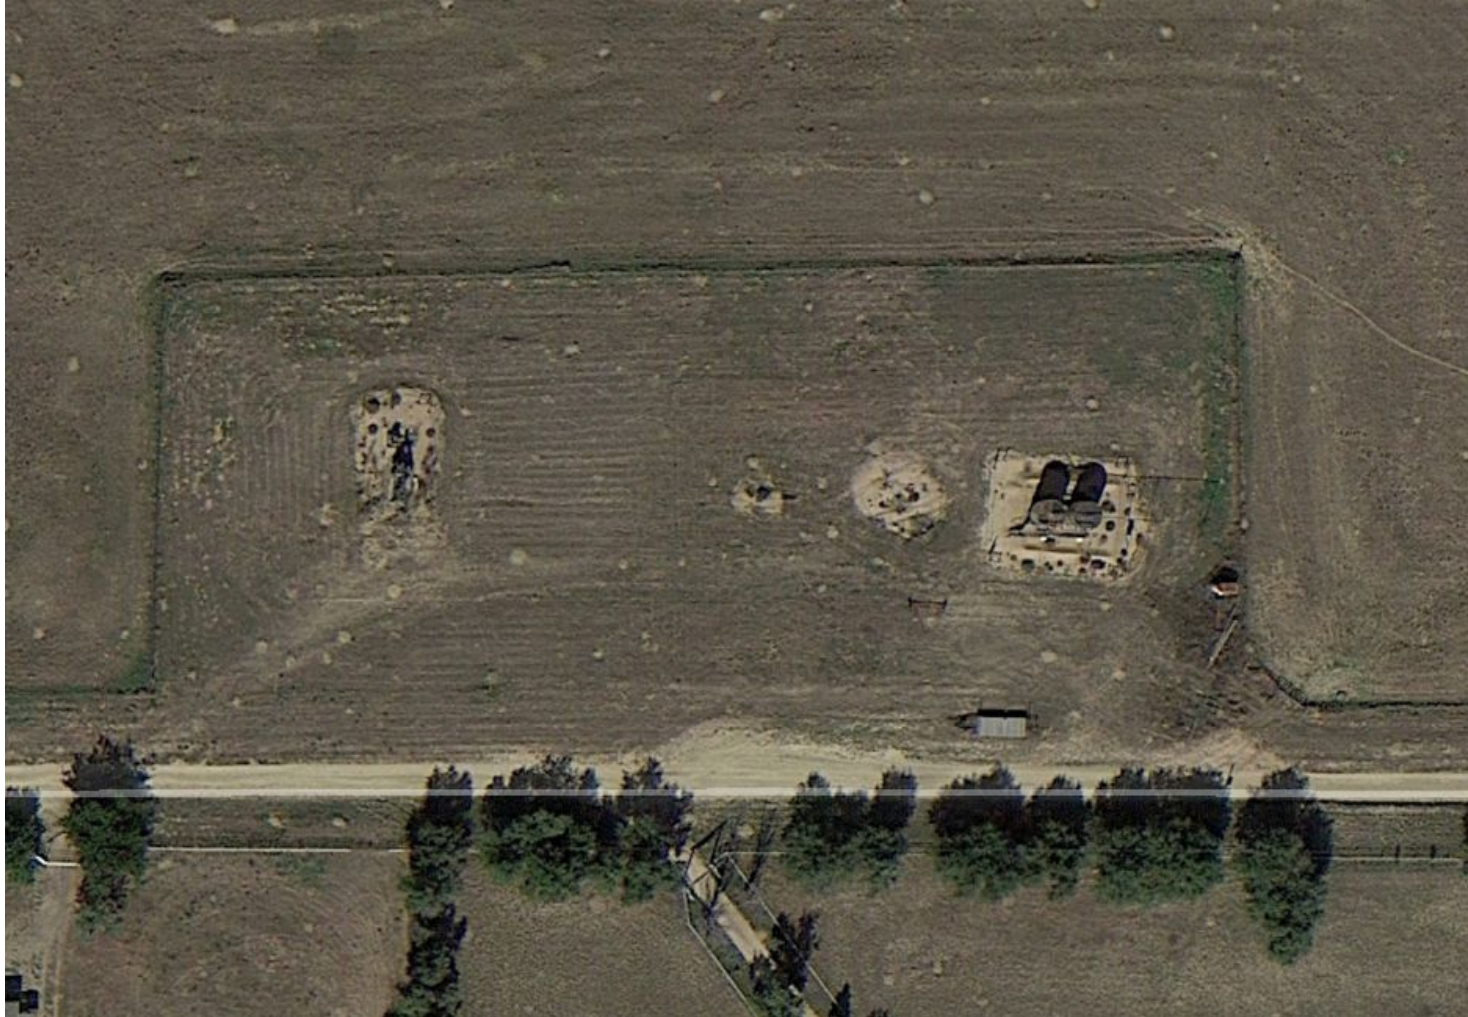
Google Earth aerial imagery taken October 6, 2014. Well was plugged and abandoned on 7/11/2013. Photo illustrates equipment had not been removed per Rule 1004.a. and remained 15 months after plugging and abandonment. As of September 5, 2018, Operator has failed to remove all equipment- see Photo 4.

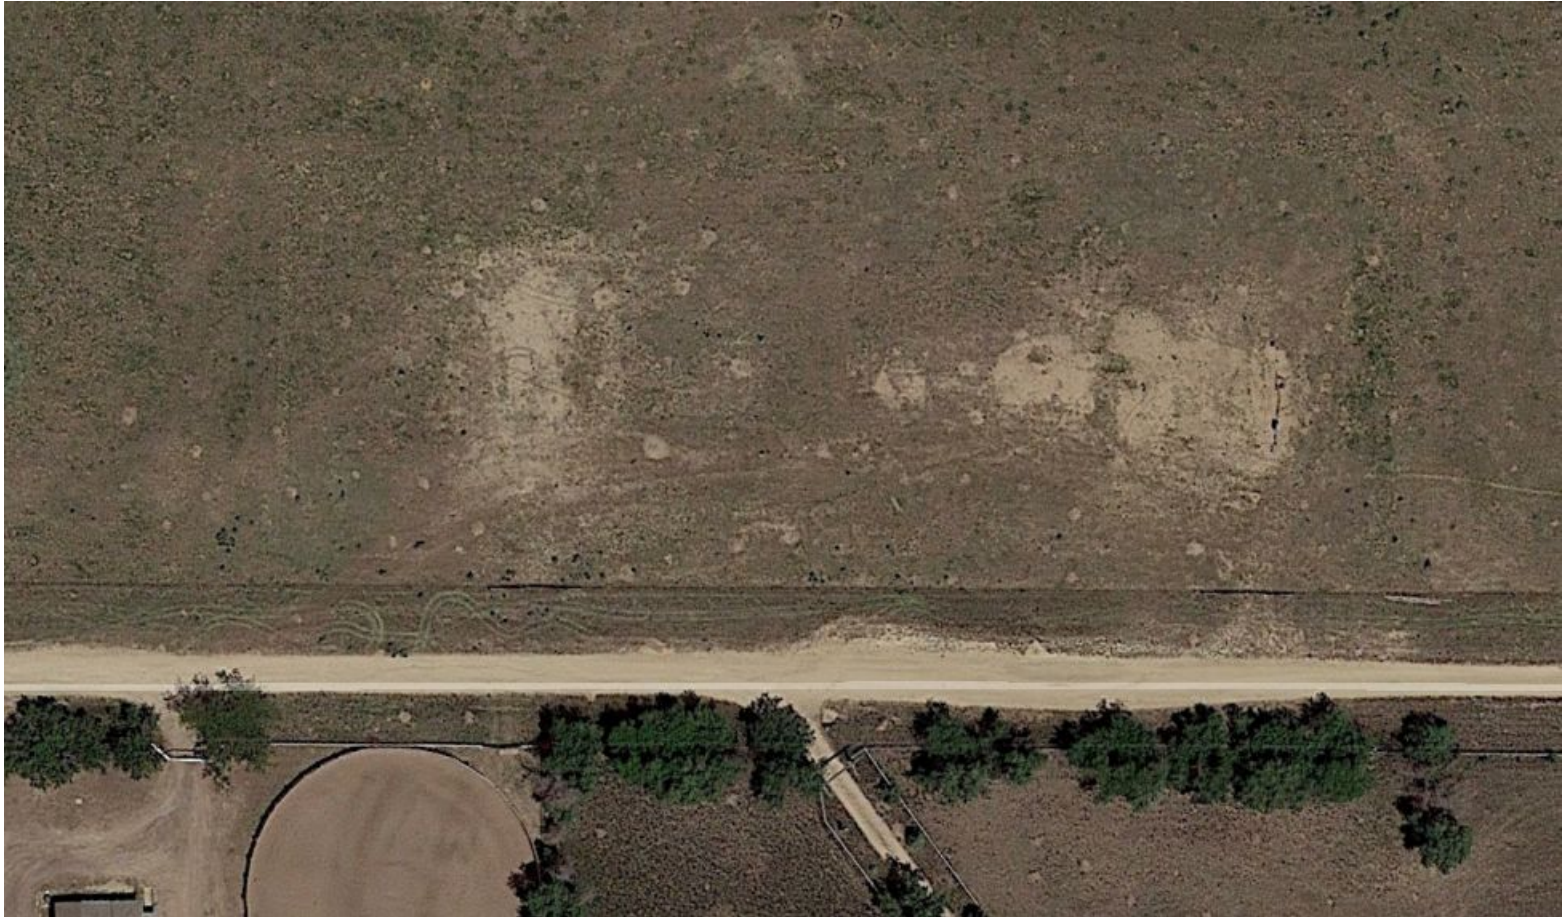
Google Earth aerial imagery taken June 9, 2017. Aerial imagery shows disturbance areas (bare patches) do not meet vegetative standards, even though the Operator submitted a Final Reclamation Complete Notice on January 28, 2016.

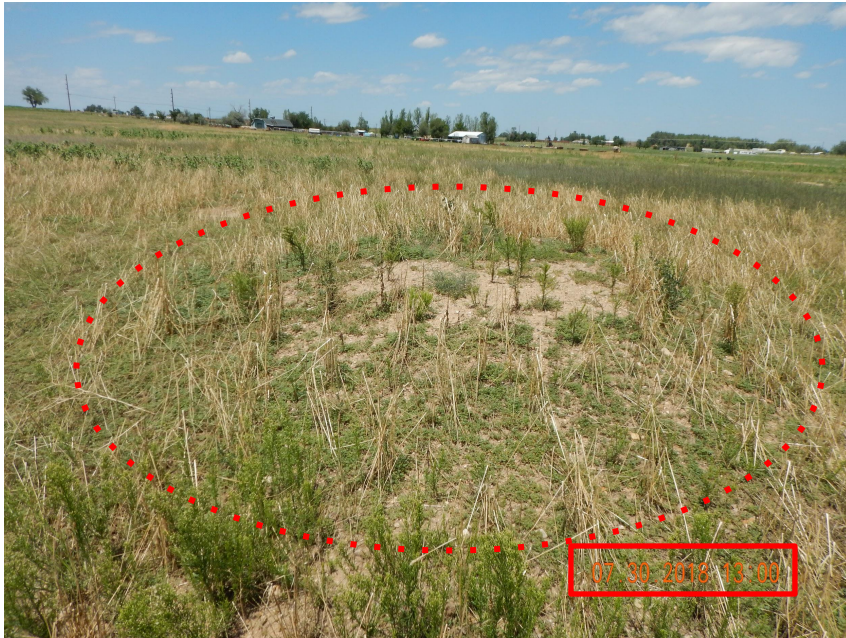
Photo 1. Photo taken from the western location on July 30, 2018, facing West. Operator has not contoured a portion of the location to match the surrounding landscape. Also, the photo illustrates vegetative standards do not meet Rule 1004 standards.

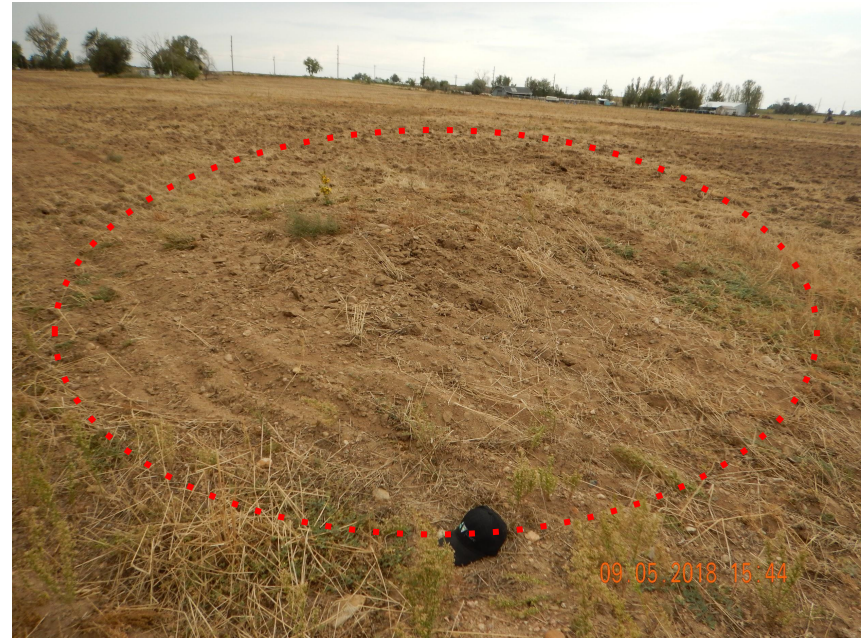
Photo 2. Photo taken from the western location on September 5, 2018, facing West. Surface owner has recently cultivated the ~30 acre parcel, including portions of this P&A location. This photo illustrates the Operator has failed to contour a portion of the location.

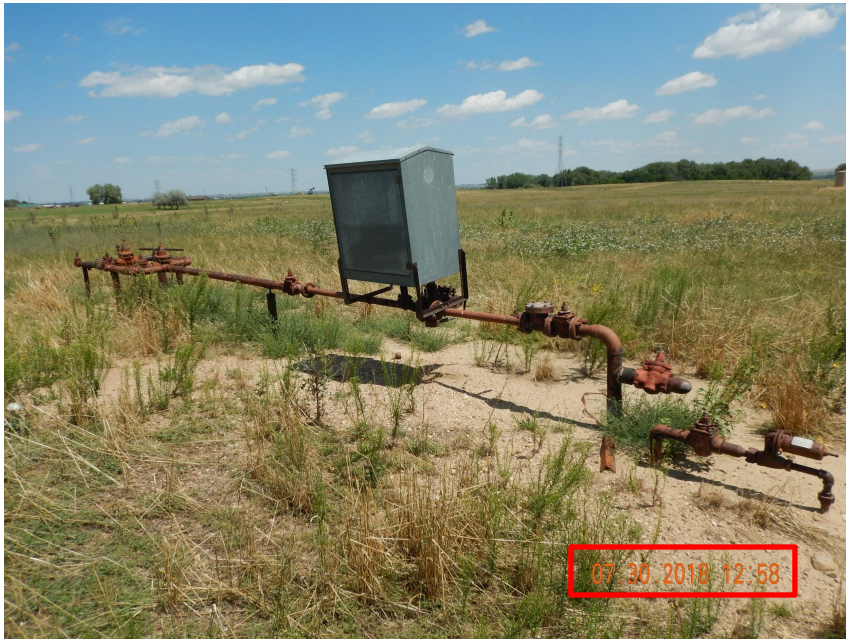
Photo 3. Photo taken from the eastern location on July 30, 2018, facing Northeast. Operator has failed to remove all equipment. It is the responsibility of the Operator to coordinate with the responsible parties to remove all equipment that was associated with oil and gas operations.

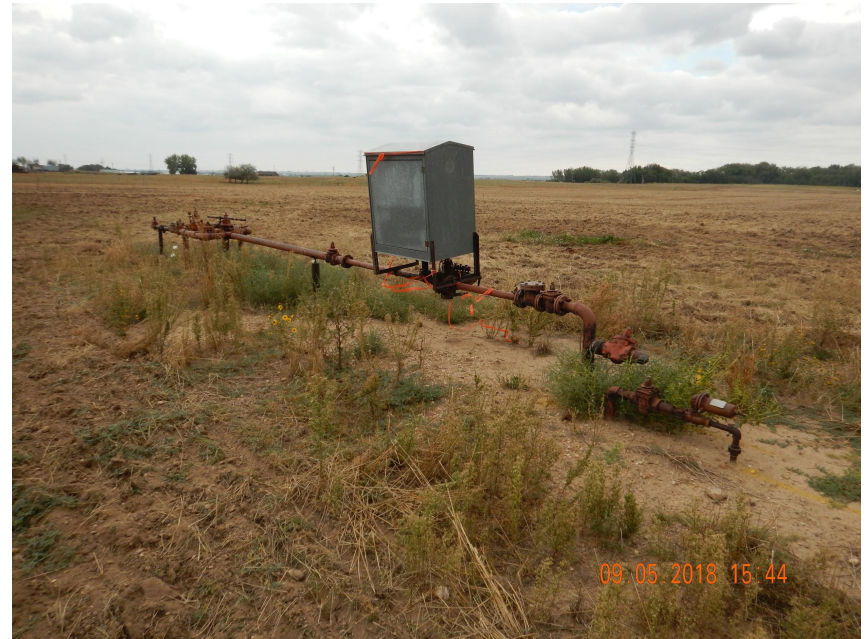
Photo 4. Photo taken from the eastern location on September 5, 2018, facing Northeast. Equipment remains at the P&A location. Equipment has been flagged and a recent "Locate" was performed. Unclear whether the "Locate" was conducted by the surface owner because of the recent cultivation or whether the Operator was responding to the corrective action.

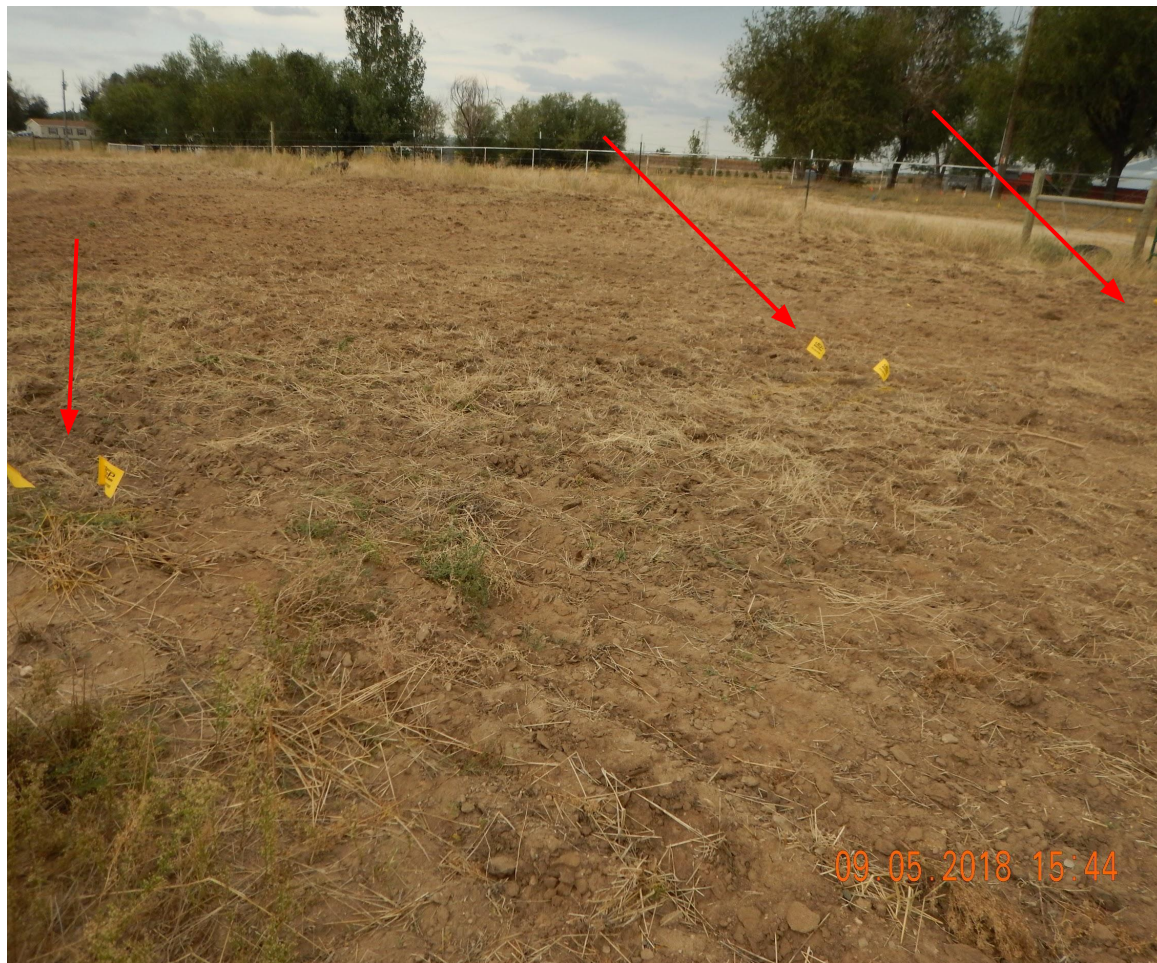
Photo 5. Photo taken from the eastern location on September 5, 2018, facing Southeast. Photo illustrates flagging from a recent "Locate". See comments under Photo 4.
