Construction and Stormwater Inspection

Operator: NOBLE ENERGY INC- #100322

Location ID: 456625

Inspection Photos
Location Name: D /19-03 Pad
Location ID: 456625

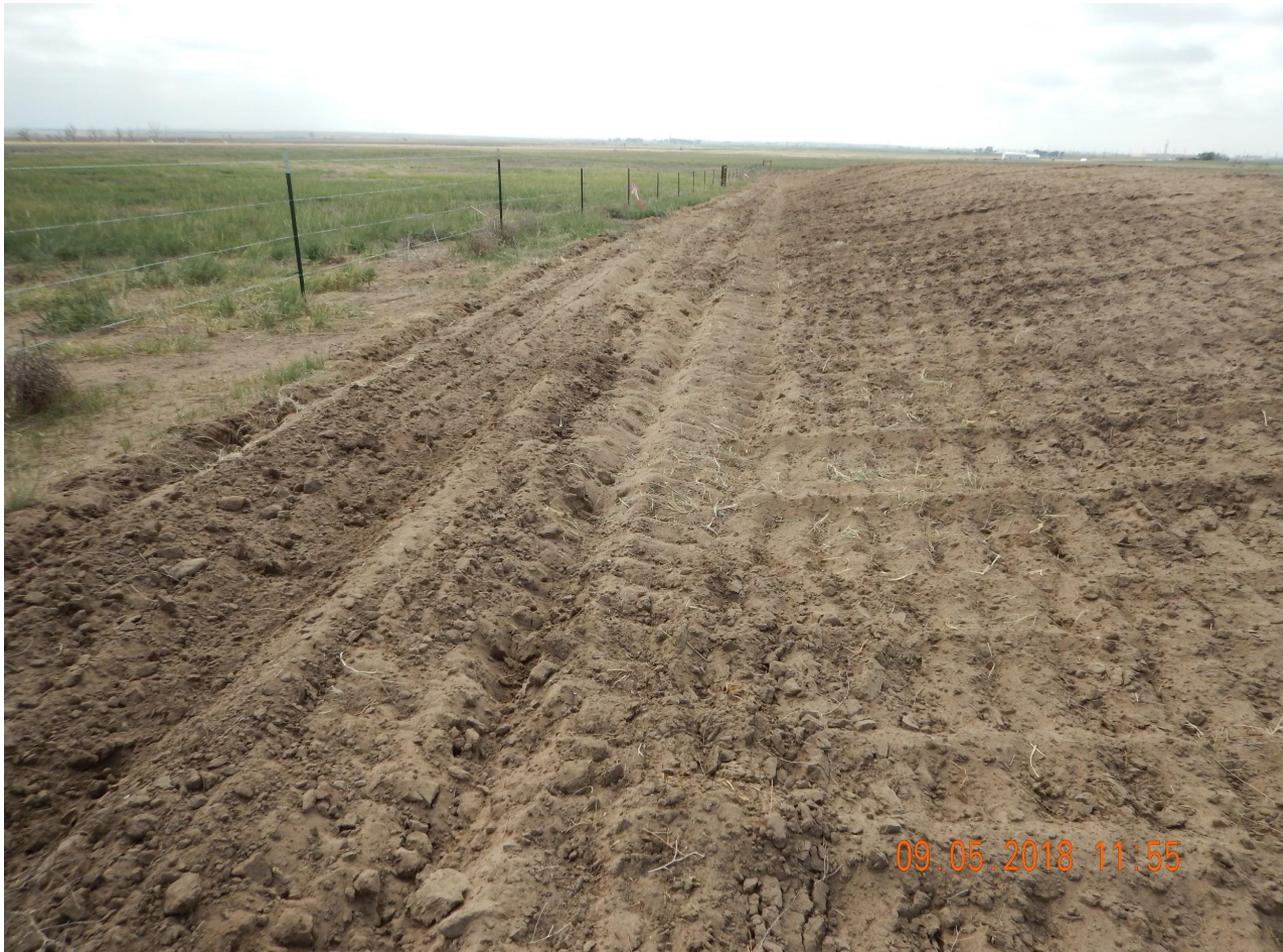
Photo 1. Photo taken from the northeastern location, facing South. Surface roughening BMP installed around portions of the perimeter location. This location is very sandy and will require more appropriate BMPs than surface roughening. Operator indicated that the entire disturbance area would be hydromulched and seeded upon completing the pad construction. Photo also illustrates the topsoil stockpile that has been temporarily stabilized with equipment tracking.

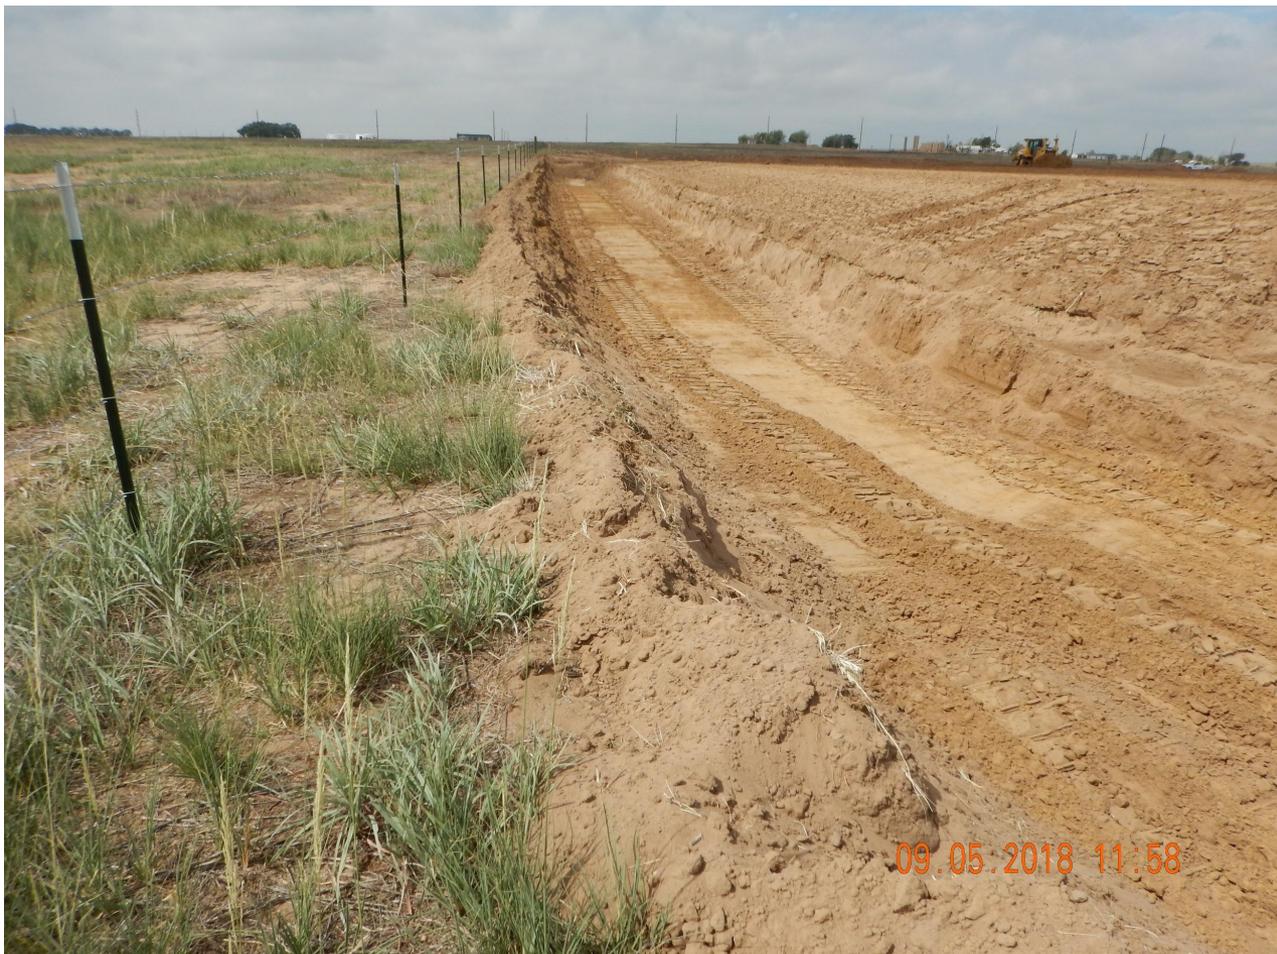
Photo 2. Photo taken from the southeastern location, facing West. Appears a retention pond has been constructed. Operator indicated pad will be sloped (0.5%) towards the south to allow for proper drainage. See comments under Photo 1.

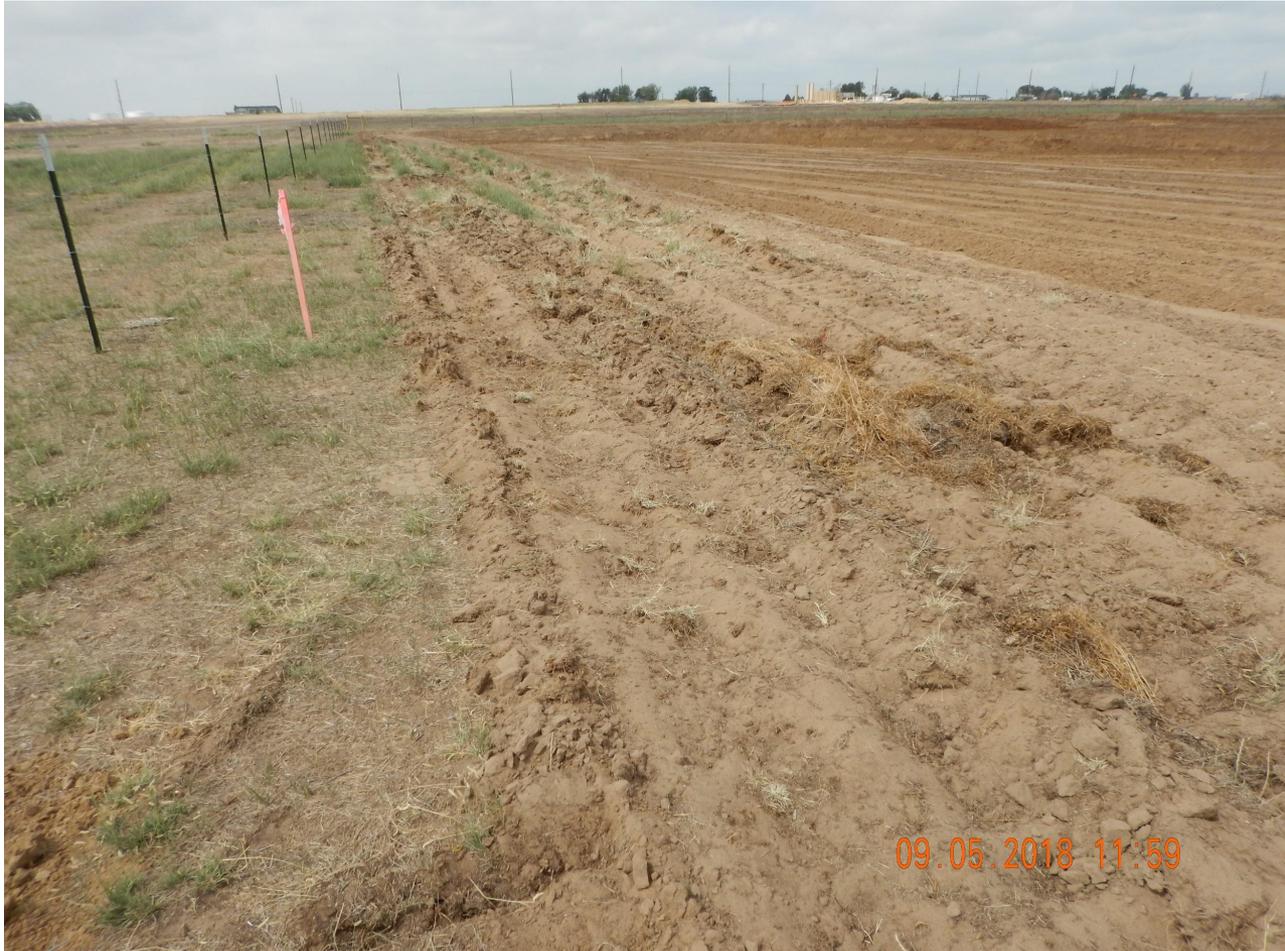
Photo 3. Photo taken from the southern location, facing West. See comments under Photo 1.

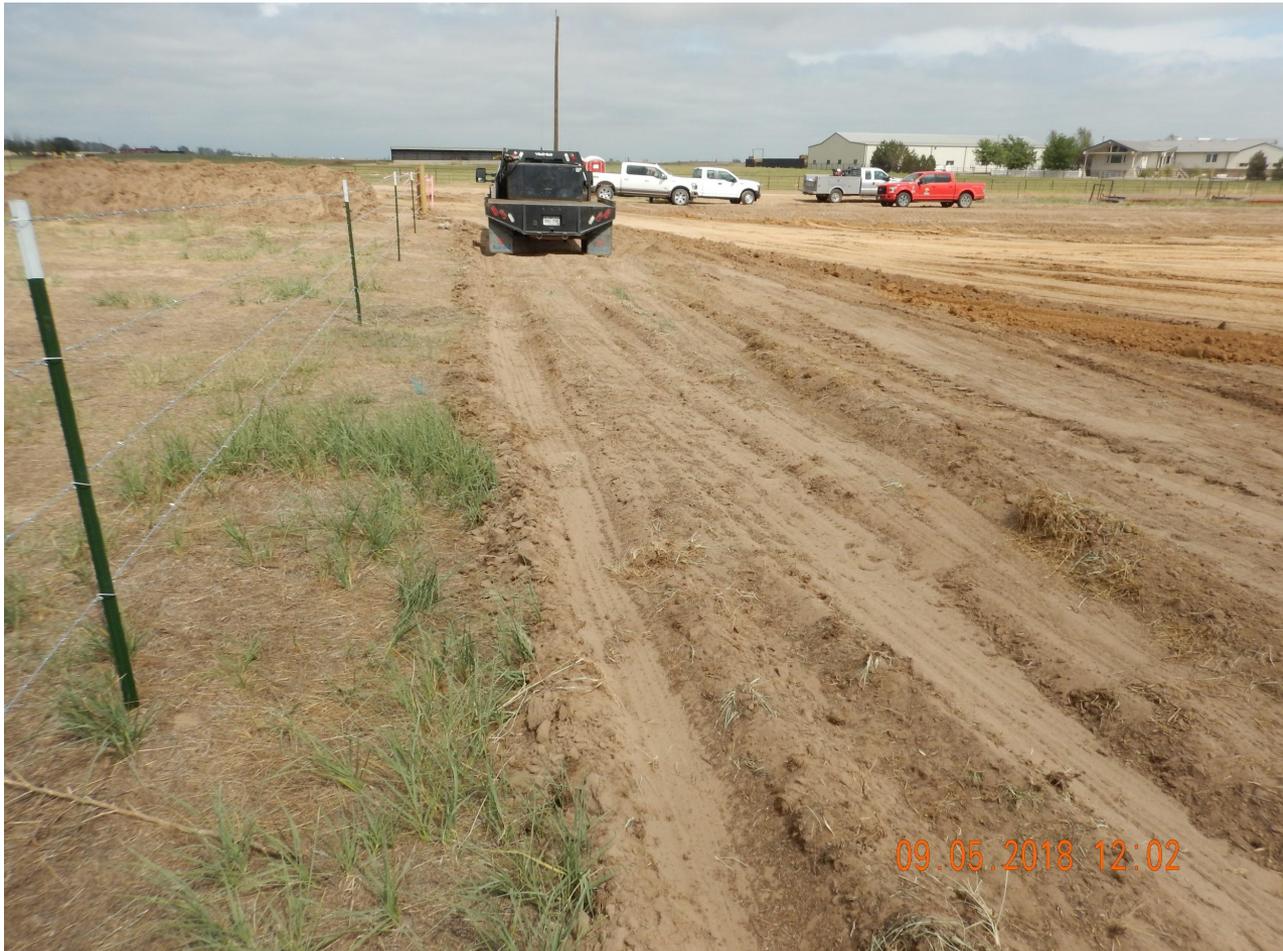
Photo 4. Photo taken from the northwestern location, facing North. Operator is driving over the top of the BMP. Operator shall keep off BMPs so they remain in proper functioning condition. Operator indicated that surface roughening BMPs are re-rippped every 2 days due to vehicle and equipment traffic.

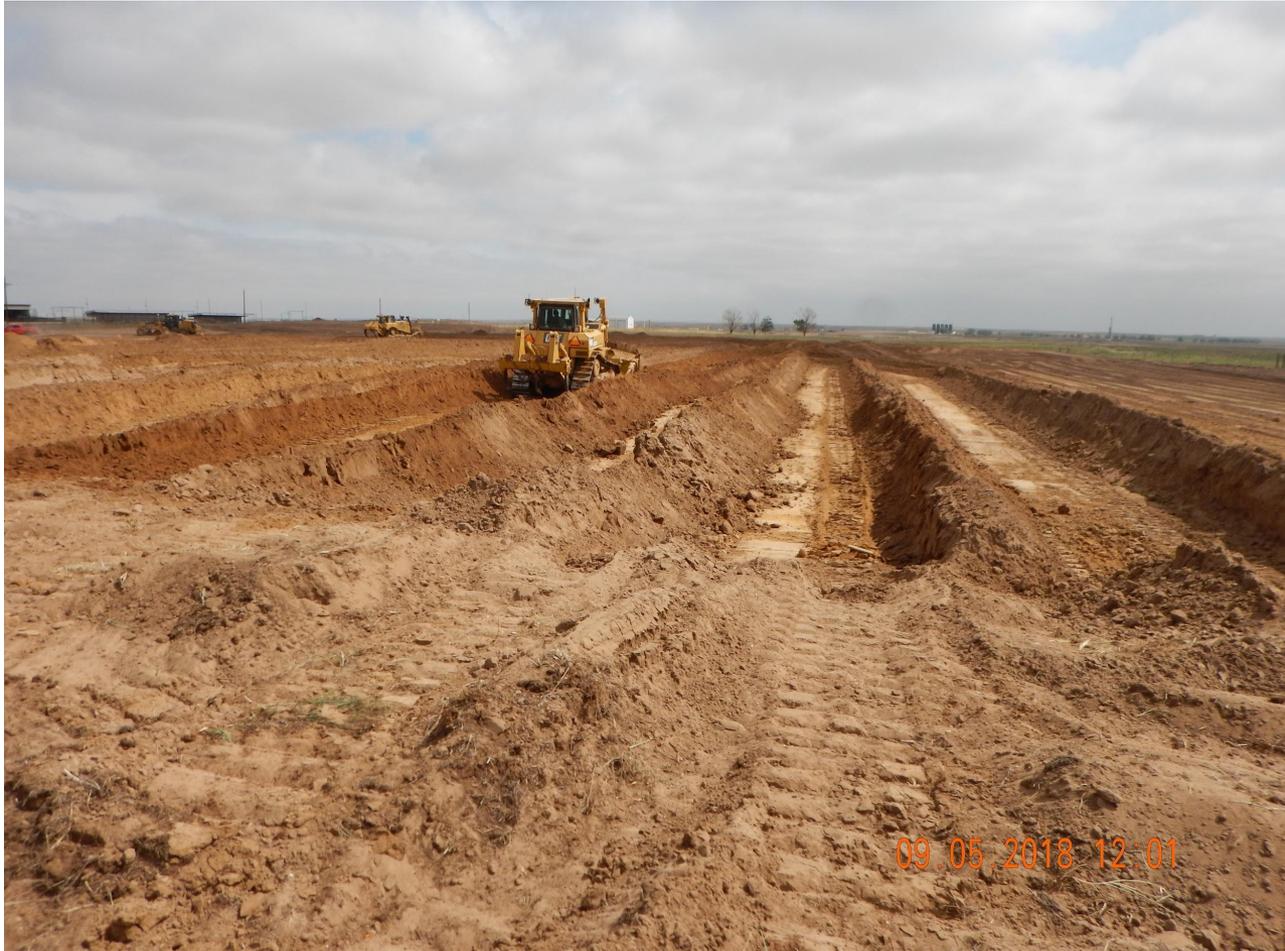
Photo 5. Photo taken from the western location, facing East. Operator is in-process of constructing the location.
