Final Reclamation Inspection

Operator: NOBLE ENERGY INC- #100322

API: 05-123-30501

Inspection Photos
Location Name: NOPENS H #24-08
API: 05-123-30501

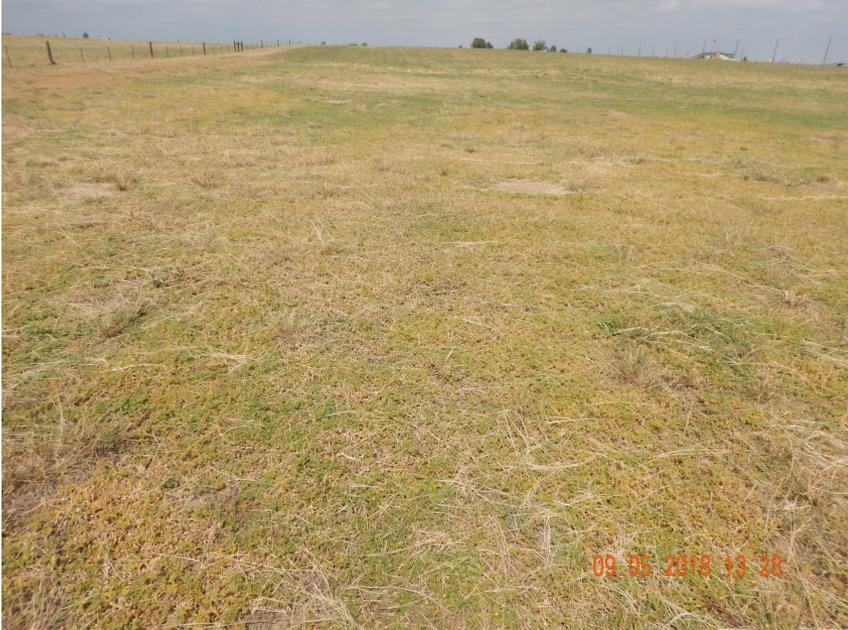
Photo 1. Photo taken from the well location, facing North. The entire well location is dominated by Puncturevine which is not a desirable plant species. Little to no desirable vegetation was observed.

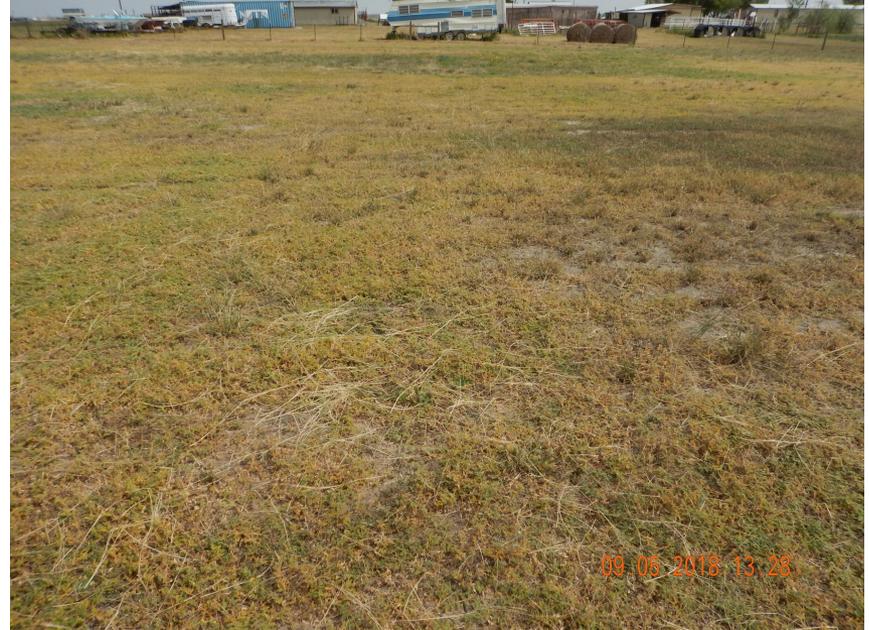
Photo 2. Photo taken from the well location, facing East. See comments under Photo 1.

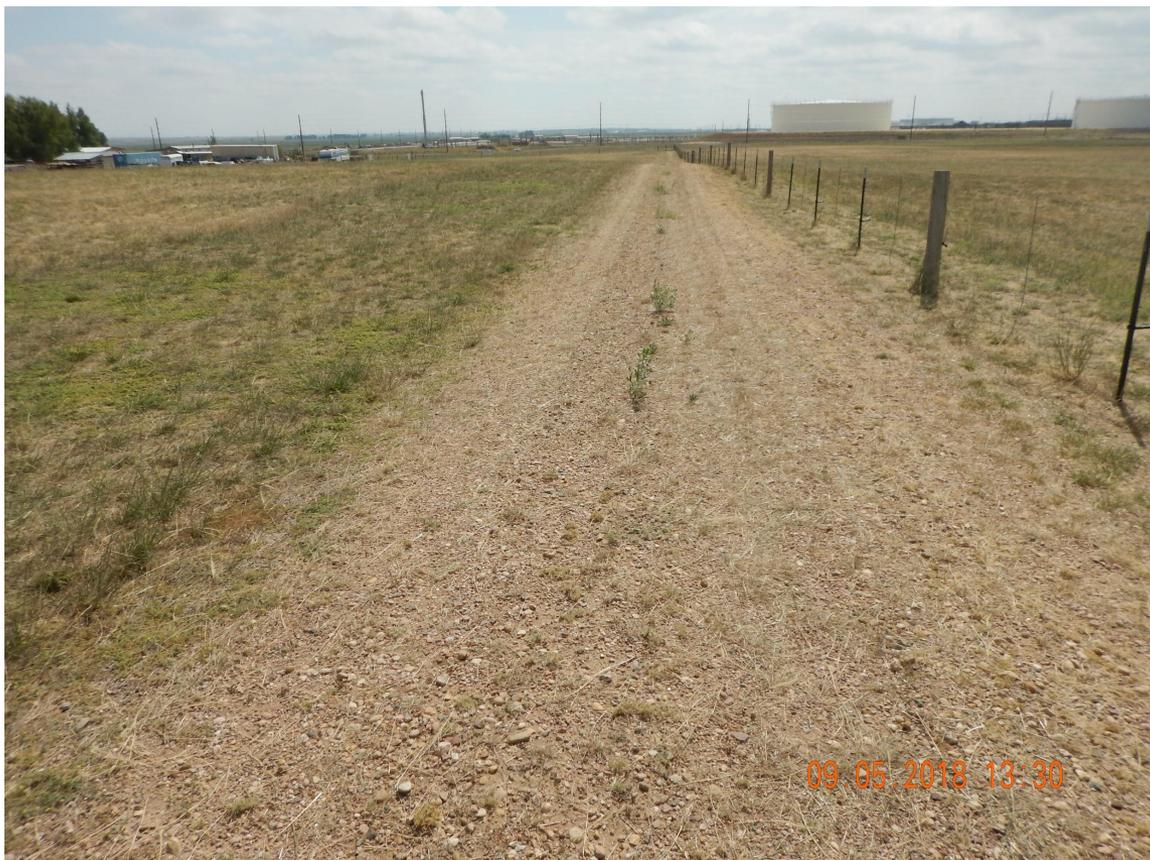
Photo 3. Photo taken along a portion of the well access road, facing South. Operator has failed to reclaim the access road per Rule 1004.a.

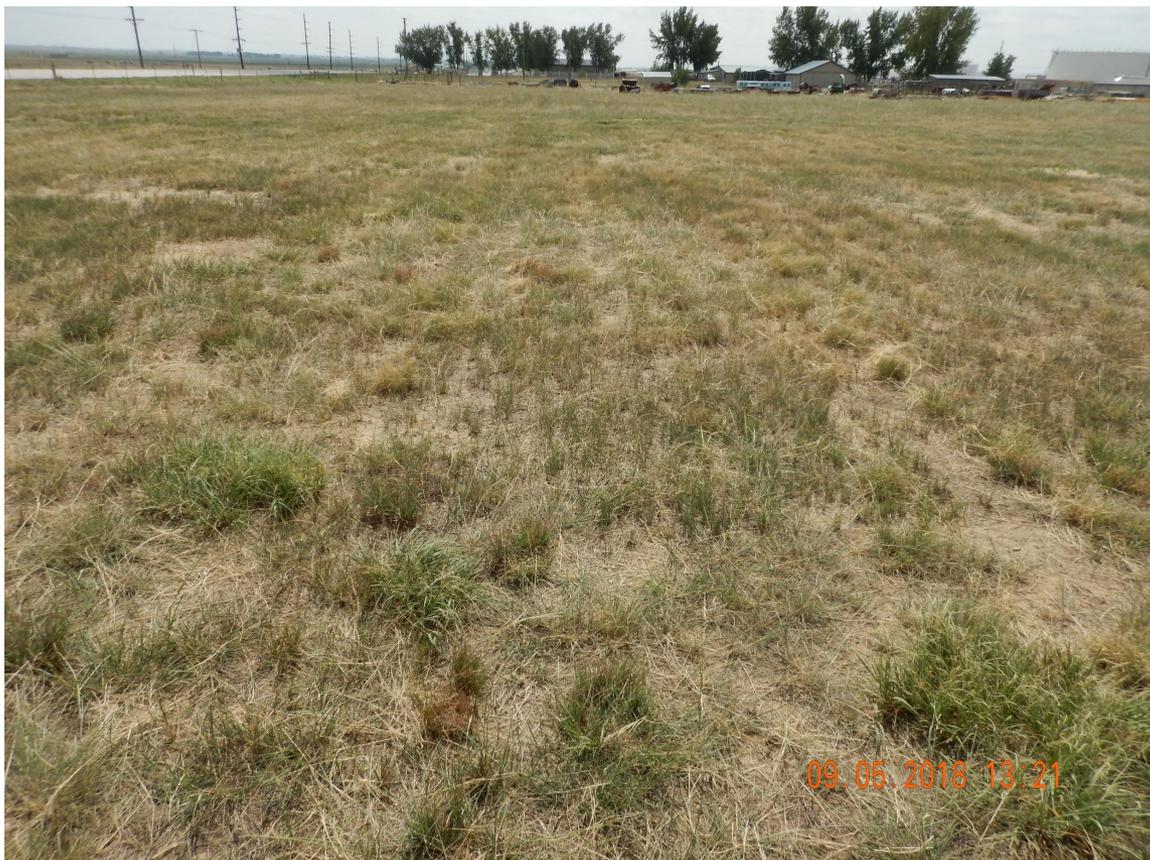
Photo 4. Reference photo taken northeast of the well location, facing South.
