Inspection Photos

Operator: DIVERSIFIED OPERATING
CORPORATION - 24461

Location ID: 409370

Inspection Doc. Number: 682503904
Weld County, CO

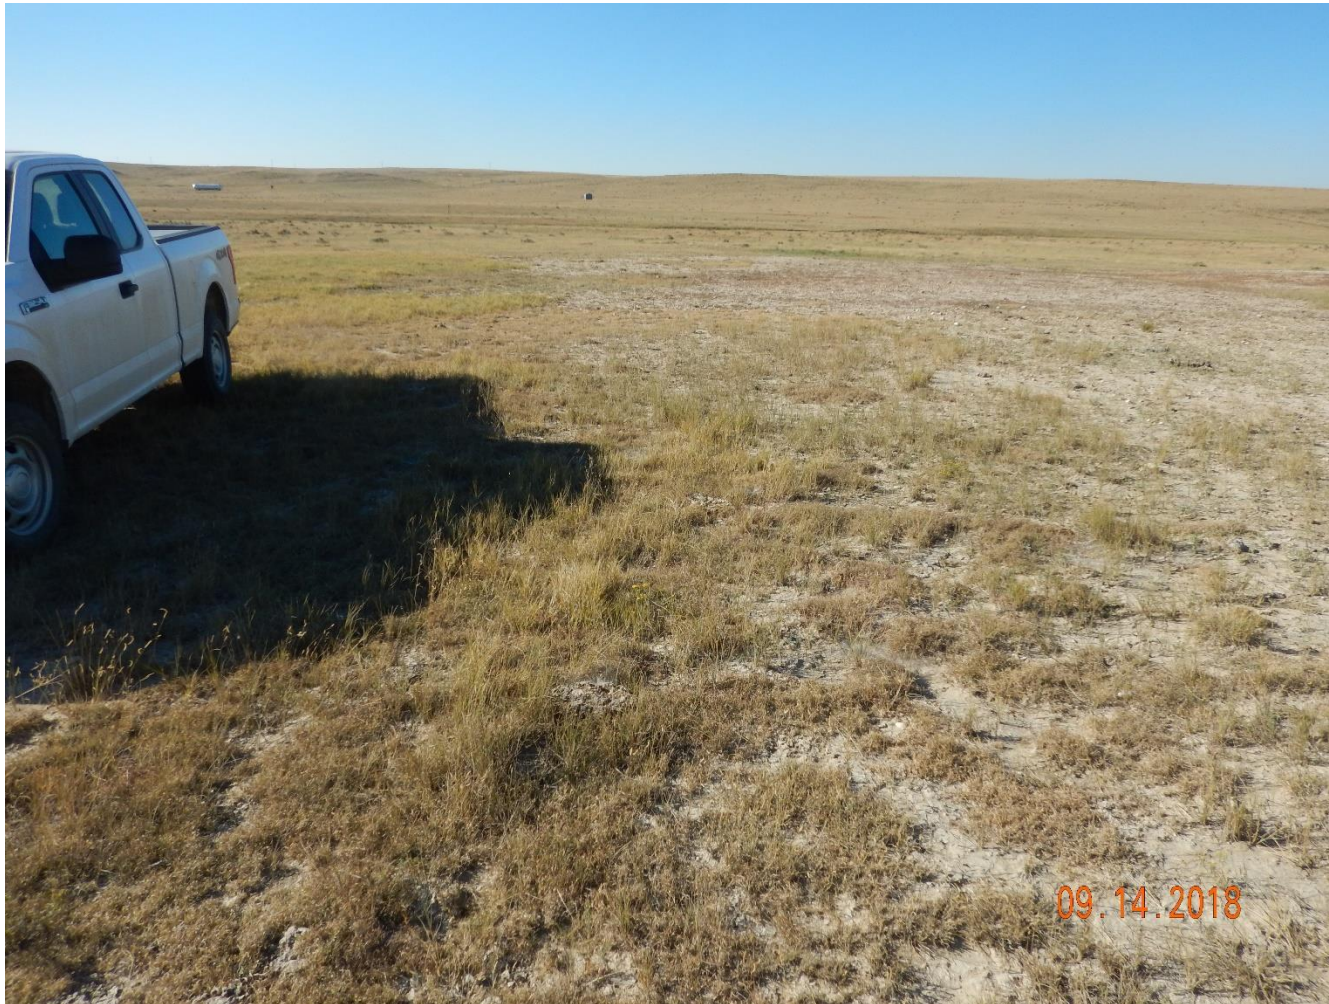
Photo 1: Photo taken from the northeast corner of the location, facing south. Photos 1-3 provides an overview of the location, from south to west. Photos show that additional reclamation activities do not appear to have been conducted; location remains predominantly bare and exposed soil, gravel remains evident, recontouring/regrading does not appear to have been conducted.

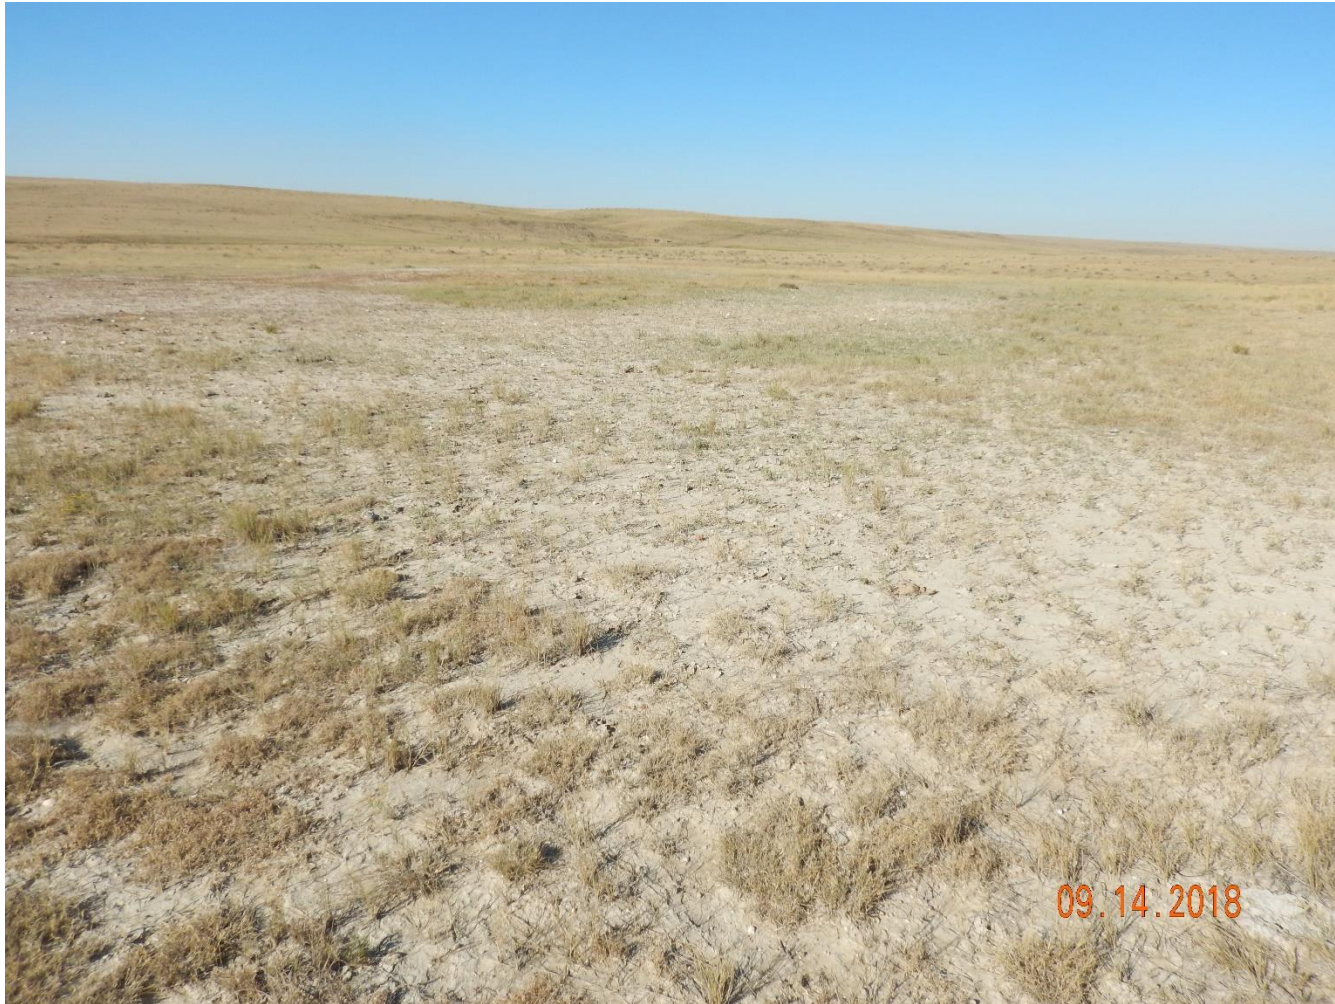
Photo 2: Photo taken from the northeast corner of the location, facing southwest

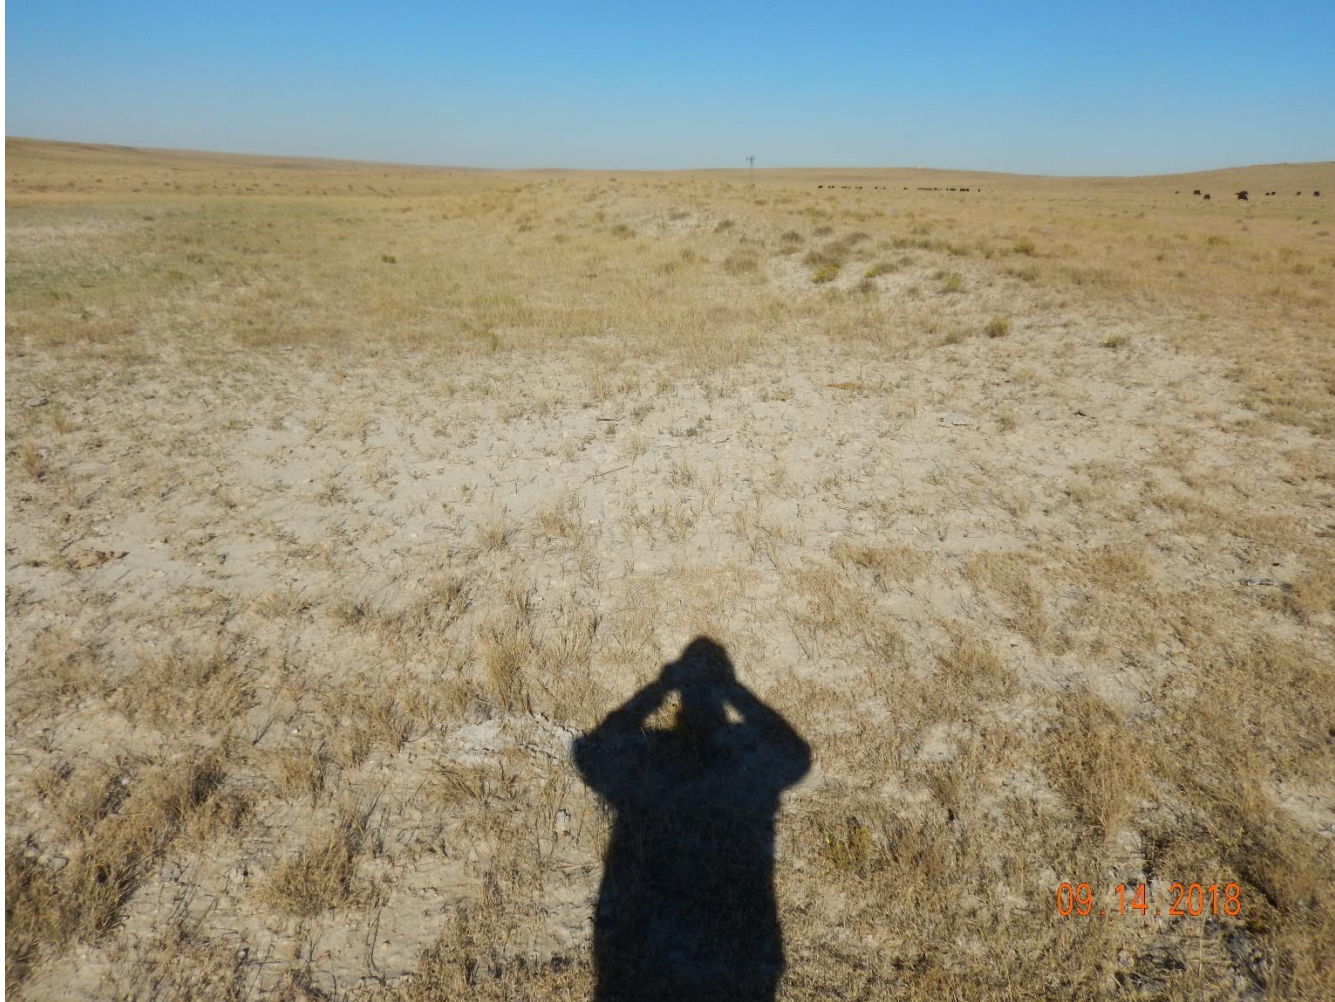
Photo 3: Photo taken from the northeast corner of the location, facing west. Photo shows what appears to be a soil stockpile (berm).

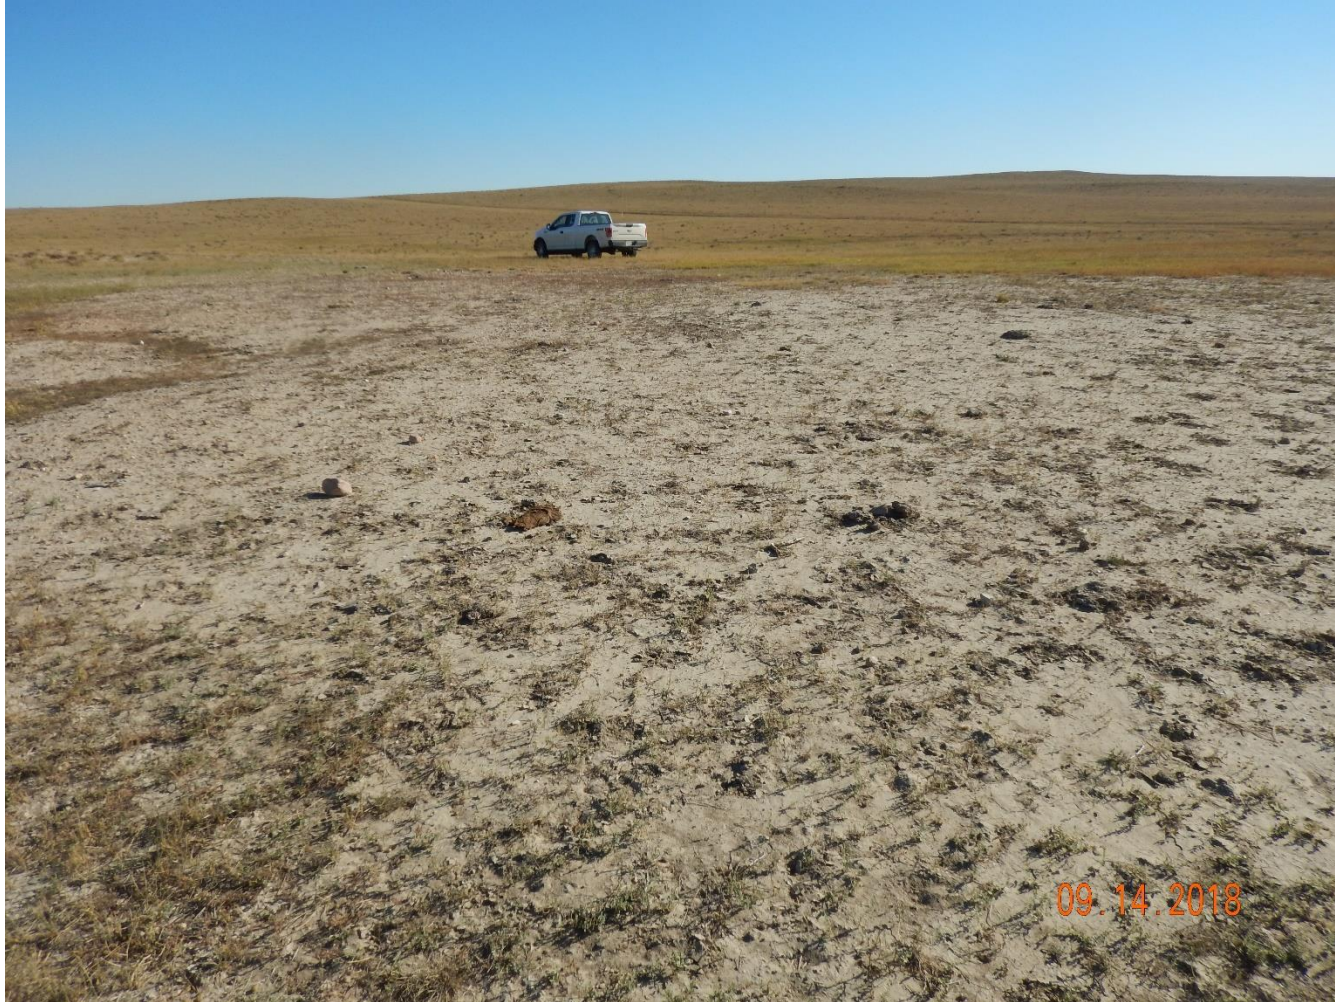
Photo 4: Photo taken from the southwest corner of the location, facing northeast. Photo shows location remains predominantly bare and exposed soil. Unable to find evidence that additional reclamation activities have been conducted per the corrective actions

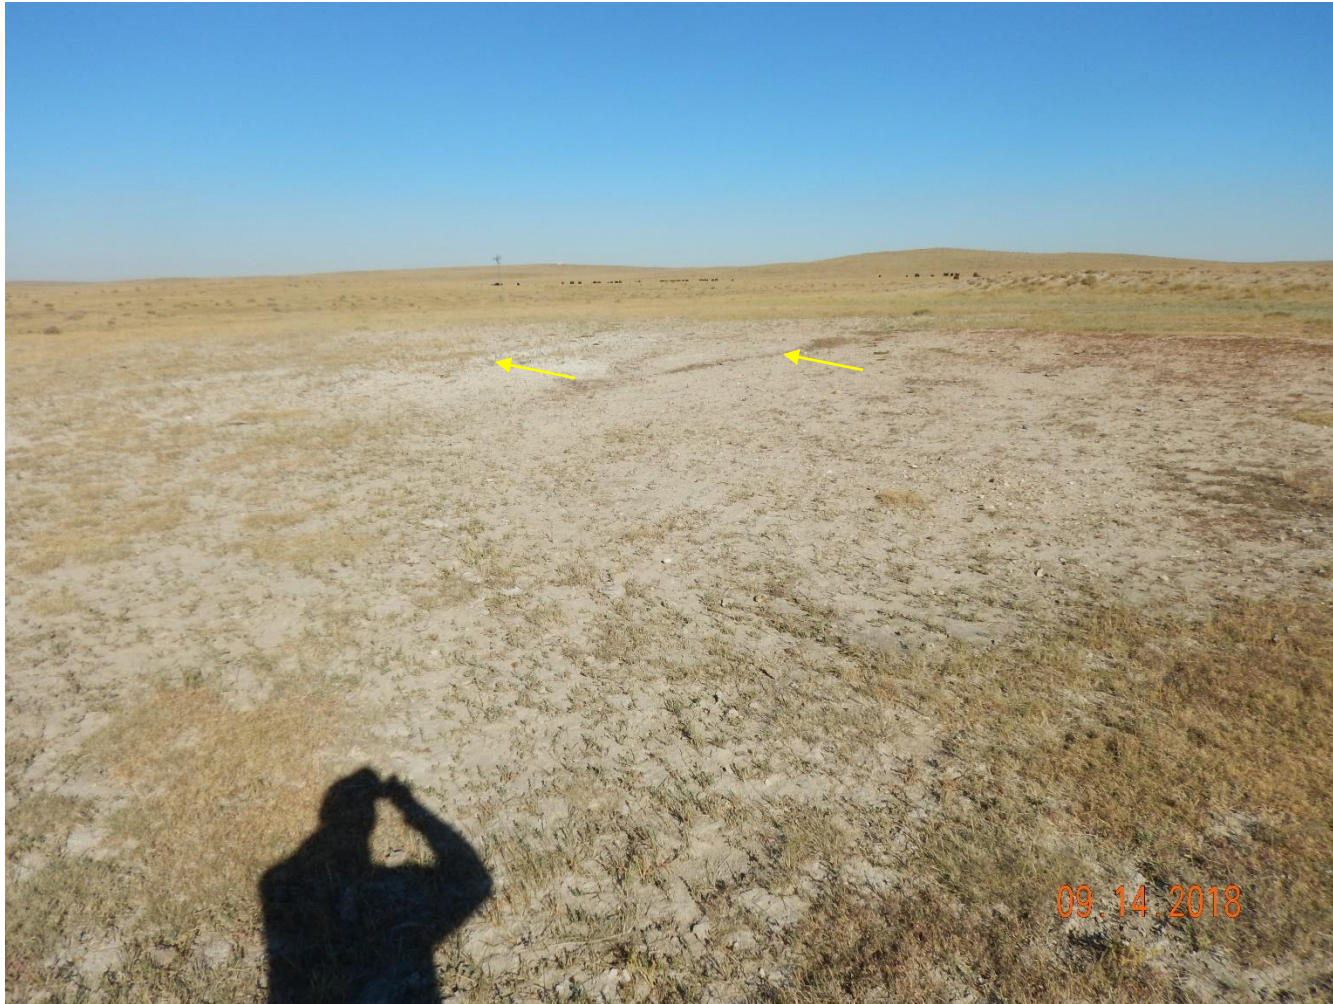
Photo 5: Photo taken from the south end of the location. Photo shows area where erosion degradation remains evident.

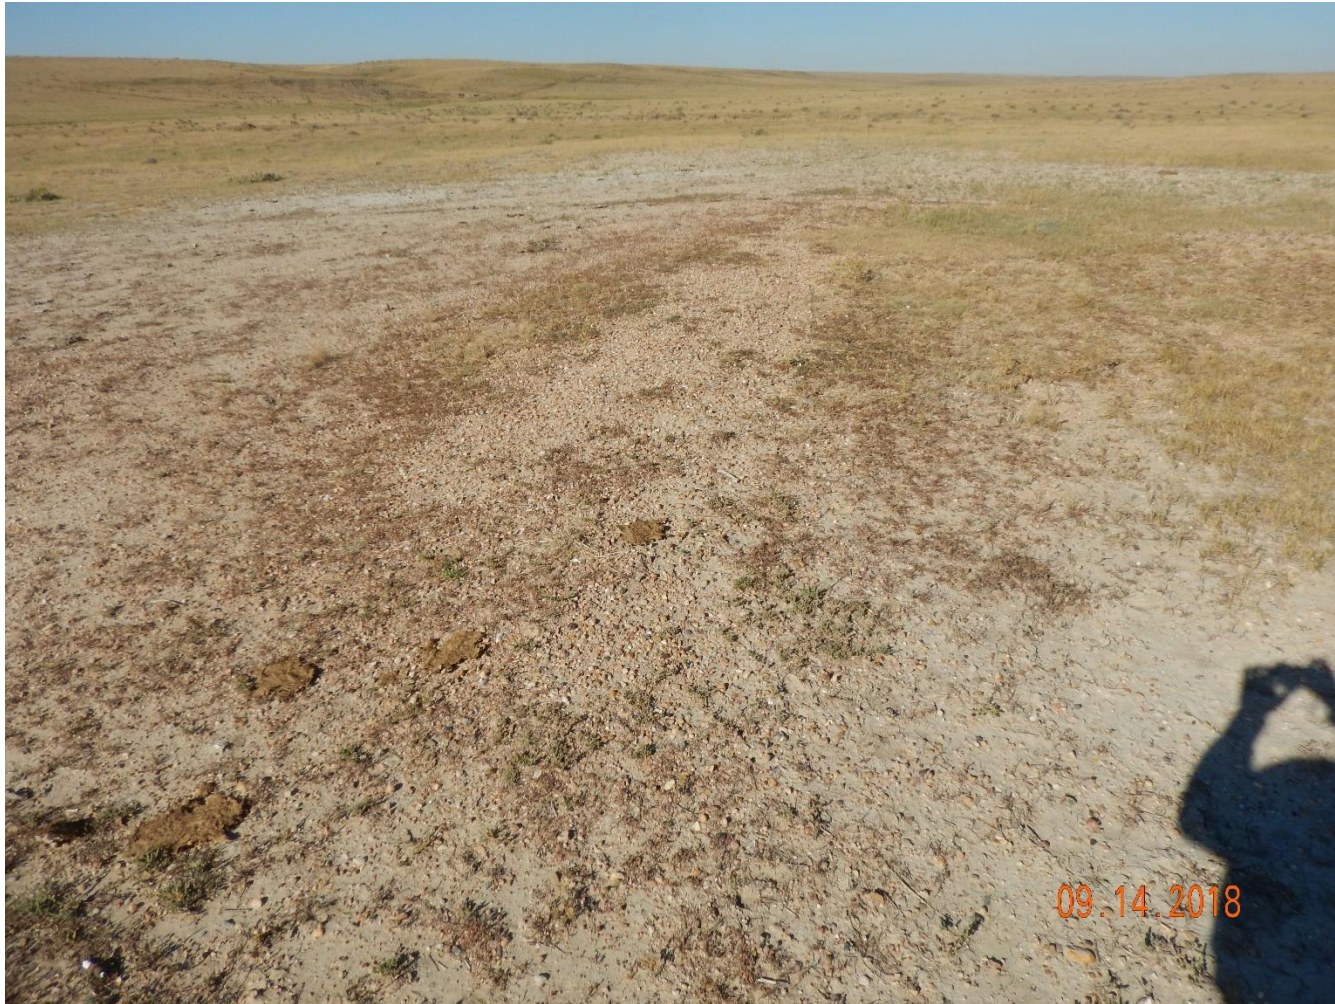
Photo 6: Photo taken from the center of the pad, facing west. Photo shows gravel/base has not been removed from the location.

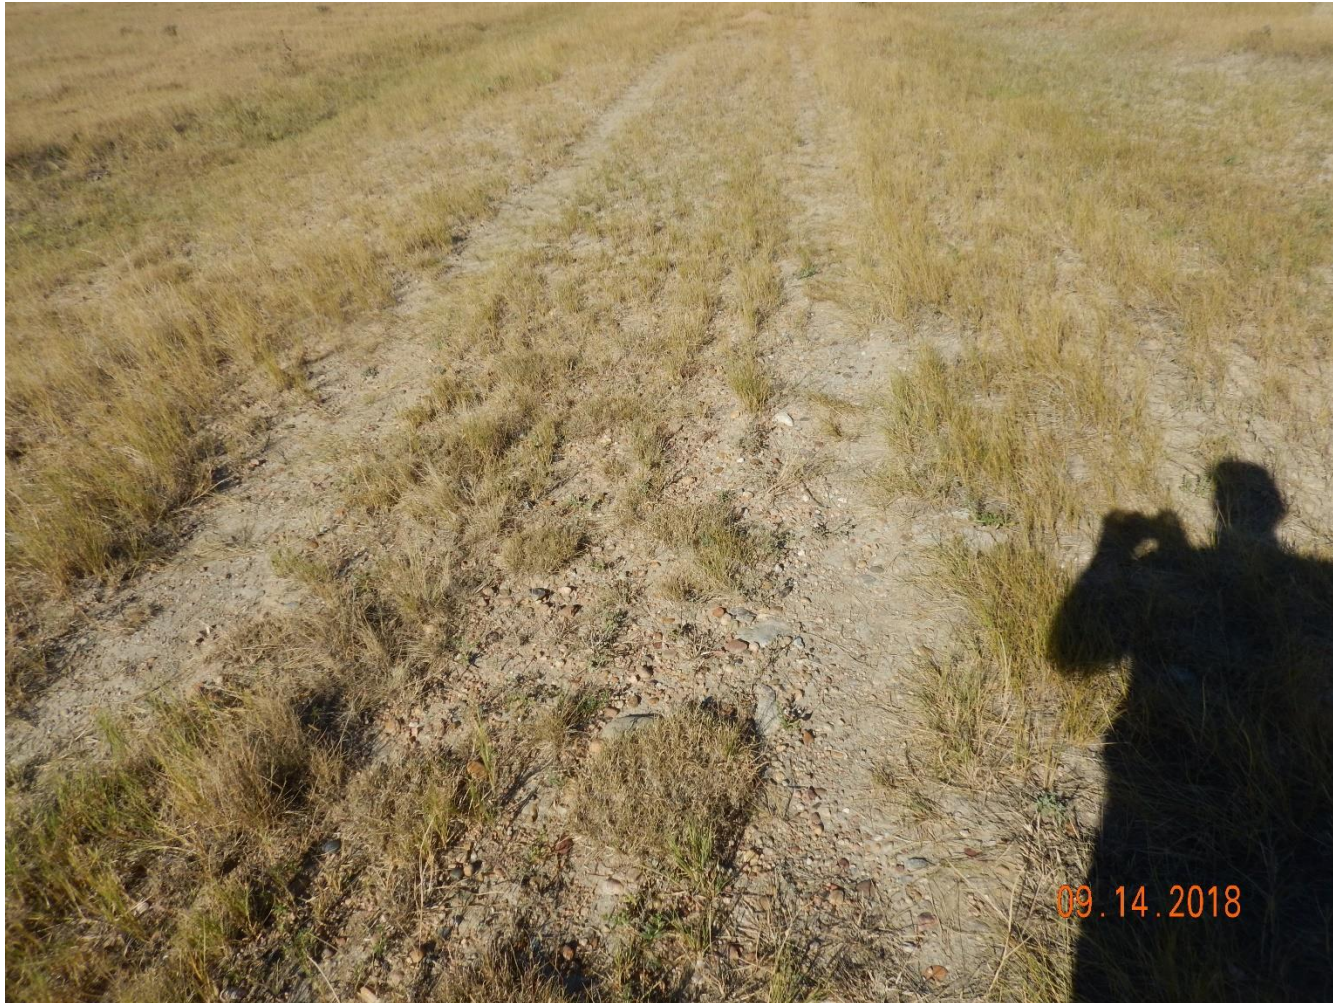
Photo 7: Photo taken from the access road, east of the location. Photo shows access road has not been reclaimed.

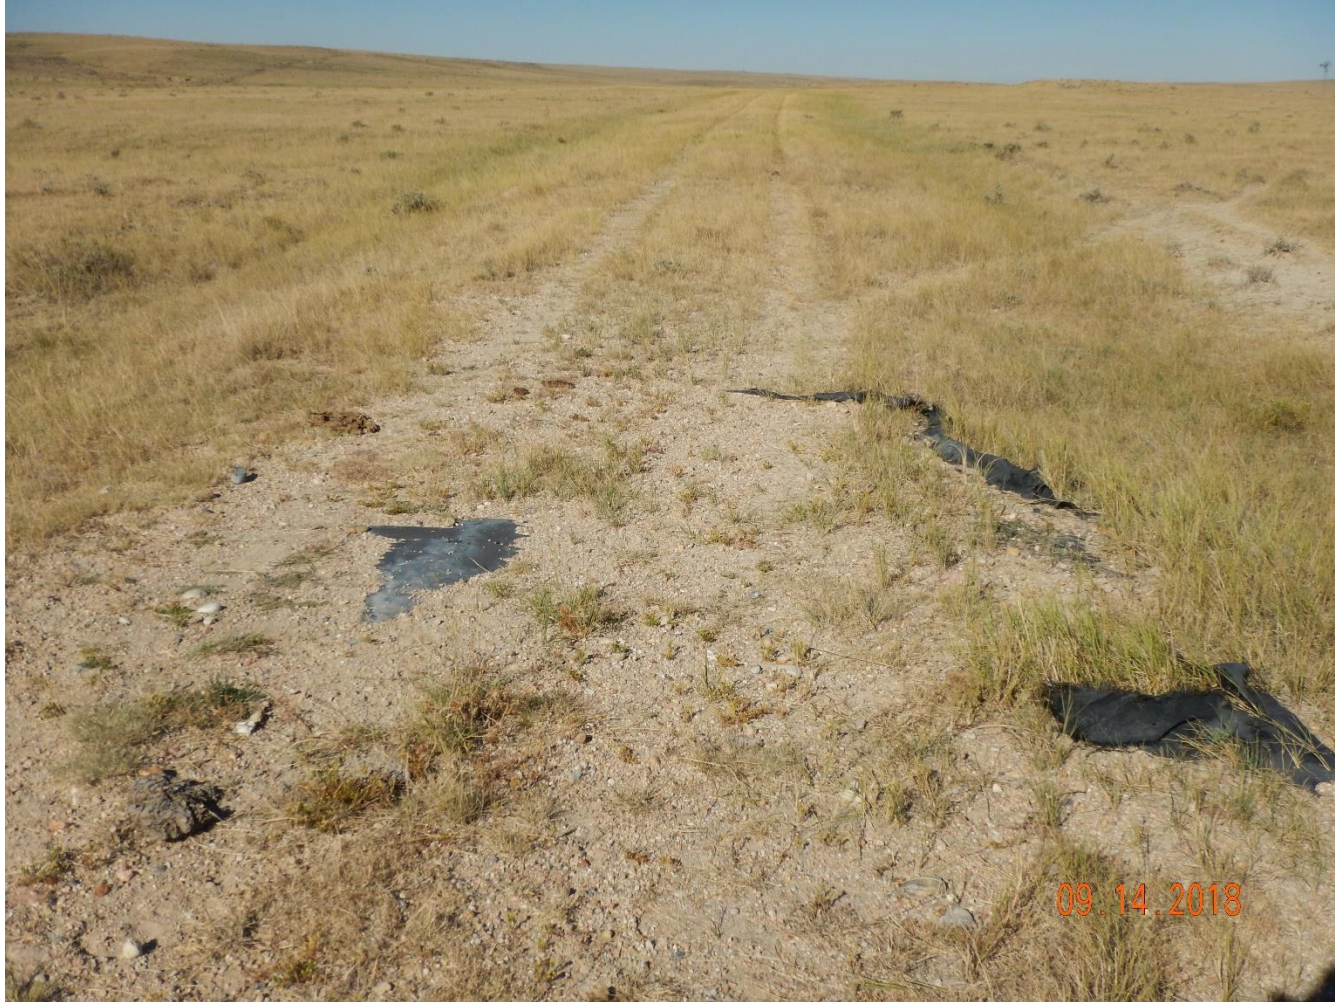
Photo 8: Photo taken from the access road, east of the location facing west. Photo shows access road has not been reclaimed.

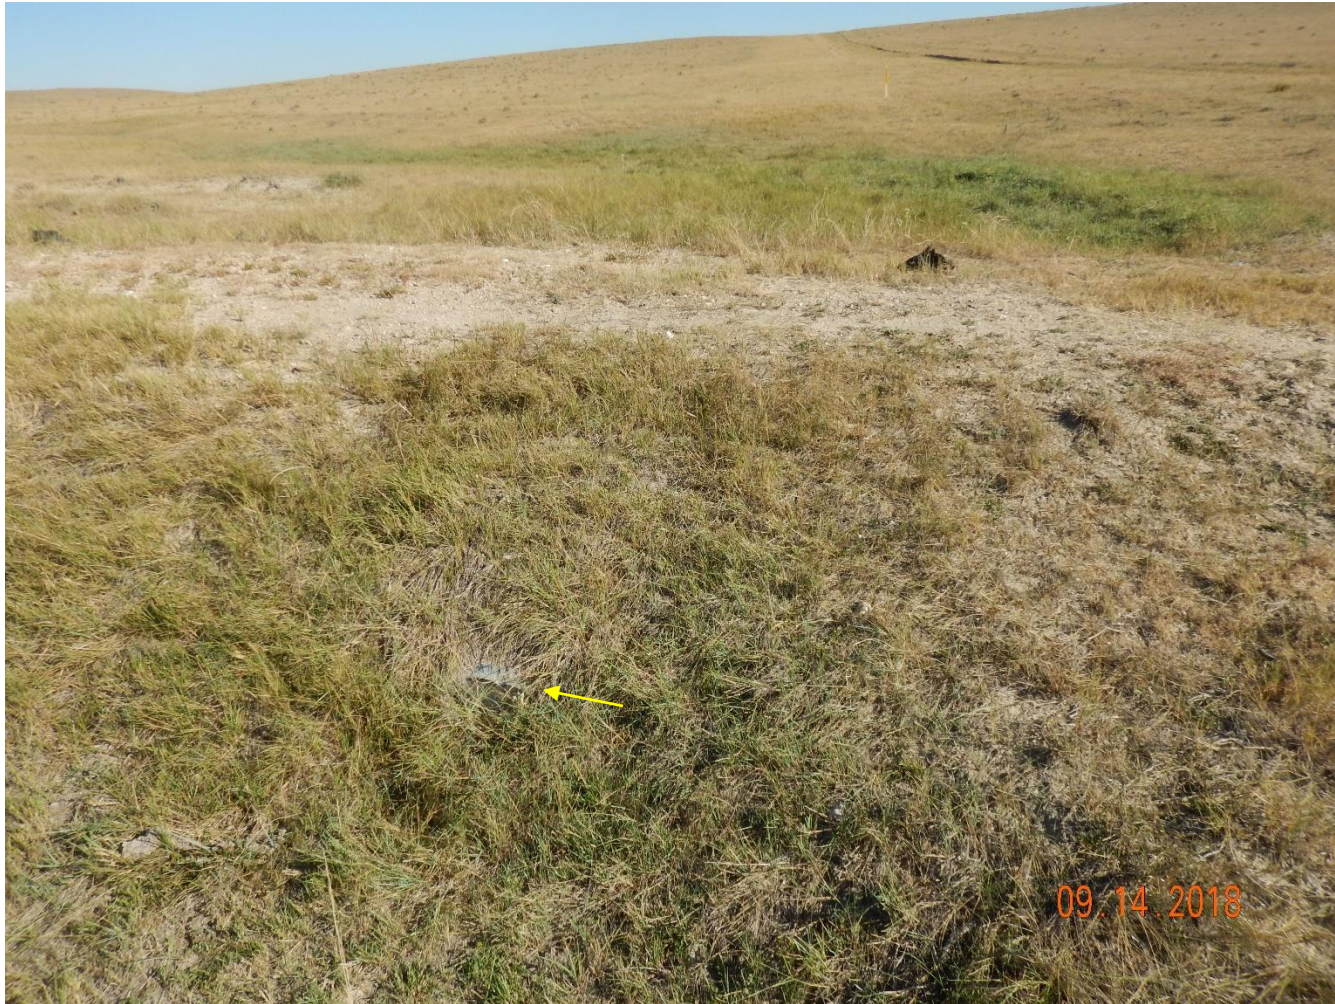
Photo 9: Photo taken from the access road, east of the location facing north. Photo shows access road has not been reclaimed. Photo also shows culvert has not been removed.
