Inspection Photos
Location Name: Bashor PC / AA17-23
Location #: 306260

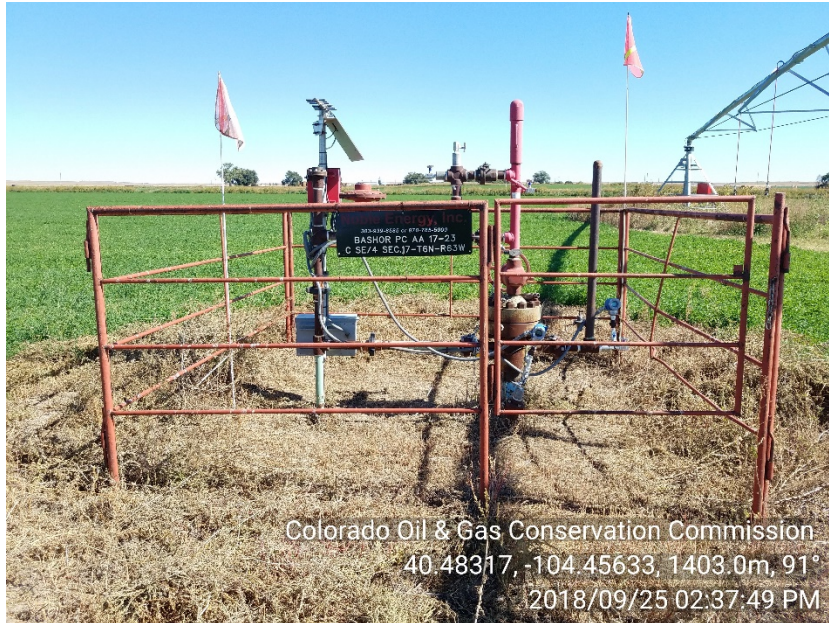
Photo #1

Bashor PC AA17-23 (API # 05-123-24320) wellhead

SI - Casing Leak

**Observed audible venting from bottom of well
casing head (Dry vapor - No fluid)**

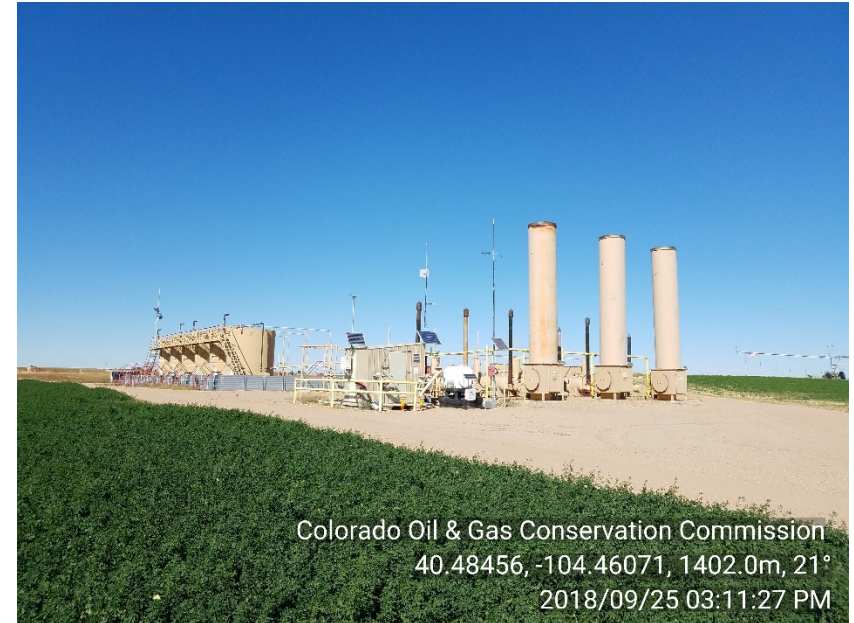
Photo #2

Bashor PC AA17-23 Battery
