Inspection Photos

Operator: GRAND MESA OPERATING CO #
35080

Location ID: 456610

Inspection Doc. Number: 682503915
Lincoln County, CO

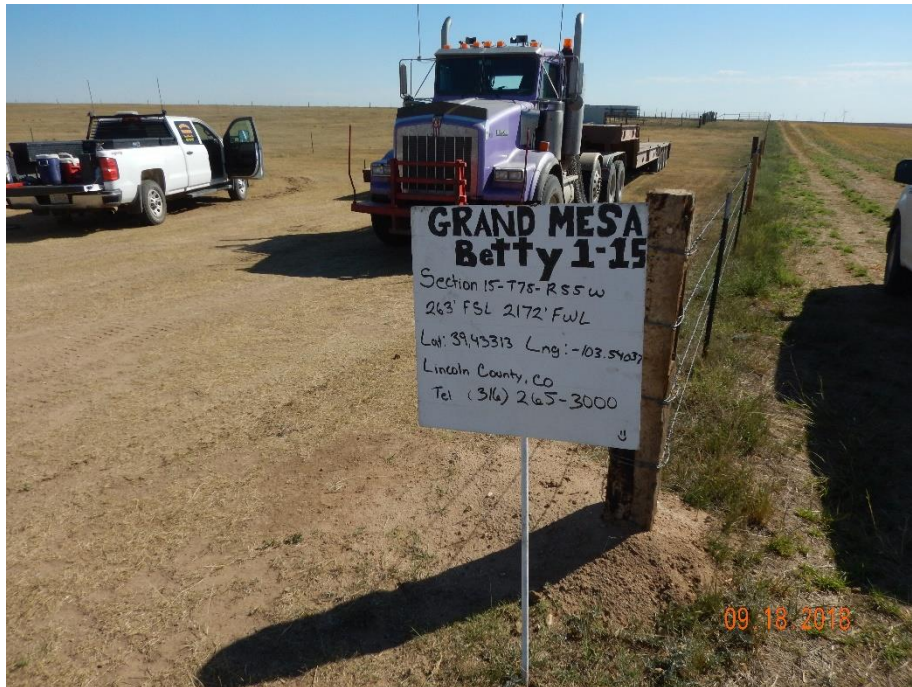
Photo 1: Photo of sign on south end of the location.

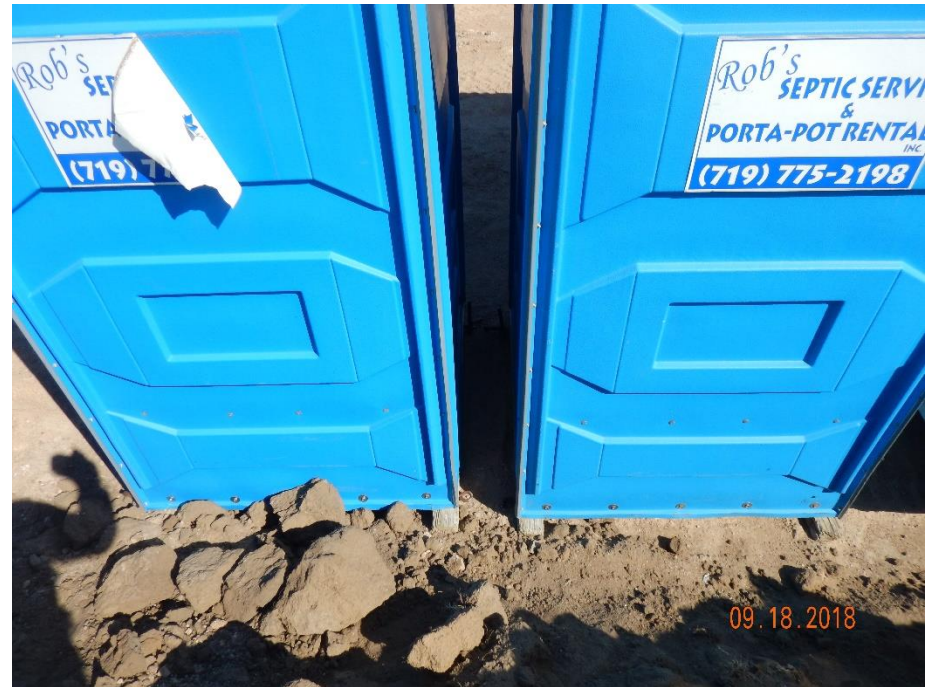
Photo 2: Photo taken from the south end of the location. Photo shows two porta-johns that have been staked/secured.

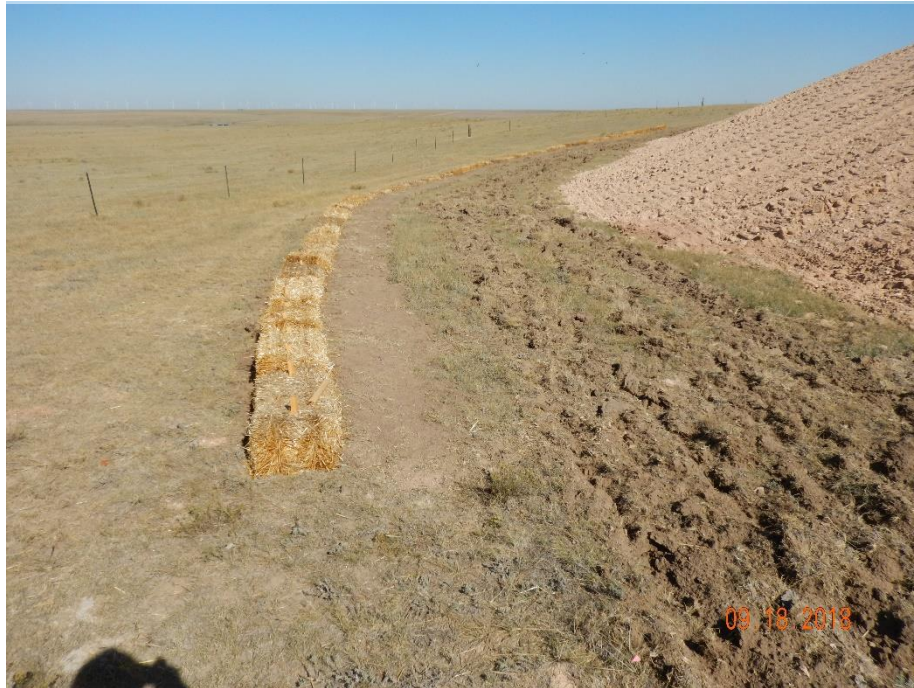
Photo 3: Photo taken from the southwest corner of the location, facing north. Photo shows bales have been installed as a stormwater/erosion control BMP. BMPs appears to have been installed in accordance with good engineering practices. Photo also shows surface roughening along perimeter appears to have been updated/maintained.

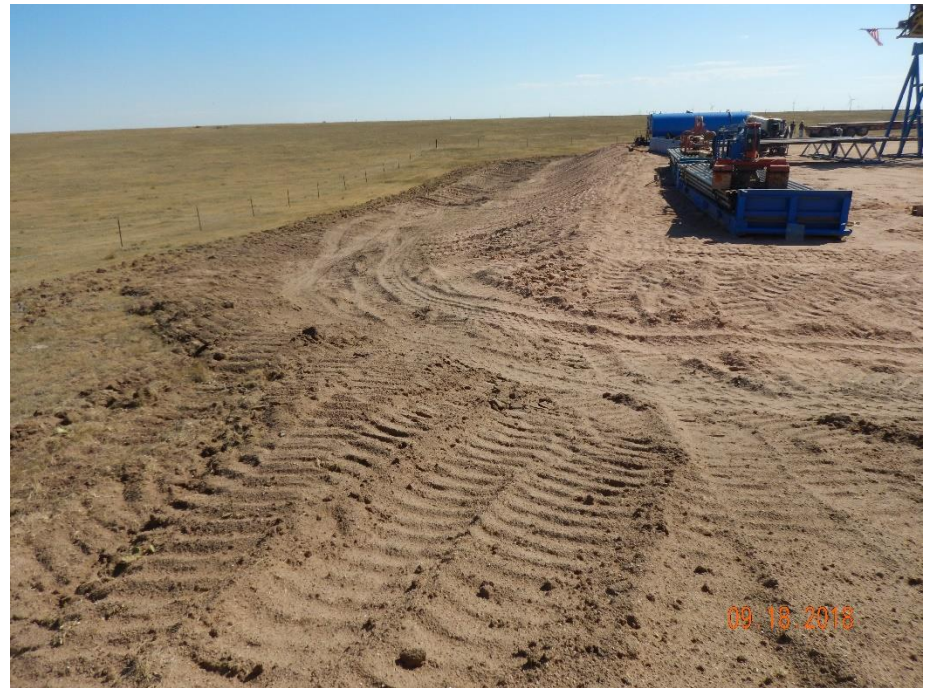
Photo 4: Photo taken from the northwest corner of the pad, facing east. Photo shows operator has implemented berms along the perimeter of the pad, and another on the perimeter of the location. Surface roughening has been used in conjunction.

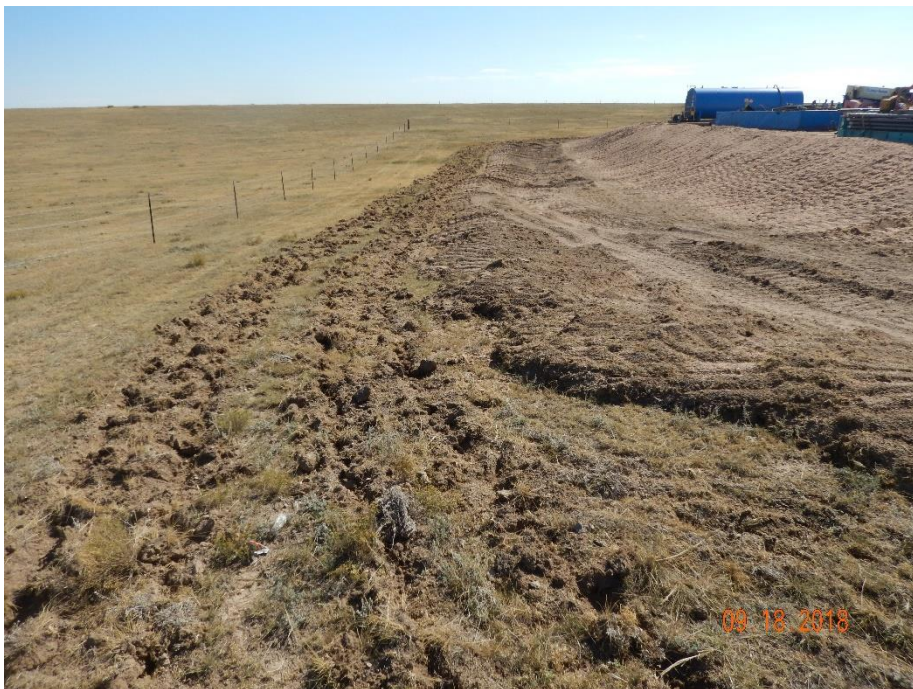
Photo 5: Photo taken from the northwest corner of the location, facing east. Photo shows operator has implemented berms along the perimeter of the pad, and another on the perimeter of the location. Surface roughening has been used in conjunction.

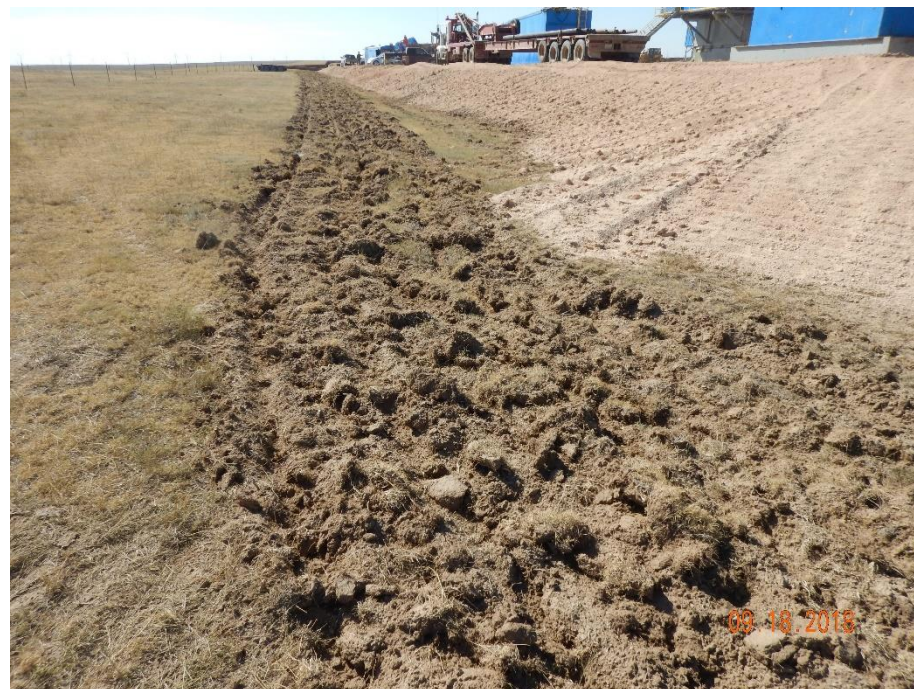
Photo 6: Photo taken from the northeast corner of the location, facing north. Photo shows additional maintenances appears to have been conducted on surface roughening.
