Inspection Photos

Operator: BISON OIL & GAS II LLC - 10661

Location ID: 455627

Inspection Doc. Number: 682503958

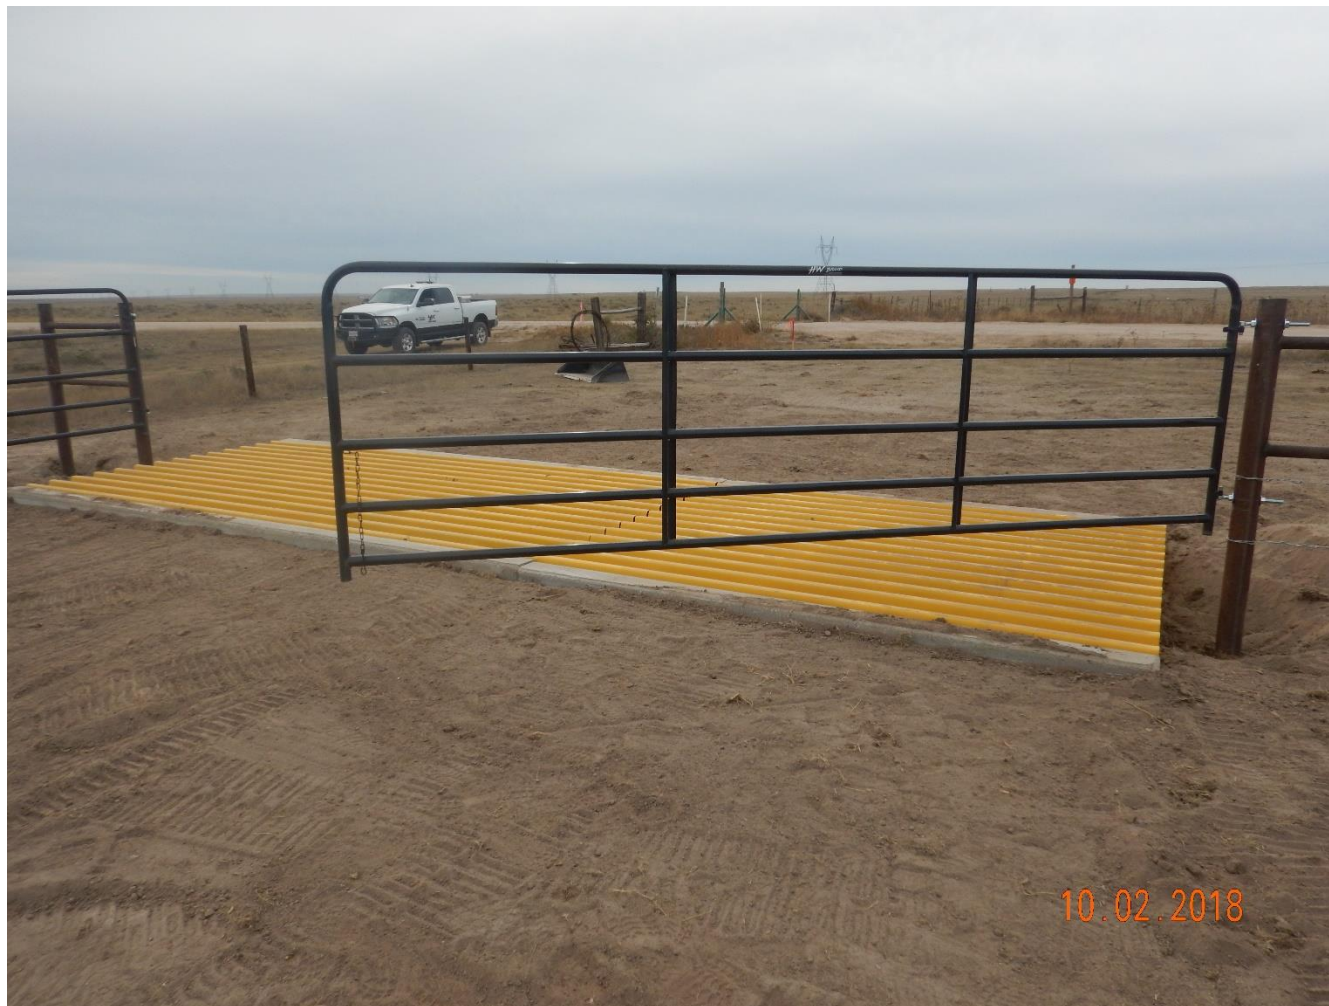
Photo 1: Photo taken from the access road entrance at CR 96. Initial construction activities observed include road construction. Operator has installed cattle guard to act as a tracking pad. Contractor on site indicated and additional tracking pad will be installed between cattle guard and CR

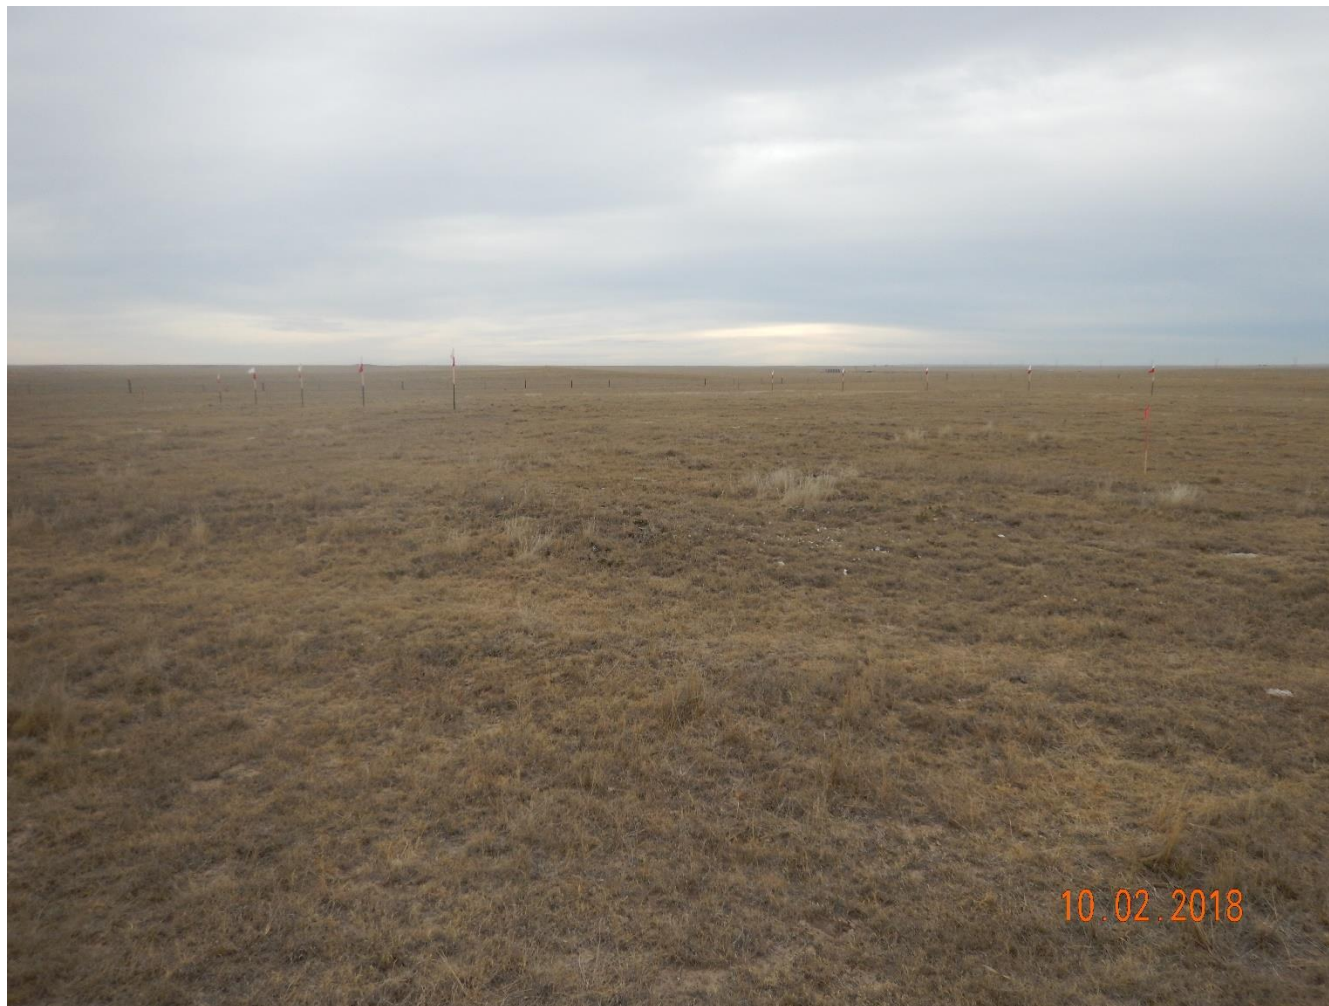
Photo 2: Photo taken from the west end of the staked wells on location, facing northeast. Construction activities on pad have not yet begun. Photo shows vegetation on location pre-disturbance.

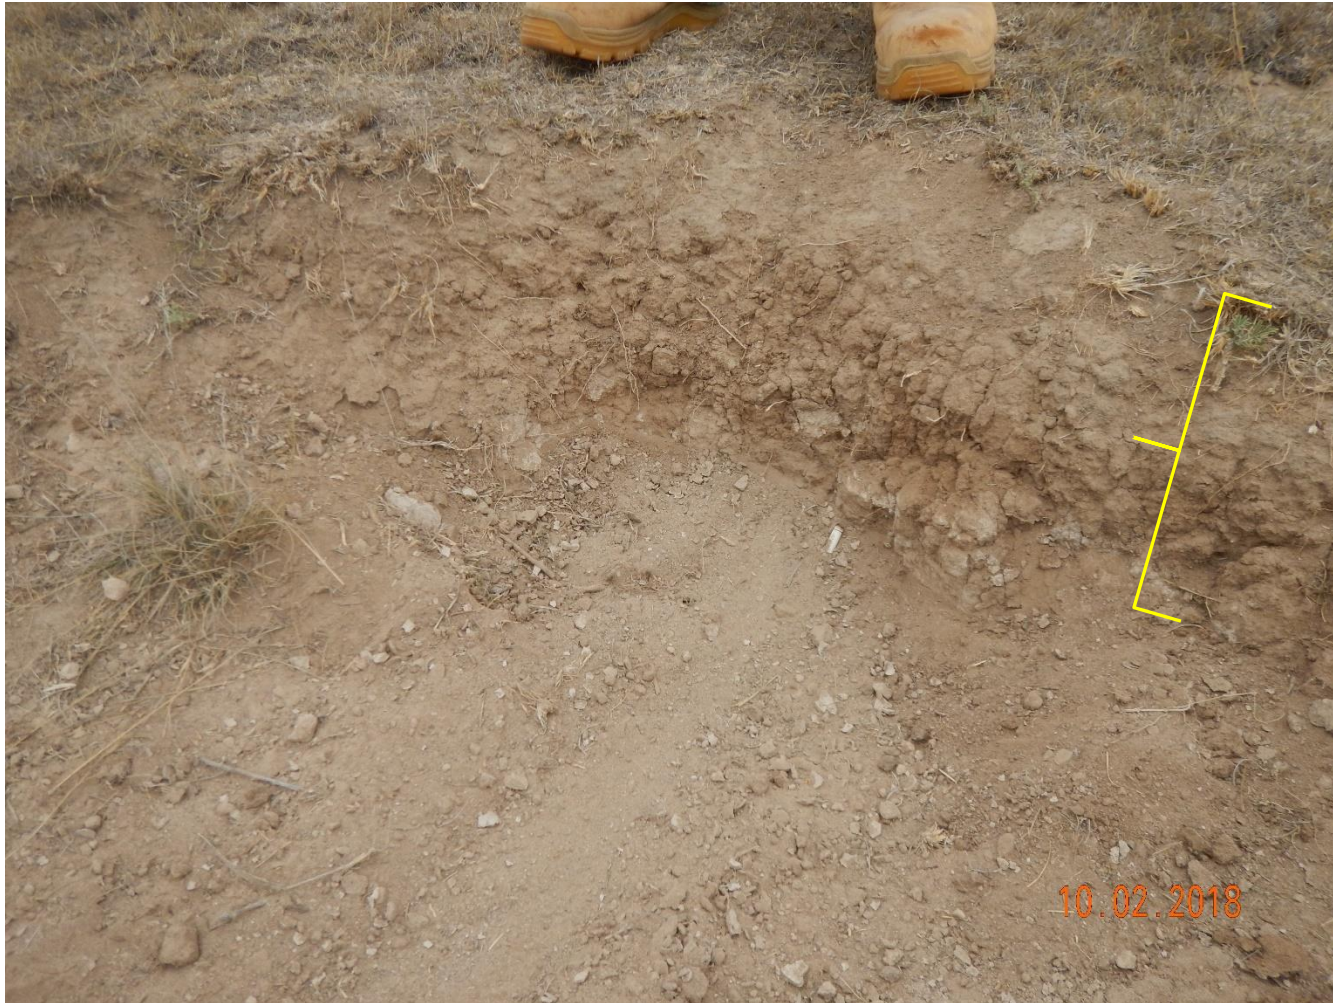
Photo 3: Photo taken from the staked wells on location. Photo shows topsoil depth at the center of the location appears to be at least 6 inches in depth. Operator will need to determine topsoil depths at other areas of the location to ensure sufficient topsoil salvage will be conducted in accordance with 1002.b(2)
