Inspection Photos

Operator: WESTERN OPERATING COMPANY #
95620

Location ID: 312291

Inspection Doc. Number: 682503989

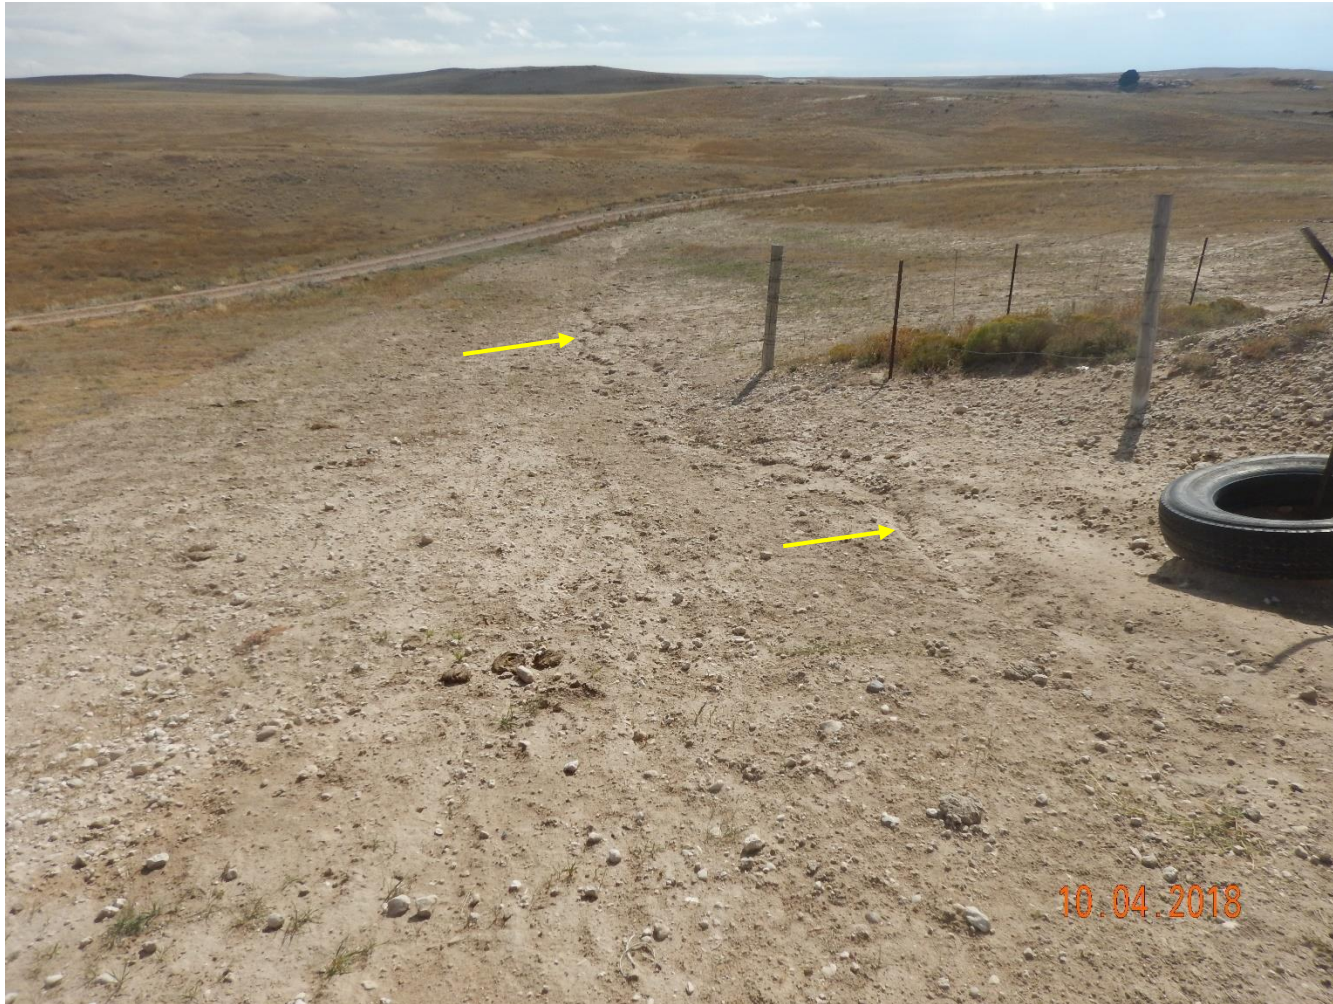
Photo 1: Photo taken from the east end of the well, facing southeast. Photo shows areas of the interim that operator previously regraded and seeded. Operator failed to implement required stabilization or stormwater and erosion control BMPs per CAs. Photo shows erosion degradation has been allowed to continue.

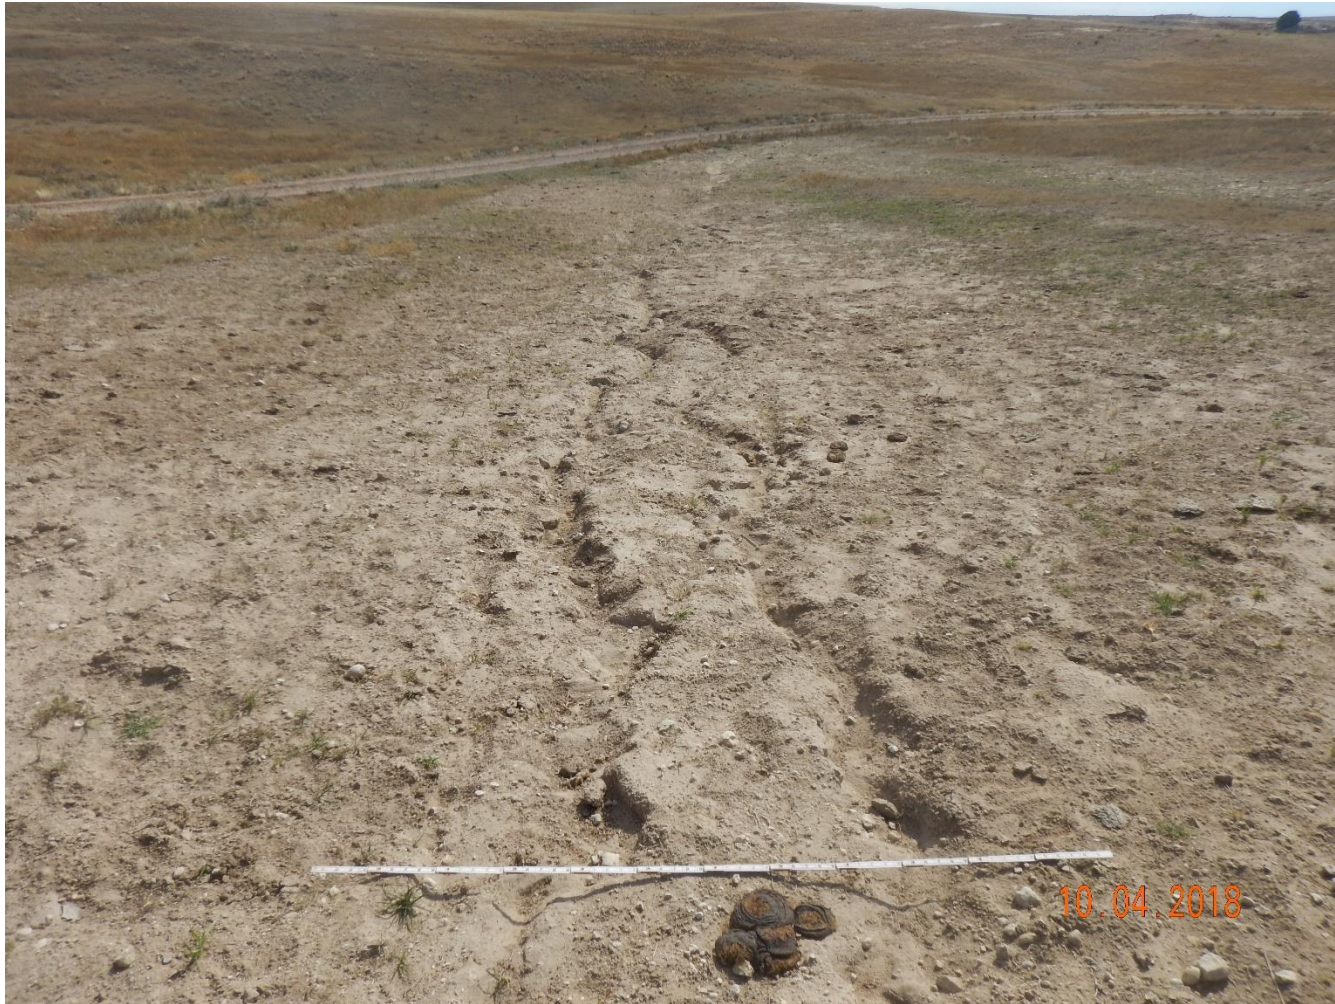
Photo 2: Photo taken from the east of the location, facing southeast. See comments under photo 1. 6 foot measuring stick for reference.

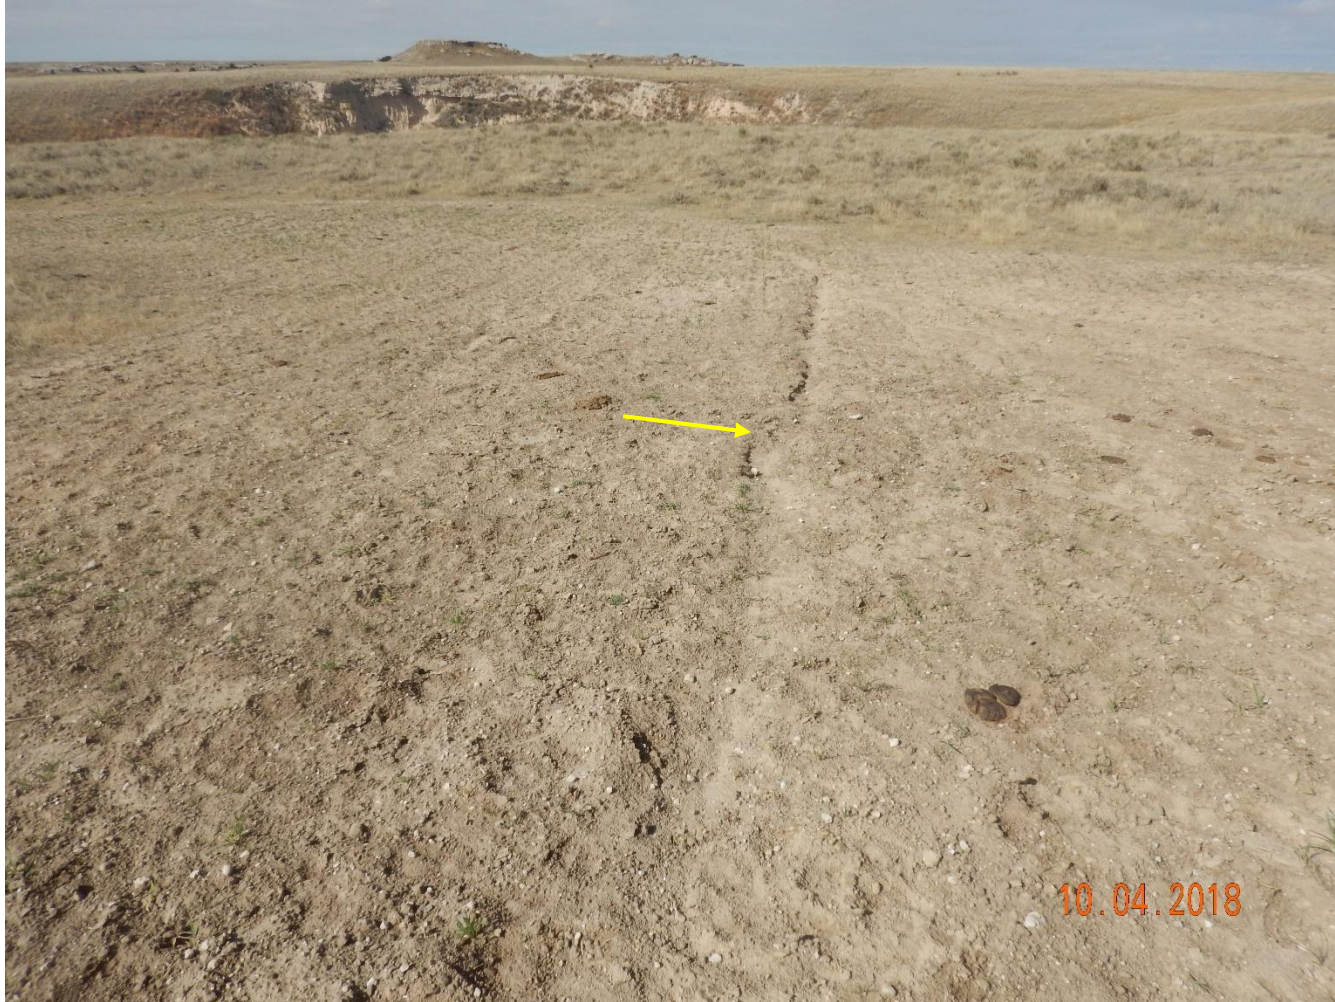
Photo 3: Photo taken from the southwest of the location, facing west. See comments under photo 1.

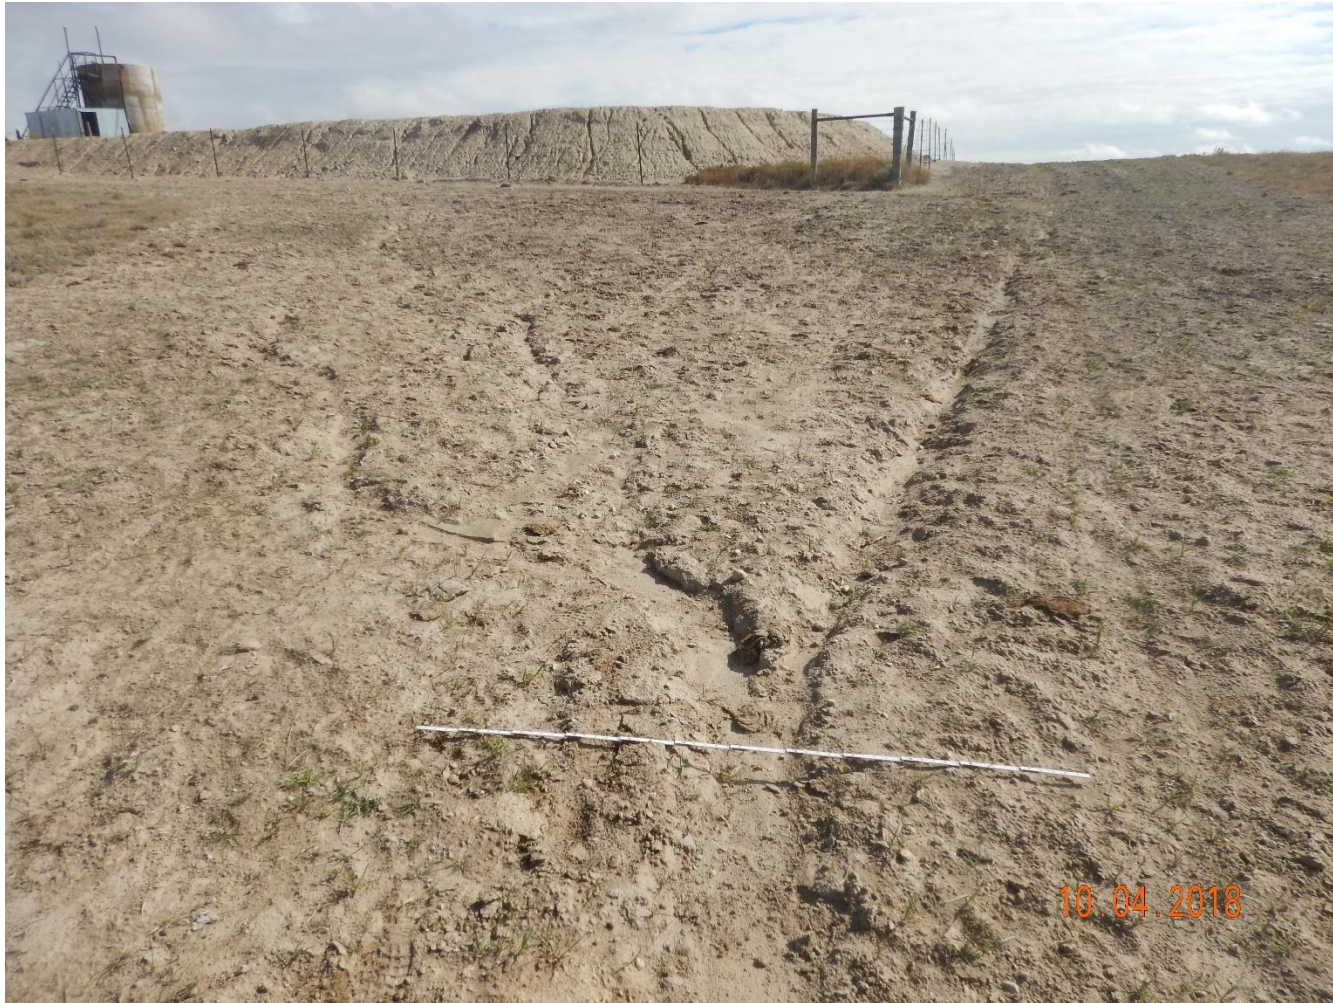
Photo 4: Photo taken from the southwest of the location, facing east. See comments under photo 1. 6 foot measuring stick for reference.

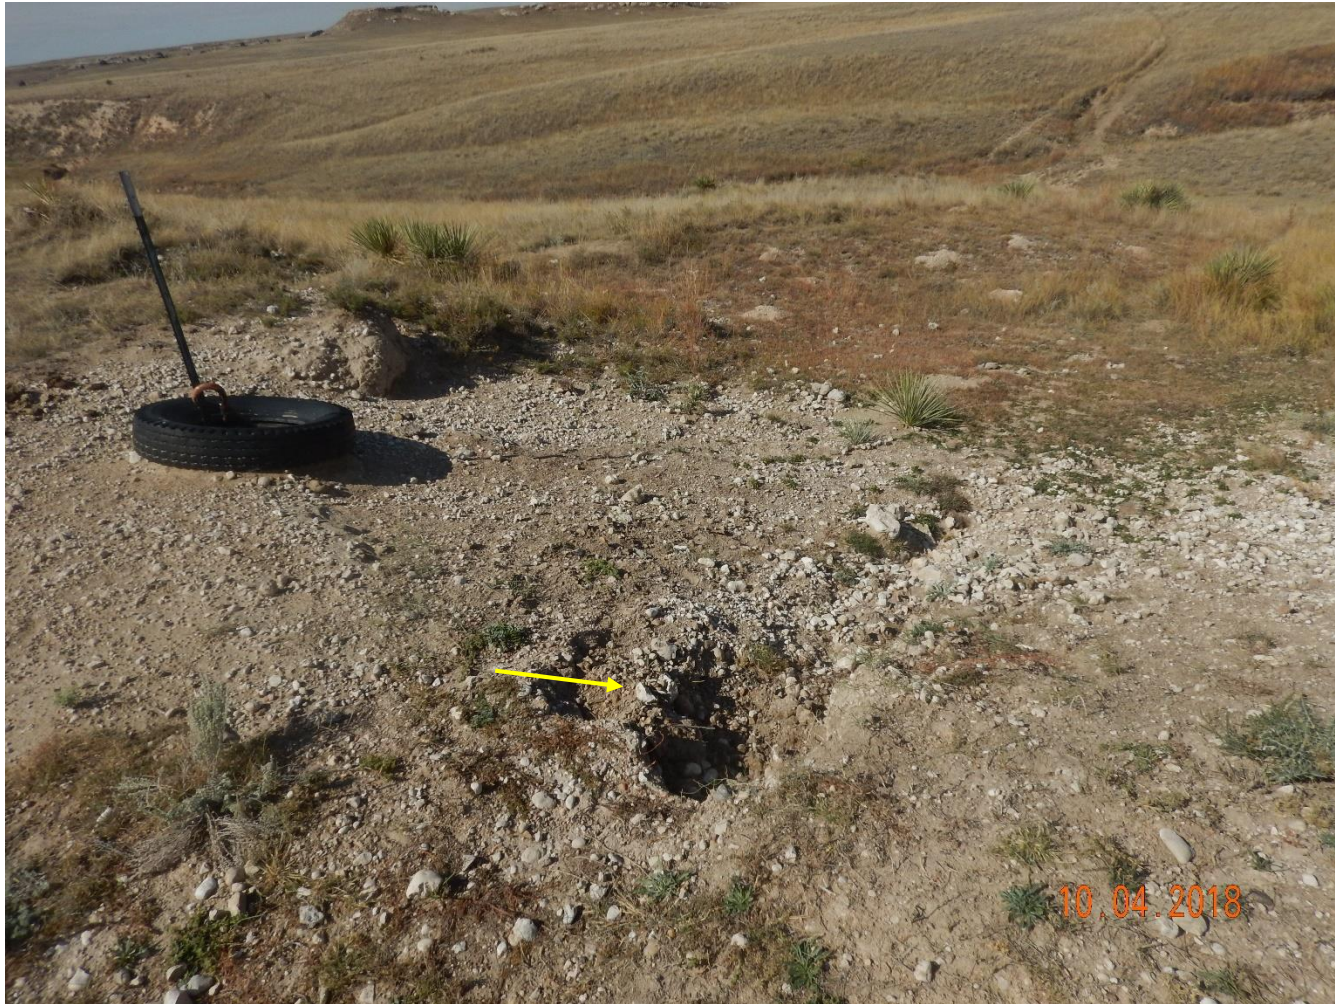
Photo 5: Photo taken from the west end of the location. Photo shows area where operator once repaired gully erosion, however no stabilization or stormwater and erosion controls were implemented. Erosion degradation has been allowed to continue.

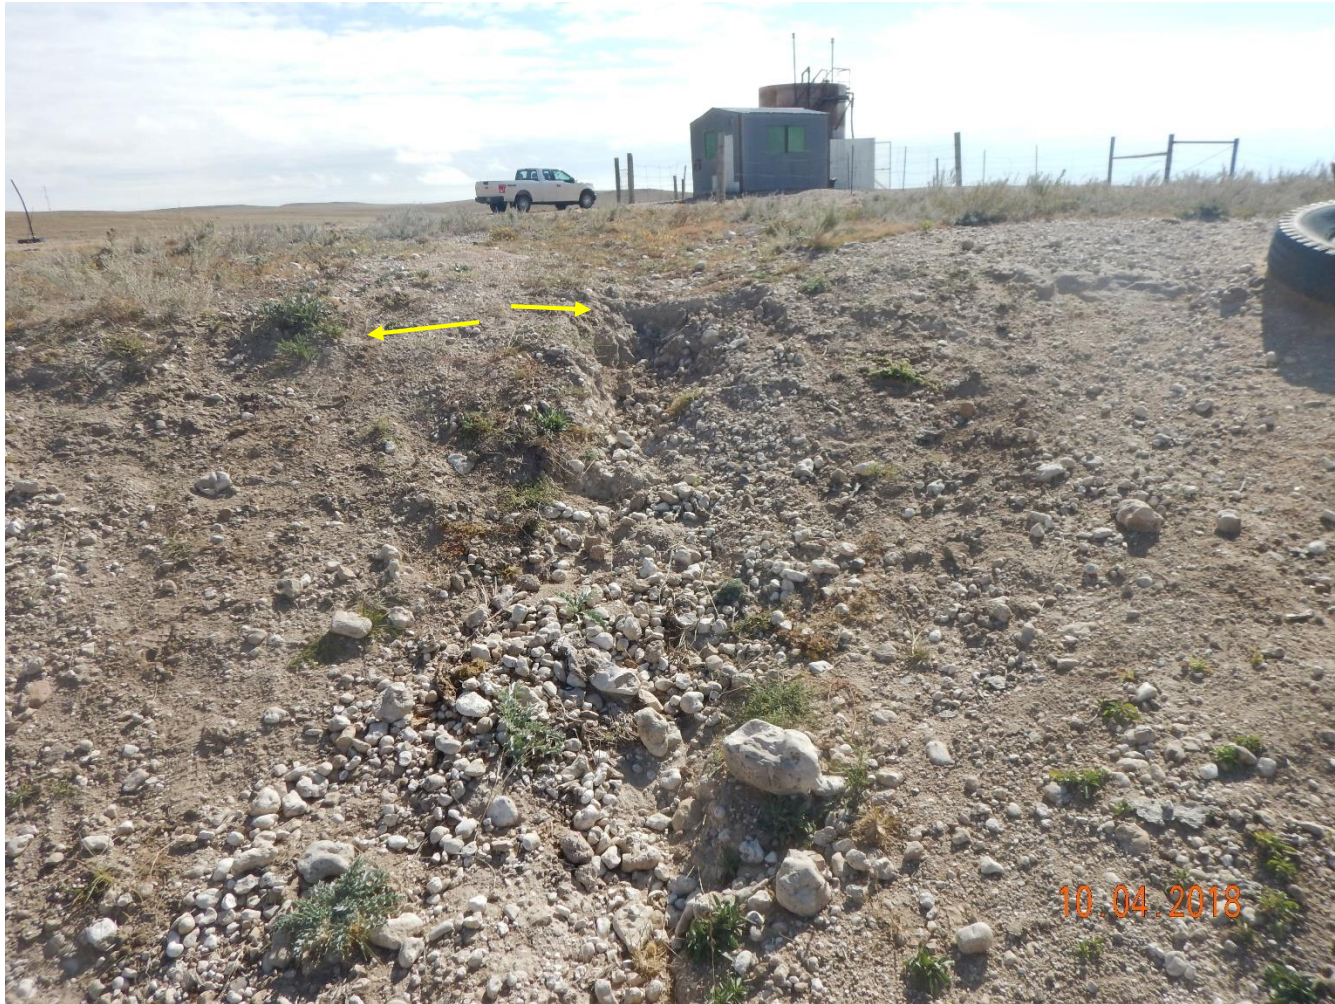
Photo 6: Photo taken from the west end of the location, facing east. See comments under photo 5.

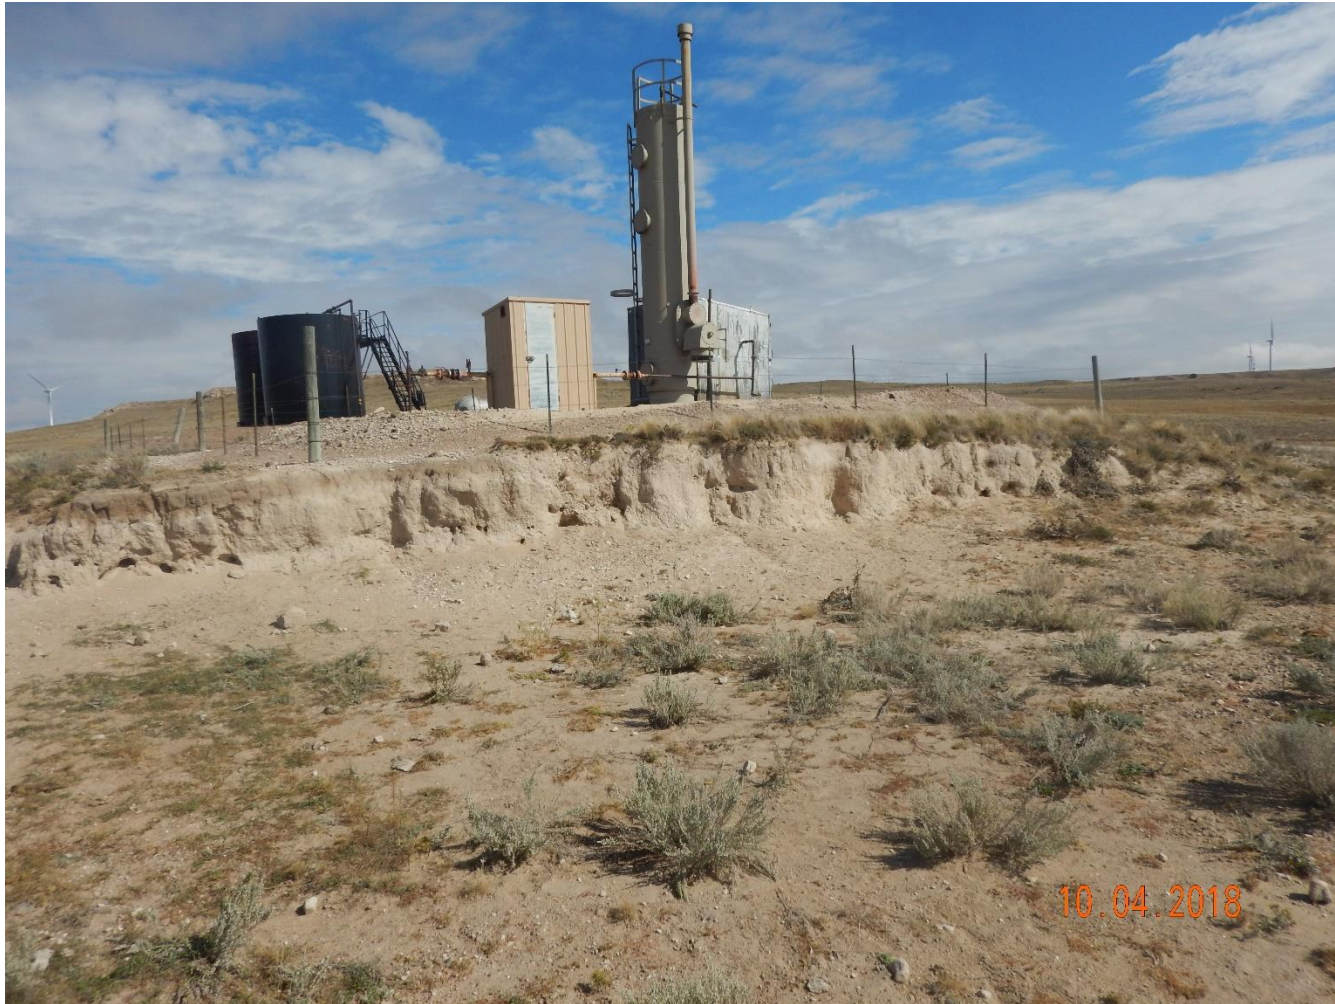
Photo 7: Photo taken from the center of the location, facing north. Photo shows barrel observed in previous inspection has been removed.
