# Construction and Stormwater Inspection

Operator: EXTRACTION OIL & GAS INC - #10459

Location ID: 443166

Inspection Photos  
Location Name: ASH /9-B  
Location ID: 443166

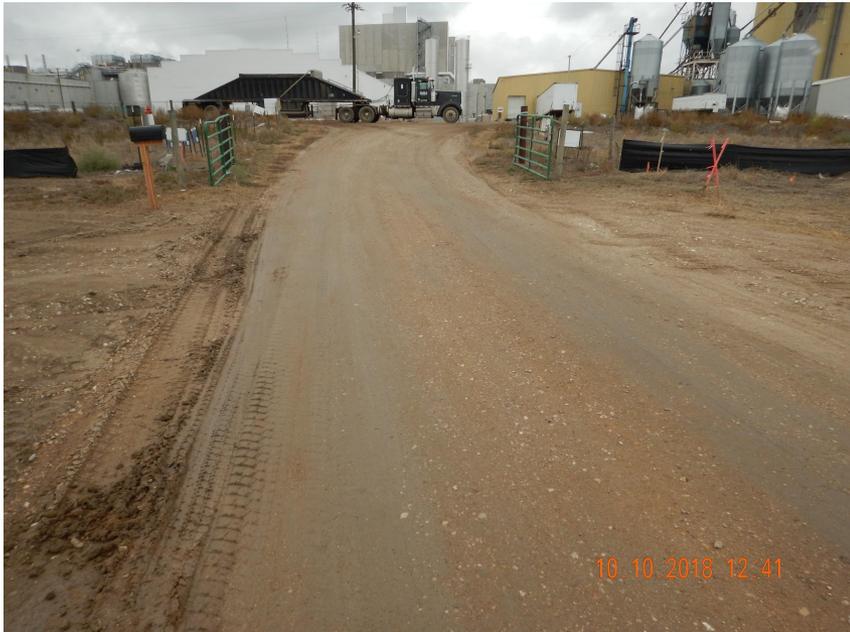
**Photo 1.** Photo taken from the entrance of location off, facing West. Access road appears to be in good condition. Note: Truck traffic was observed due to a nearby PDC remediation project.

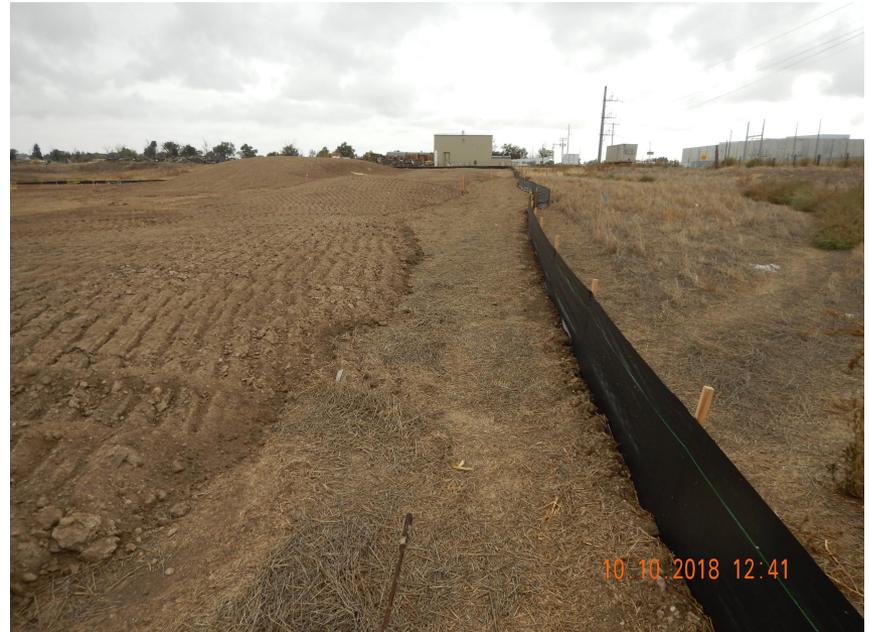
**Photo 2.** Photo taken from the western perimeter of the location, facing South. Silt fence BMP has been installed around the perimeter of the location.

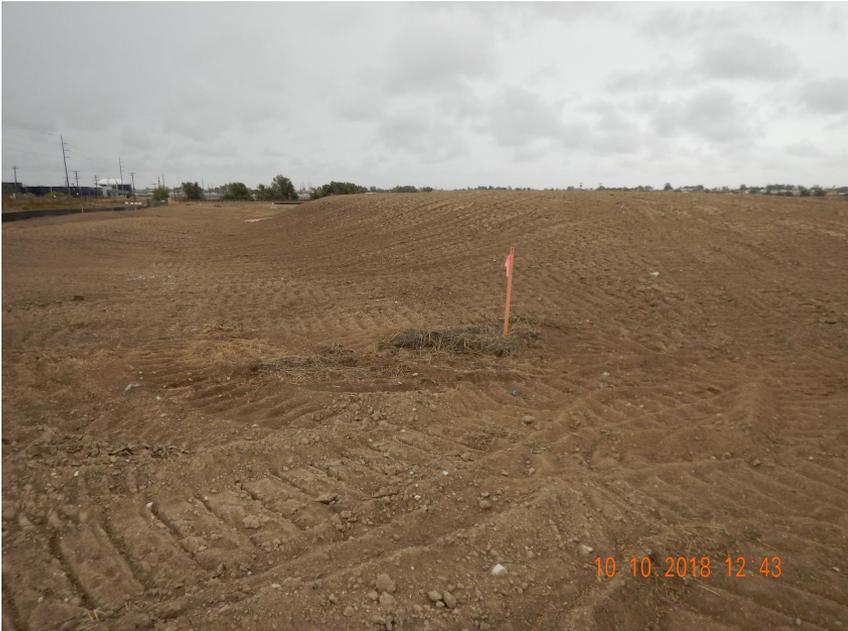
**Photo 3.** Photo taken from the southwestern perimeter of the location, facing North. Photo illustrates the topsoil stockpile stored along the southwestern perimeter of the location. Topsoil has been temporarily stabilized with equipment tracking.

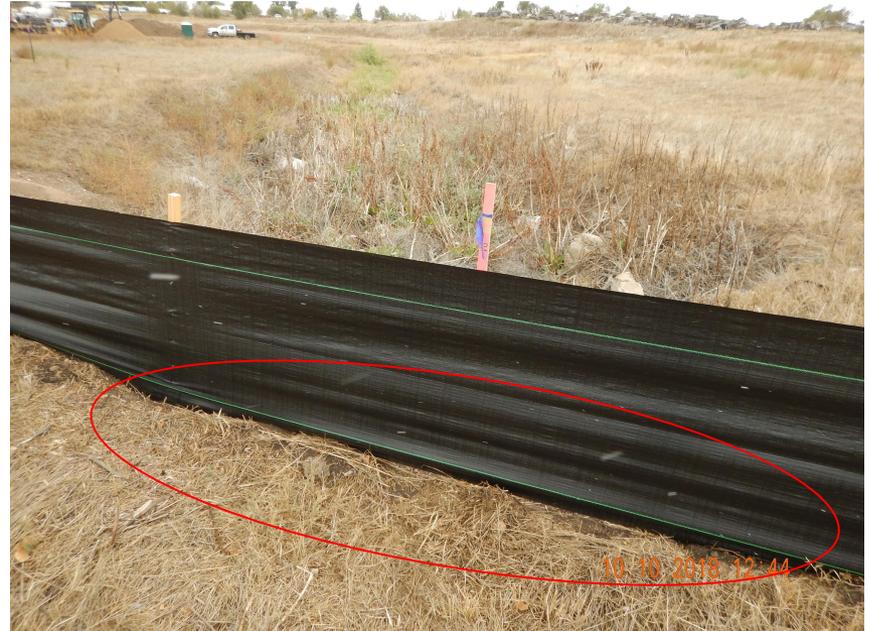
**Photo 4.** Photo taken from the southern perimeter of the location, facing South. Photo illustrates a portion of the silt fence that has not been properly trenched.

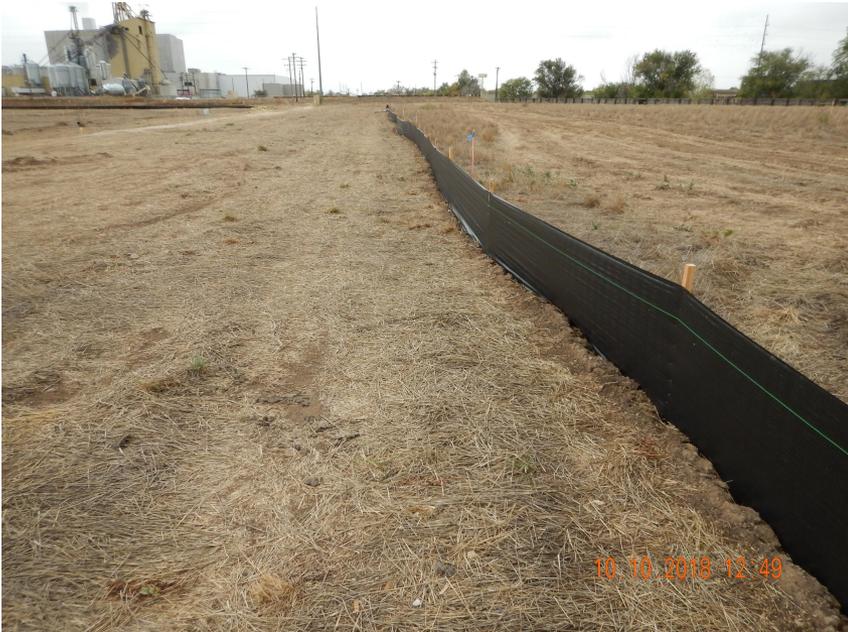
**Photo 5.** Photo taken from the eastern perimeter of the location, facing North. See comments under Photo 2.

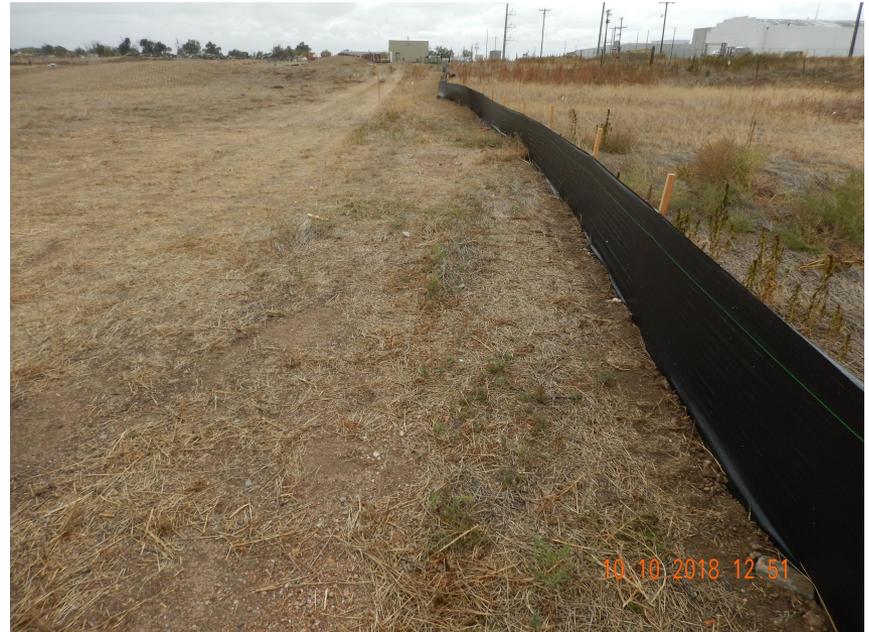
**Photo 6.** Photo taken from the northwestern perimeter of the location, facing South. See comments under Photo 2.
