Inspection Photos

Operator: PDC ENERGY INC - 69175

Location ID: 323128

Inspection Doc. Number: 682504037

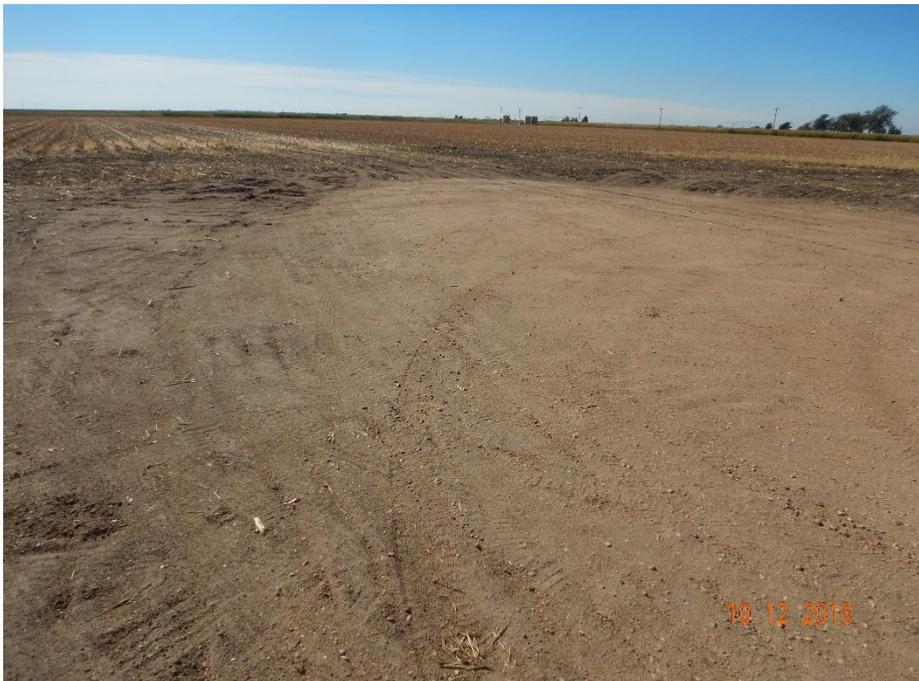
Photo 1: Photo taken from the northeast end of the battery location, facing southwest. Photos 1-2 provide overview of location.

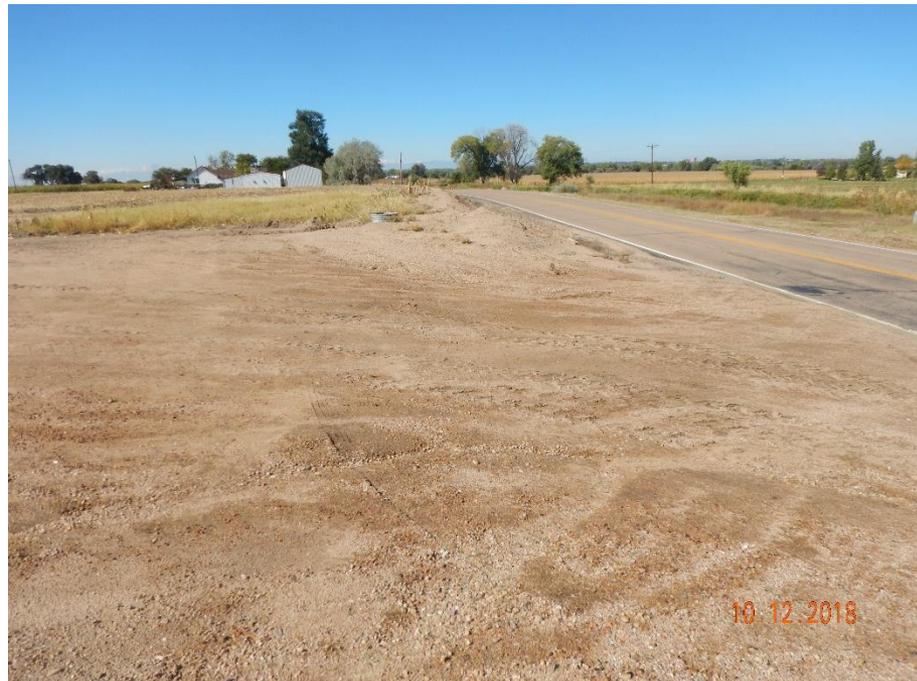
Photo 2: Photo taken from the northeast end of the battery location, facing west

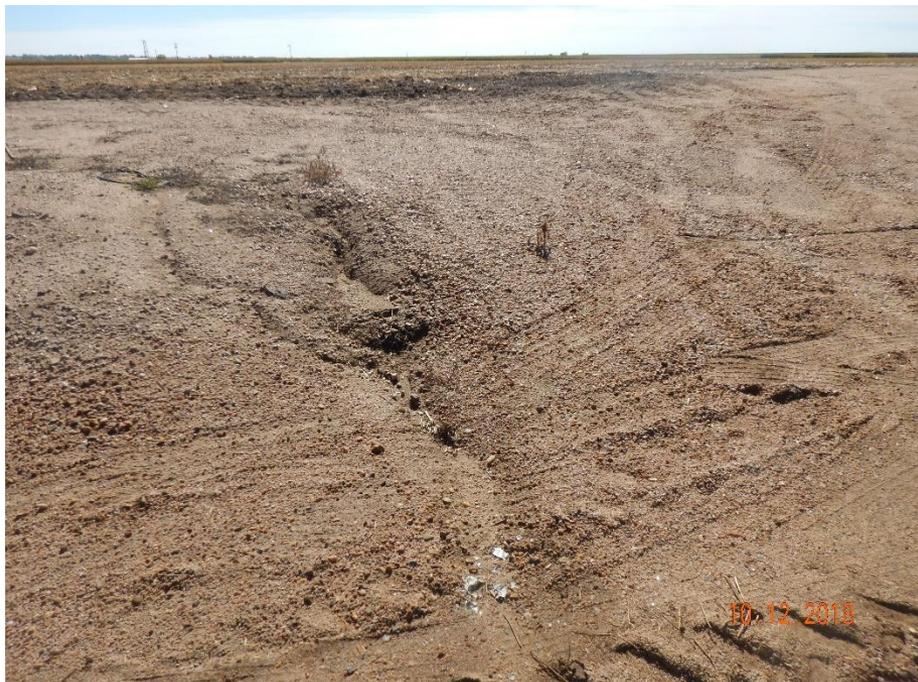
Photo 3: Photo taken from the north end of the location, facing south. Photo shows erosion degradation due to stormwater runoff from the pad. Erosion will need to be repaired, pad will need to be stabilized and BMPs implemented.

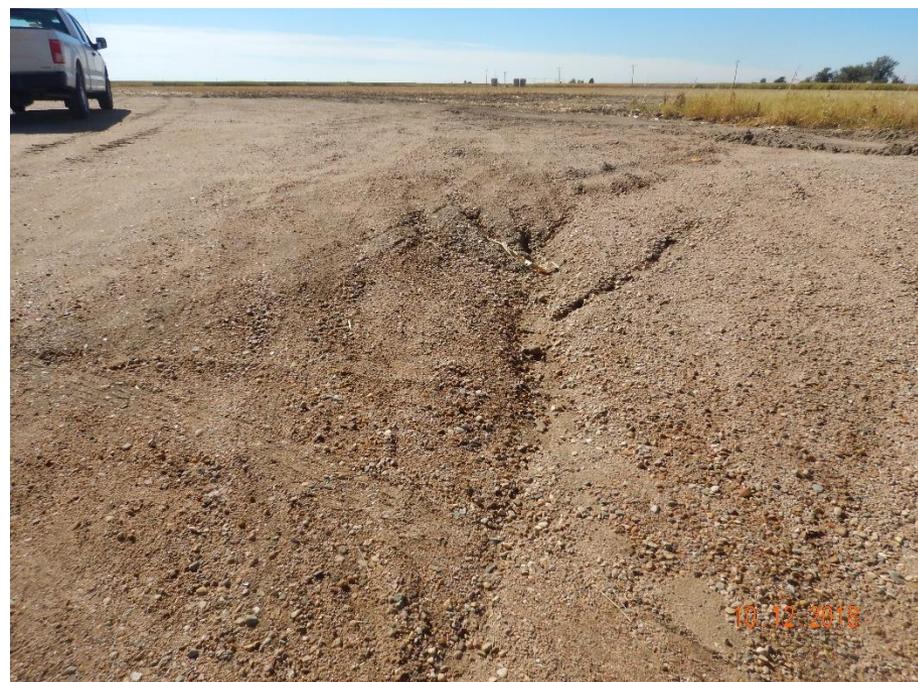
Photo 4: Photo taken from the north end of the location, facing south. Photo shows erosion degradation due to stormwater runoff from the pad. Erosion will need to be repaired, pad will need to be stabilized and BMPs implemented.
