# *Inspection Photos*

*Loc#334440*

*Inspection Number: 692400239*

Inspection Photos: Laramie Sup&Shep Loc#334440

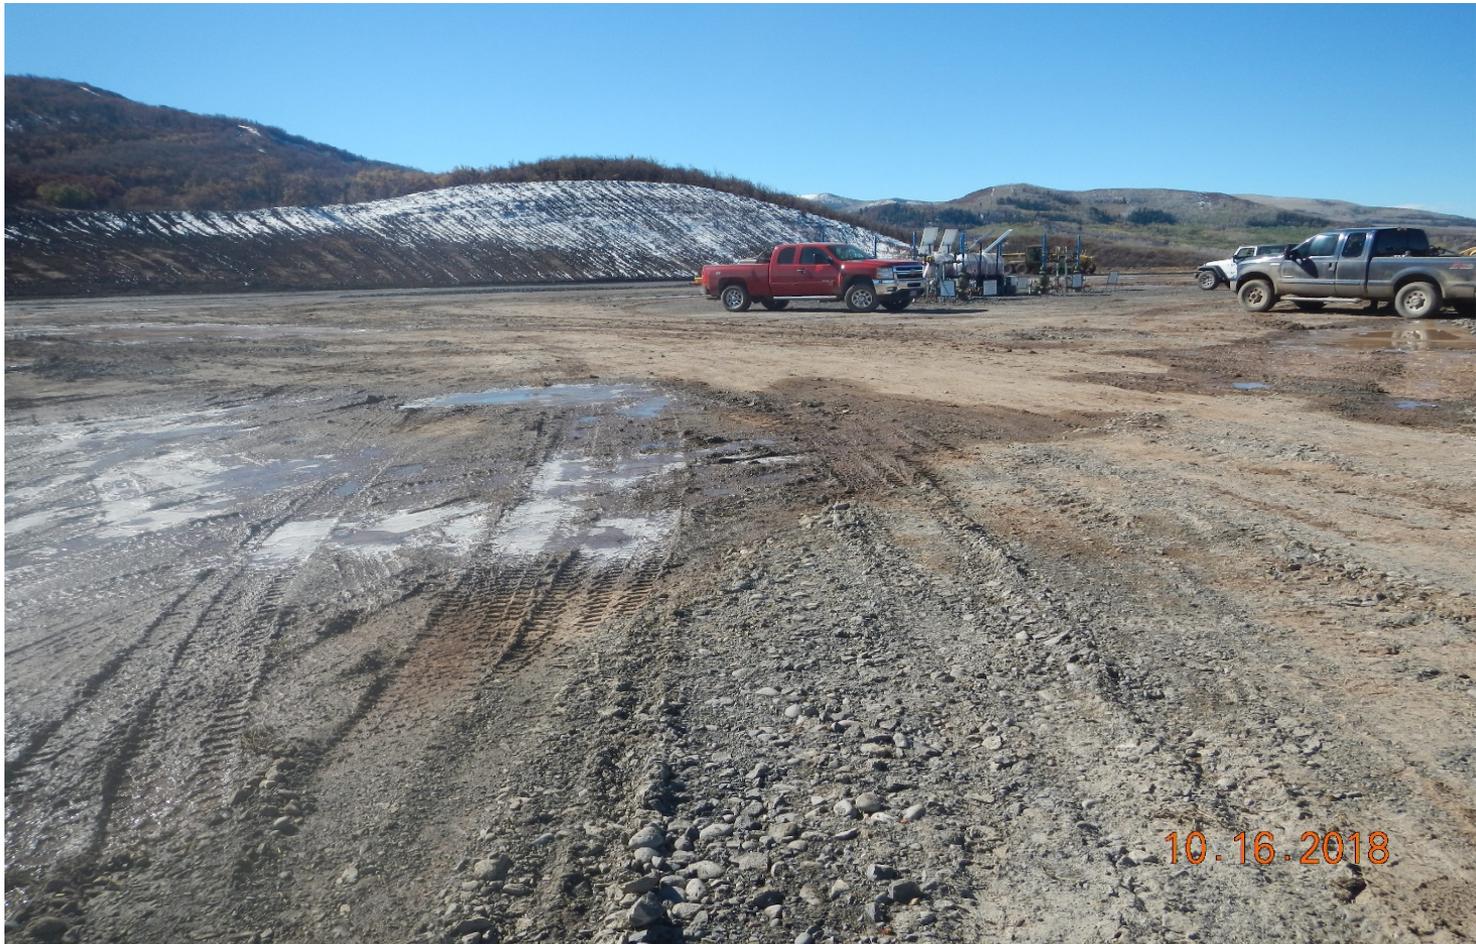
Photo#1:  
Overview of Location from entry to West.

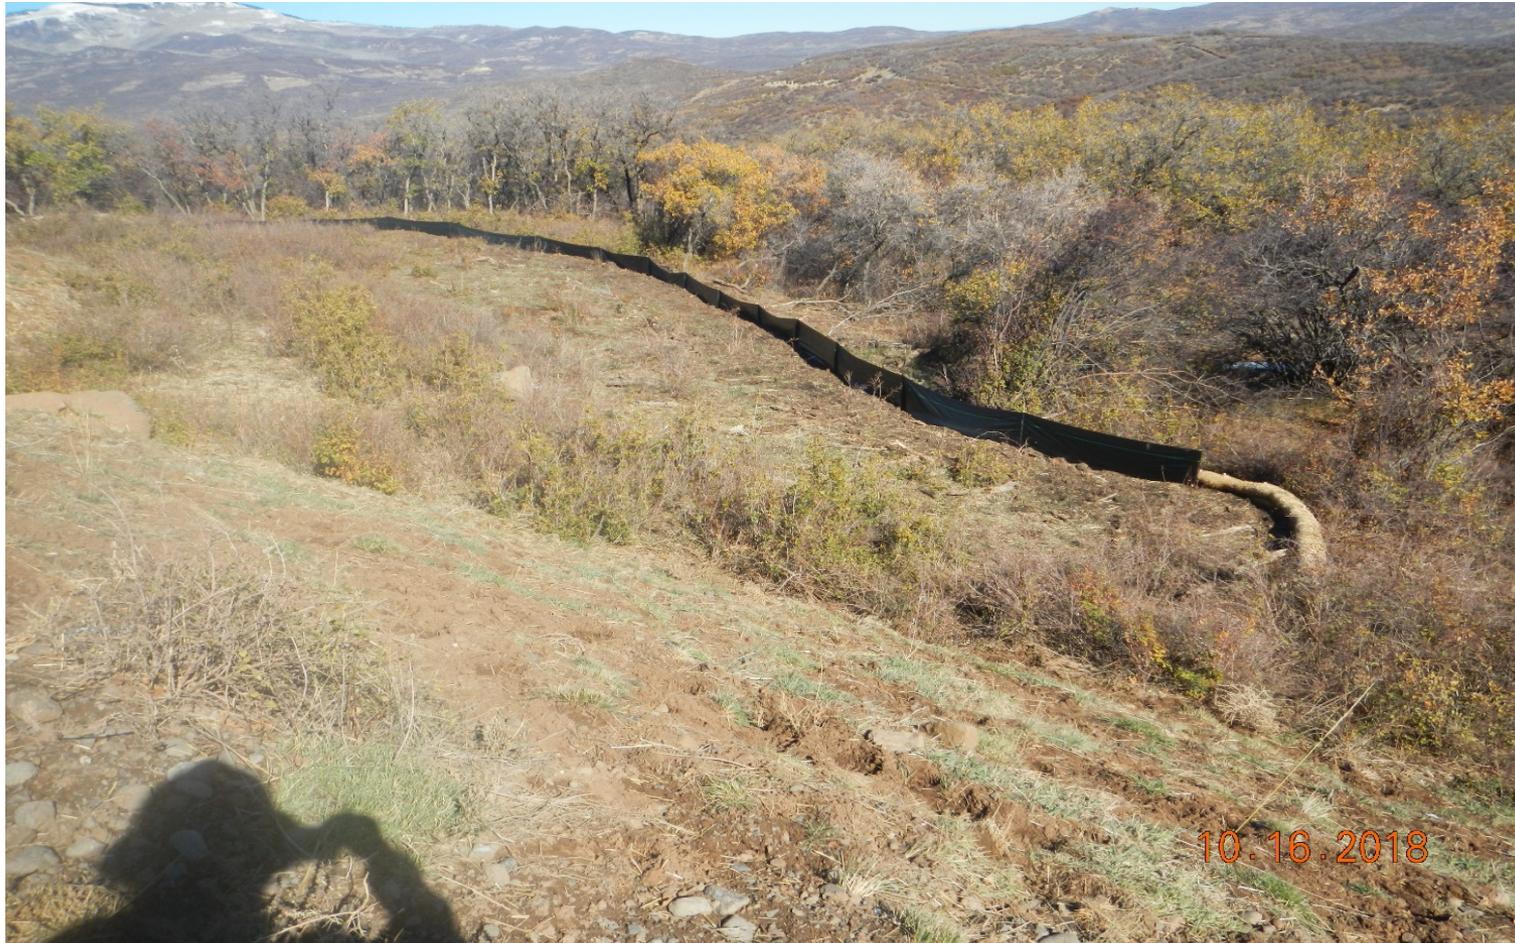
Photo#2:  
View of Silt fence installed as perimeter control.

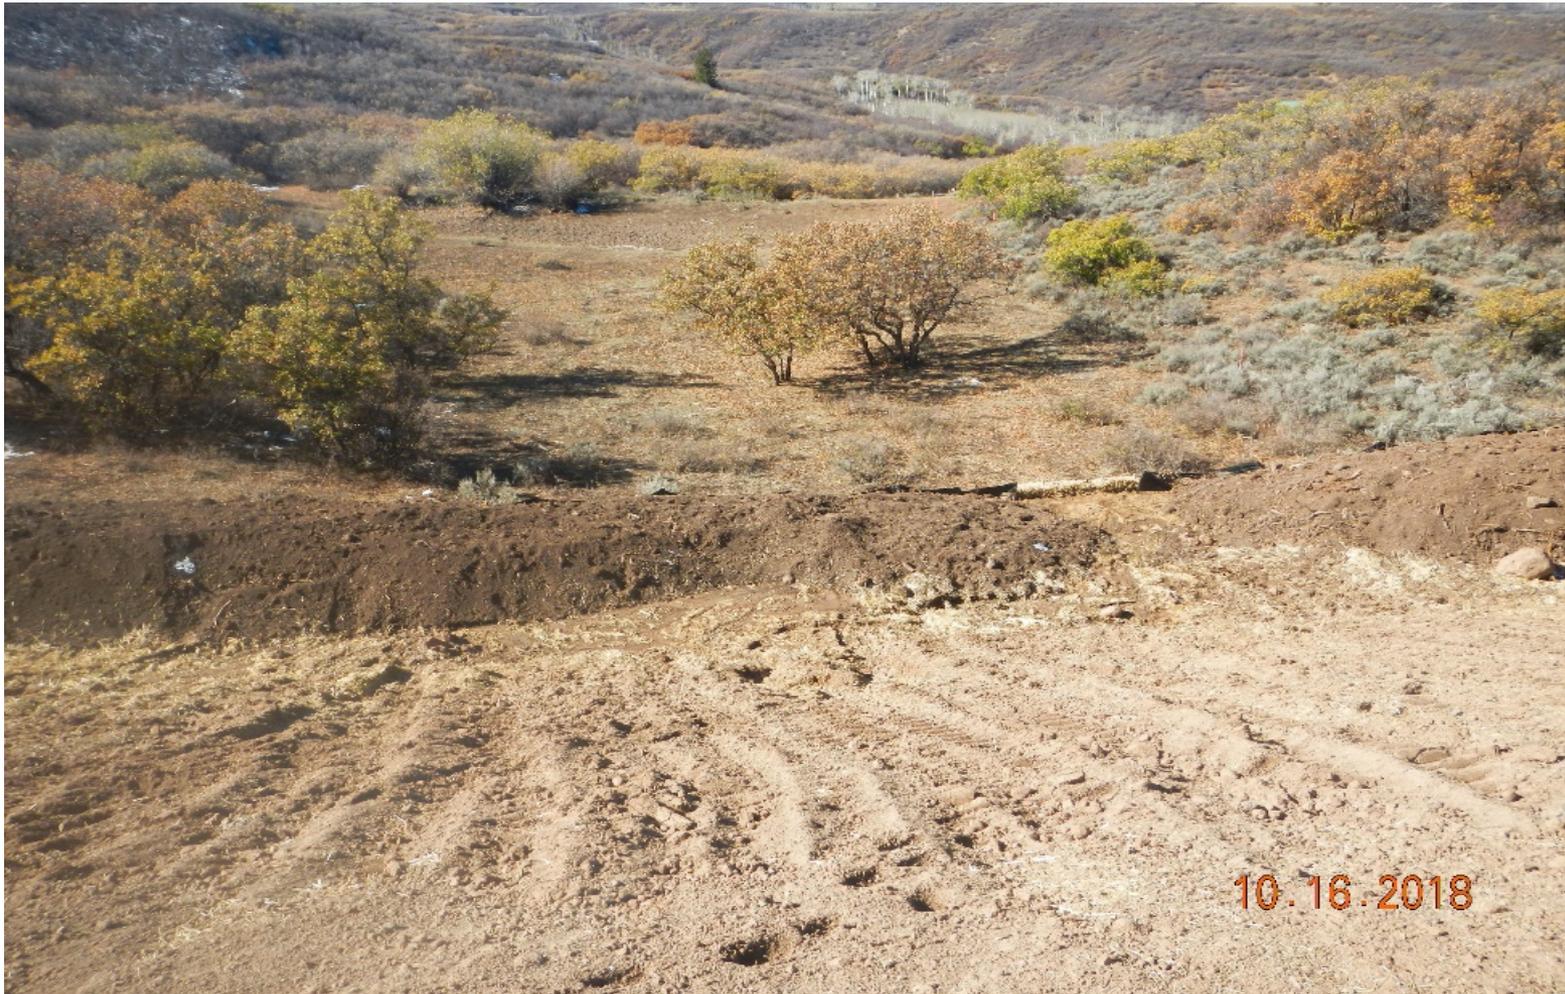
**Photo#3:**

Base of Fill slope & windrowed topsoil, where additional BMPs are needed to segregate & prevent mixing & erosion of soils.

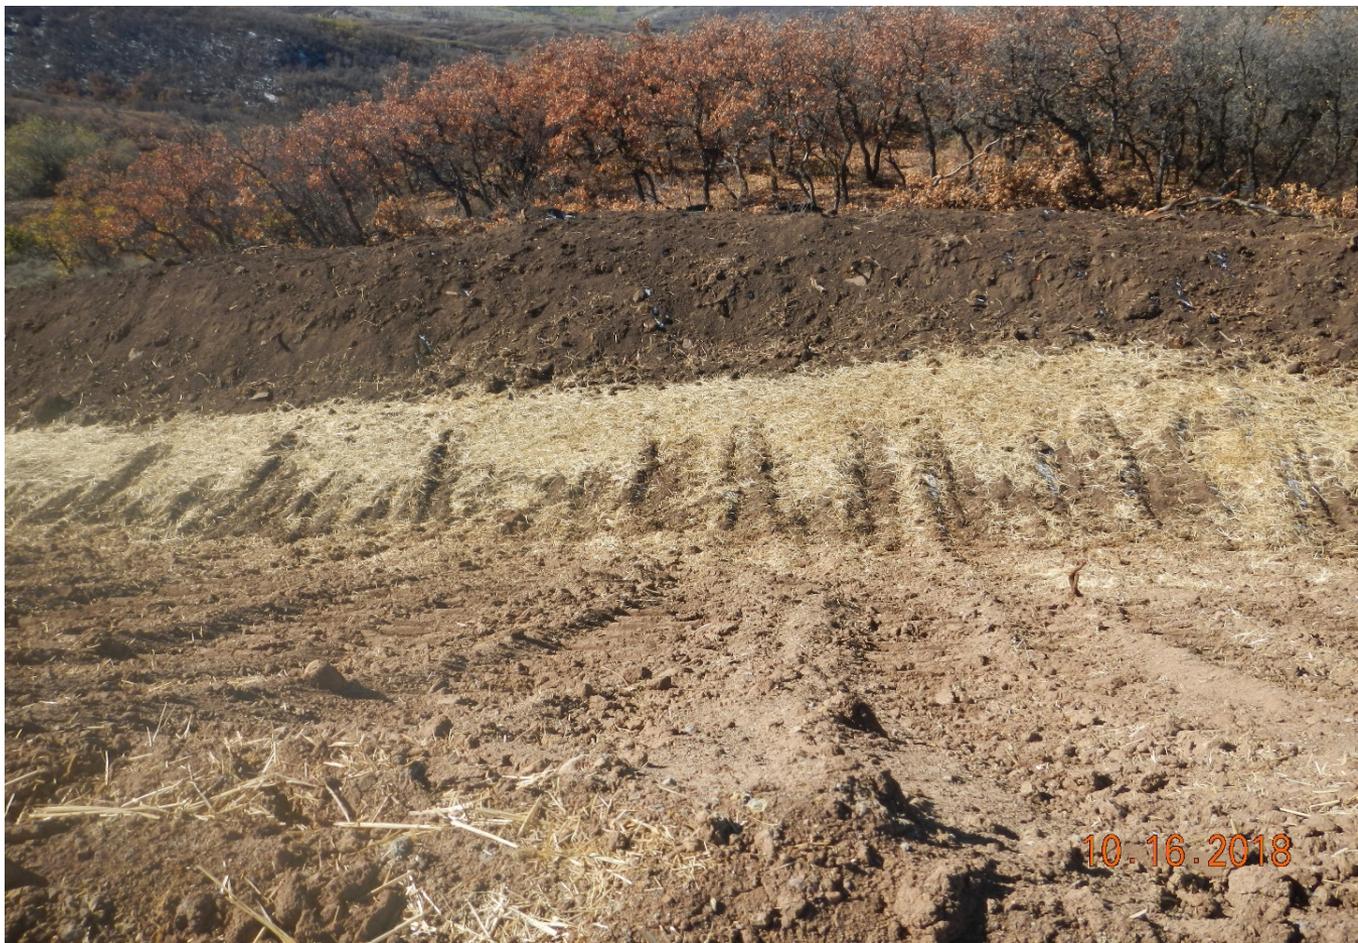
**Photo#4:**

Base of Fill slope & windrowed topsoil, where additional BMPs are needed to segregate & prevent mixing & erosion of soils.

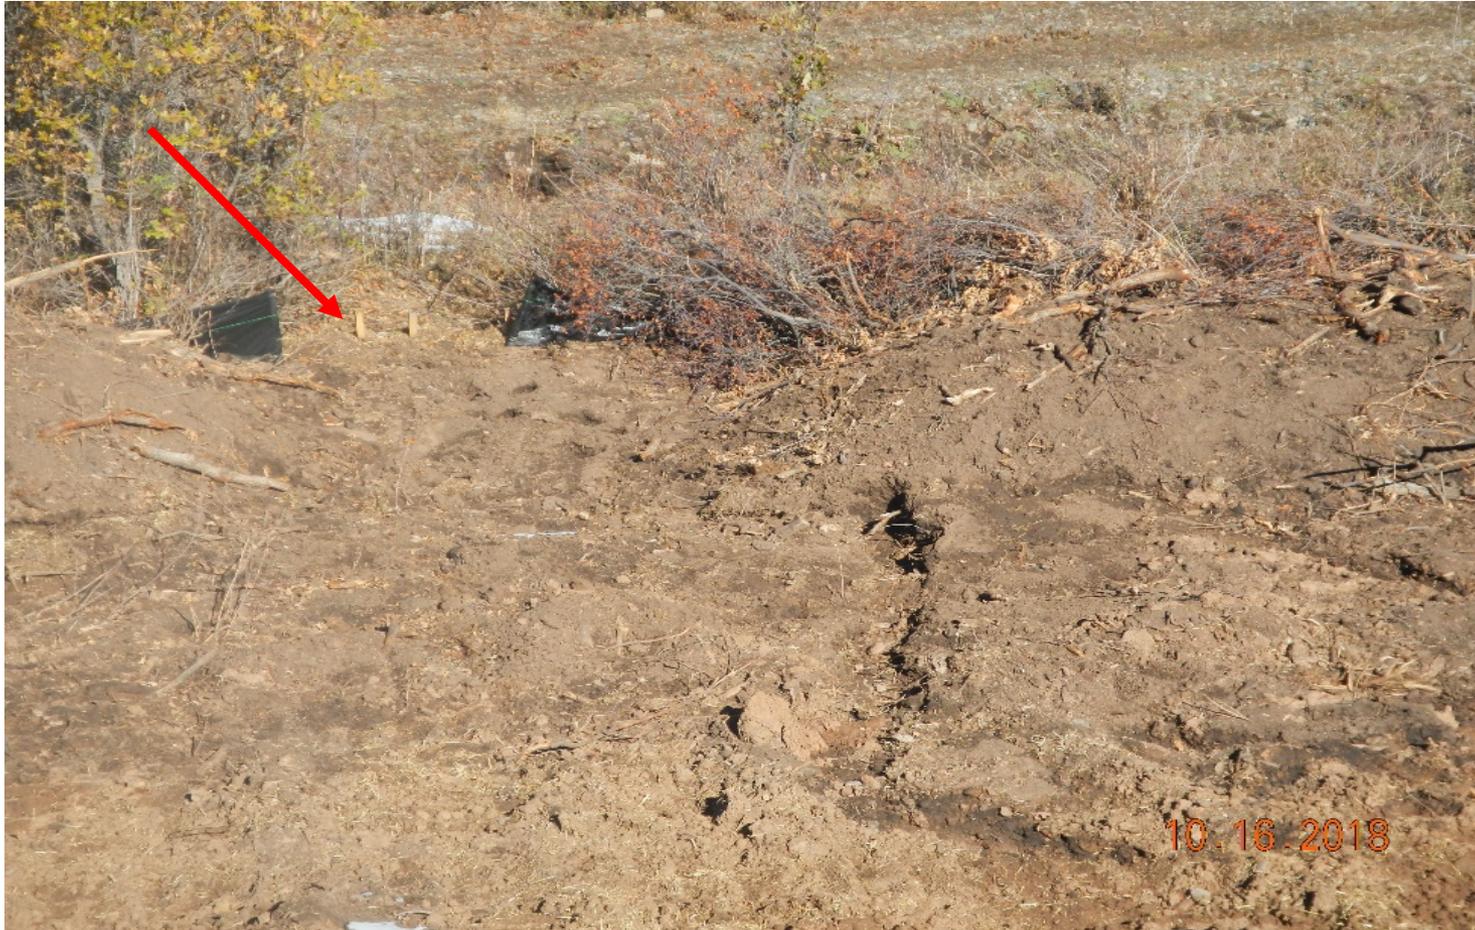
**Photo#5**

Area between base of fill slope & topsoil where erosion & mixing is occurring; overwhelmed Bmp indicated by arrow.
