# Interim Reclamation and Stormwater Inspection

Operator: VERDAD RESOURCES LLC - #10651

Location ID: 435303

**Inspection Photos**  
**Location Name: Gaffney #2-29-8-61**  
**Location ID: 435303**

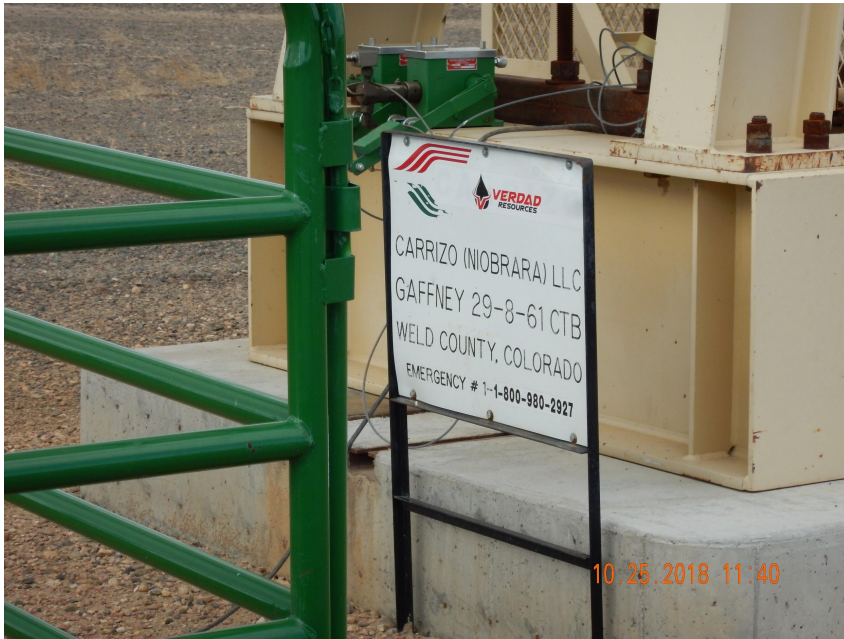
**Photo 1.** Photo taken from well location. Sign has been updated to reflect current Operator but 2 different Operators are posted. Comply with Rule 210.e.

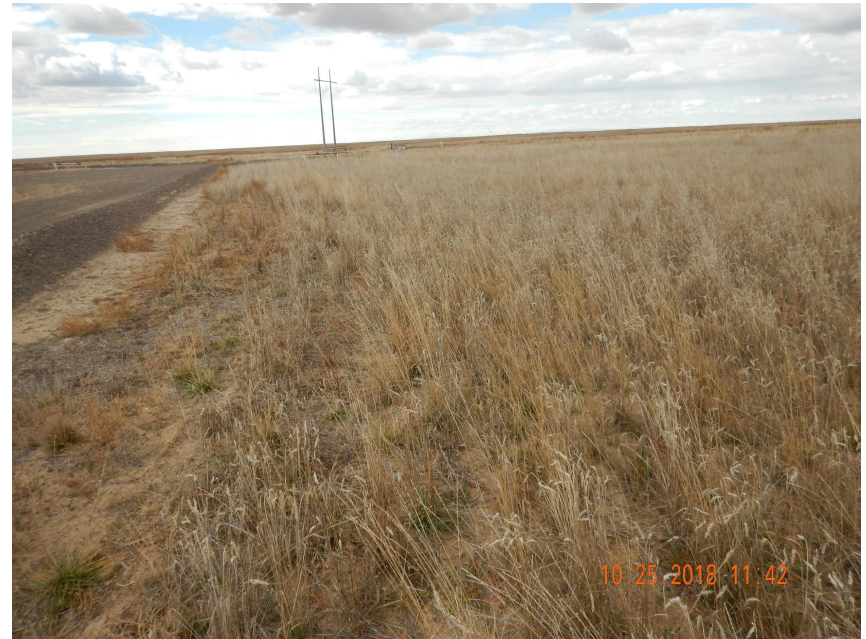
**Photo 2.** Photo taken from the northern interim area, facing West. Desirable vegetation was observed throughout portions of the interim area. Photo illustrates a wheat grass that may have germinated from the mulch product which was observed throughout the interim area.

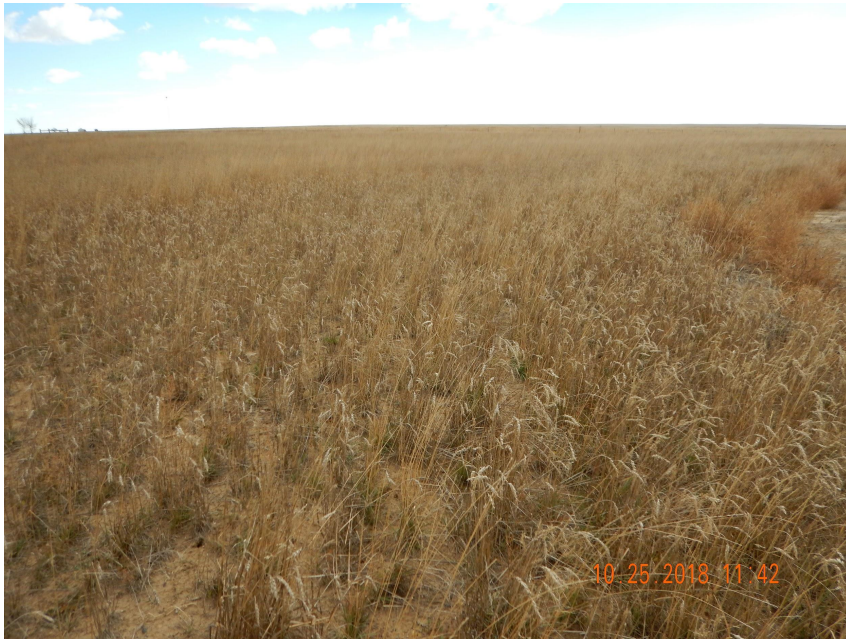
**Photo 3.** Photo taken from the northern interim area, facing East. See comments under Photo 2.

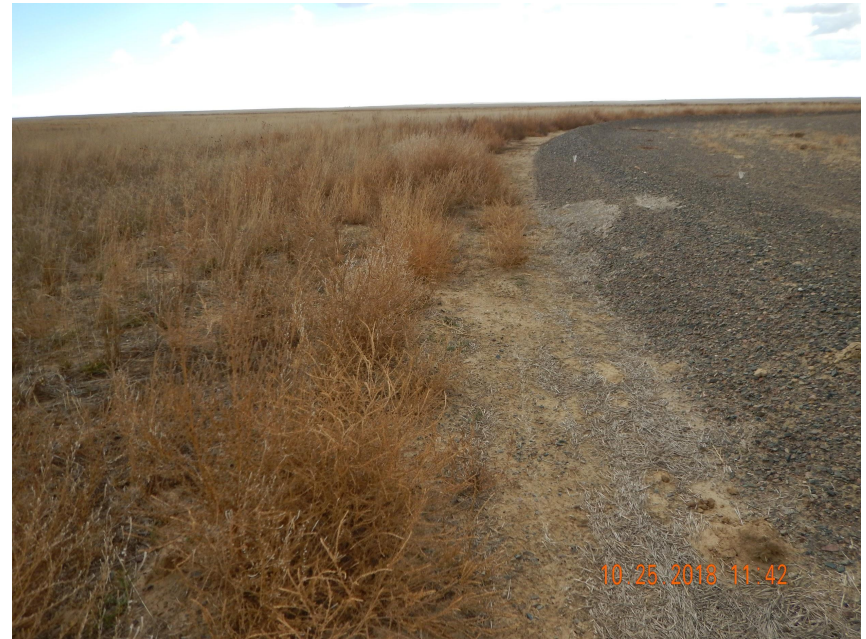
**Photo 4.** Photo taken from the eastern perimeter of the location, facing South. Photo illustrates undesirable weedy vegetation (Kochia and Russian thistle). Operator shall control and manage weedy vegetation, as this will become weed debris and potentially spread more seeds.

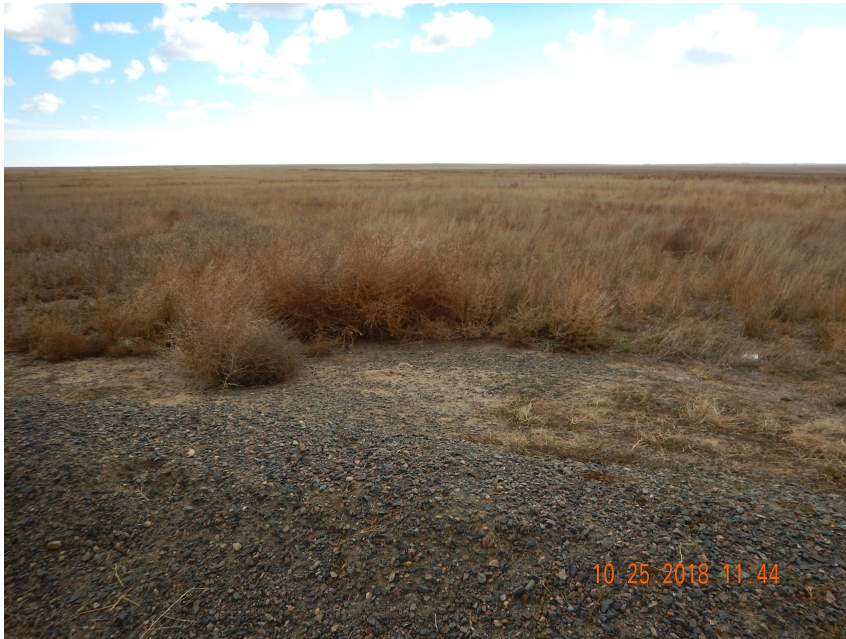
**Photo 5.** Photo taken from the eastern perimeter of the location, facing East. See comments under Photo 4.

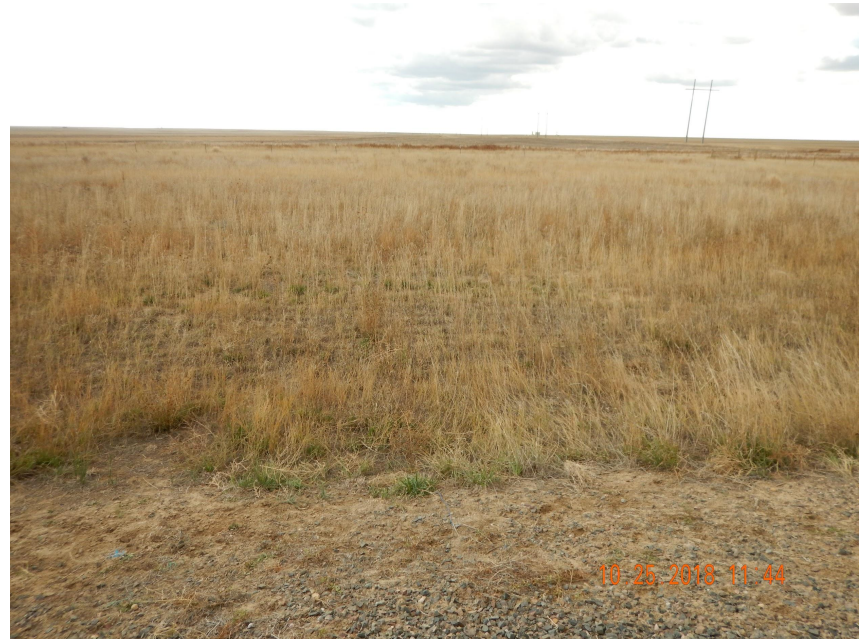
**Photo 6.** Photo taken from the southern perimeter of the location, facing South. See comments under Photo 2.
