Final Reclamation Inspection

Operator: GREAT WESTERN OPERATING COMPANY LLC- #10110

API: 05-123-11518

Inspection Photos
Location Name: CUDNEY/SANDSTEDT #1
API: 05-123-11518

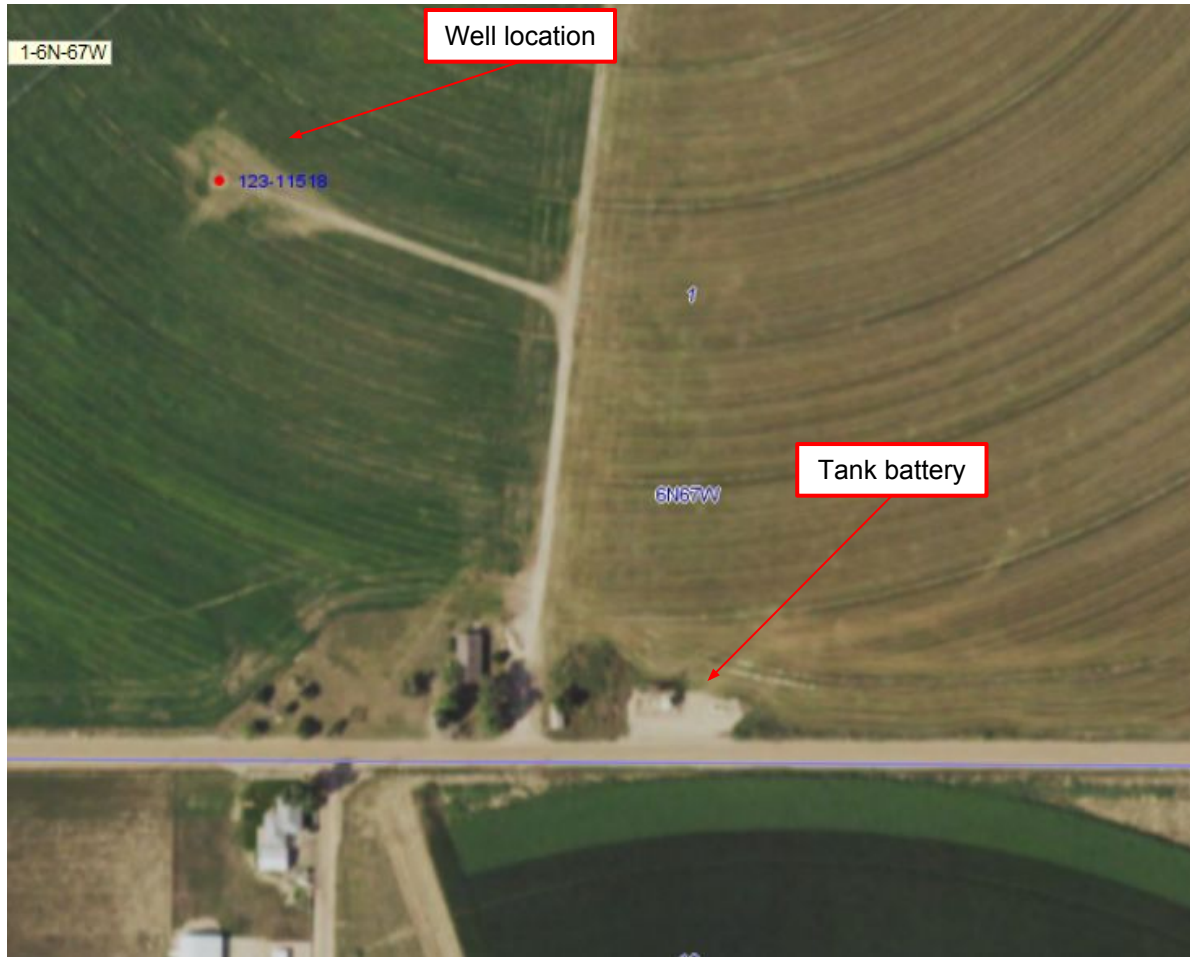
COGCC GISOnline aerial imagery from 2017 taken during active operations. Operator has failed to perform final reclamation activities (i.e., remove gravel, decompact, seedbed prep and seed) at the tank battery location.

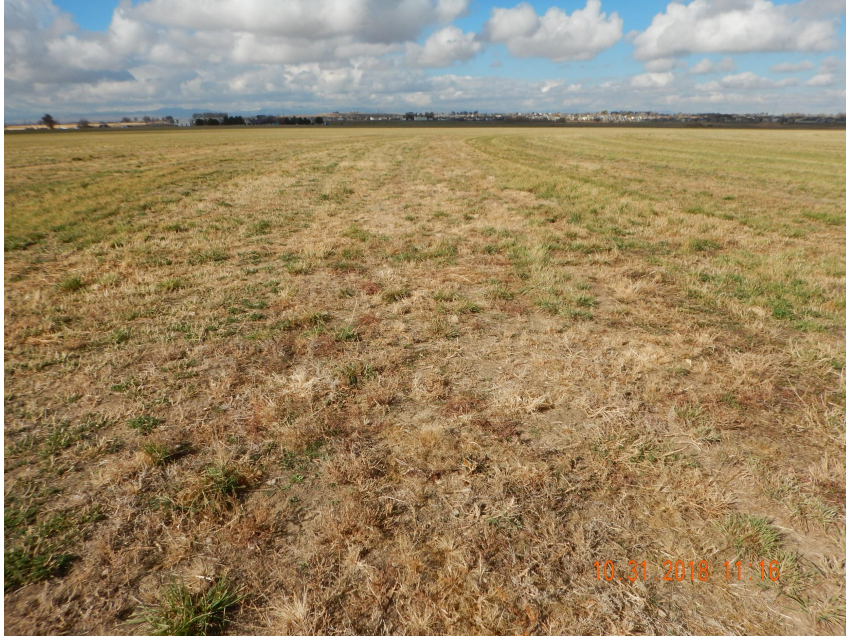
Photo 1. Photo taken from the entrance of the well access road, facing West. A vegetative assessment could not be performed because of crop harvest. However, there are obvious areas that do not appear reflective of reference area vegetative levels. Operator may need to perform additional reclamation activities to bring this into compliance.

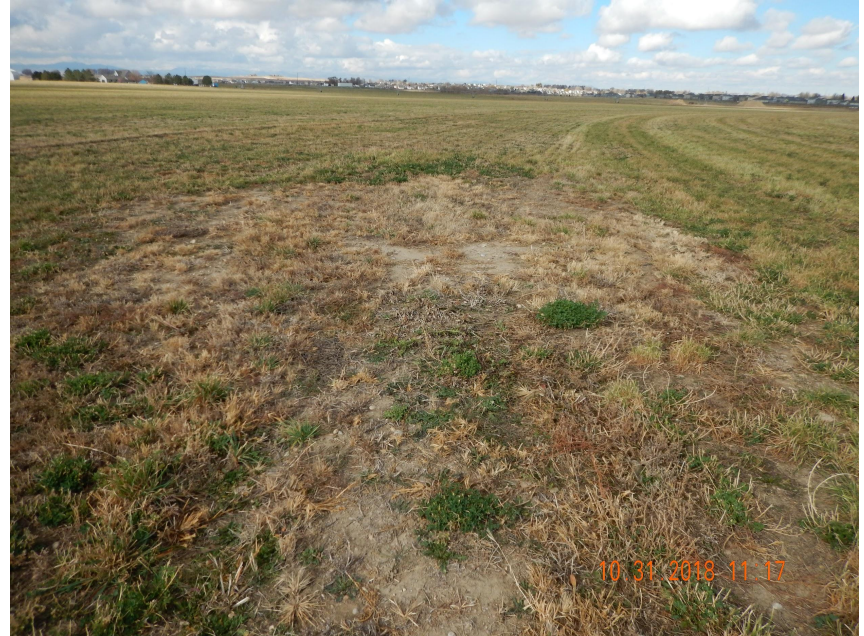
Photo 2. Photo taken from the well location, facing West. See comments under Photo 1.

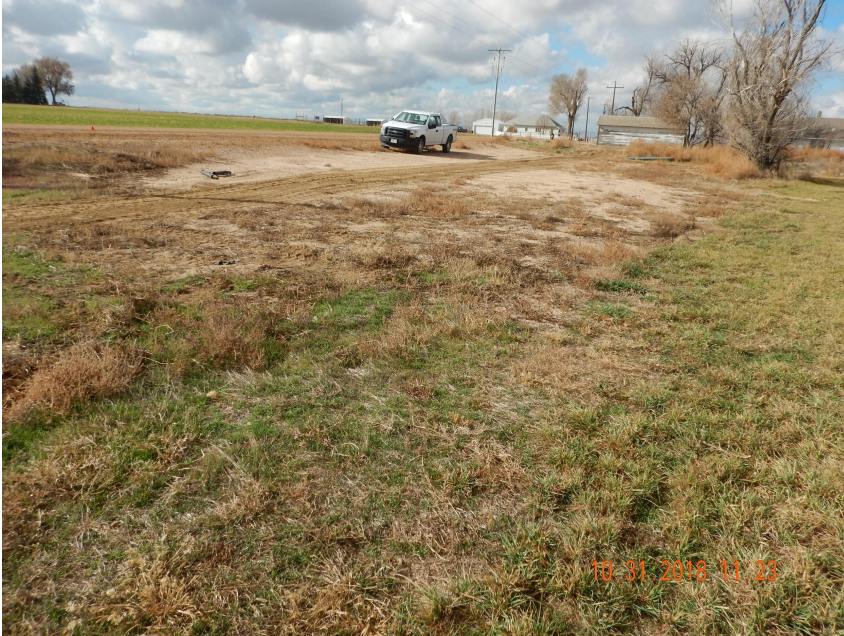
Photo 3. Photo taken from the eastern tank battery location, facing West. Operator has failed to perform final reclamation activities (i.e., remove gravel, decompact, seedbed prep and seed).

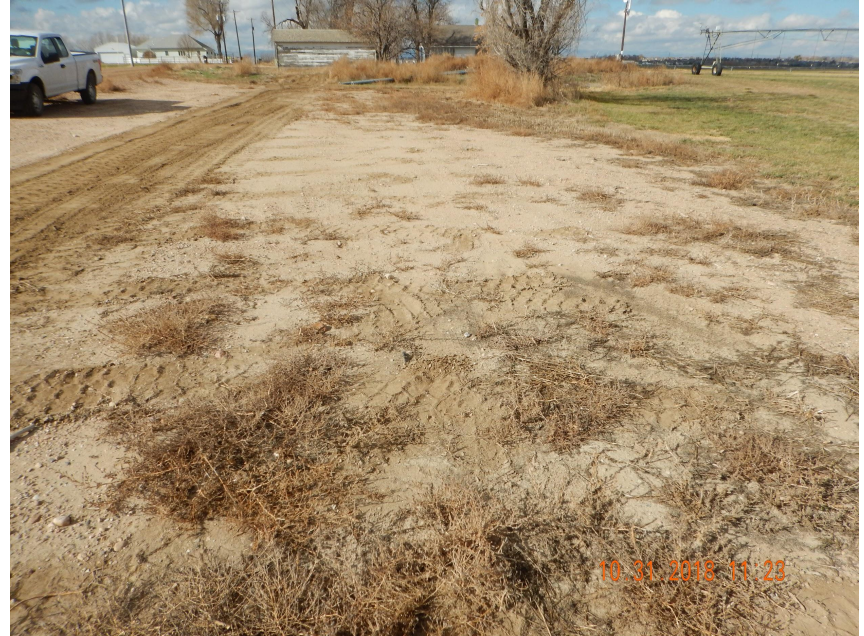
Photo 4. Photo taken from the northern tank battery location, facing West. See comments under Photo 3.

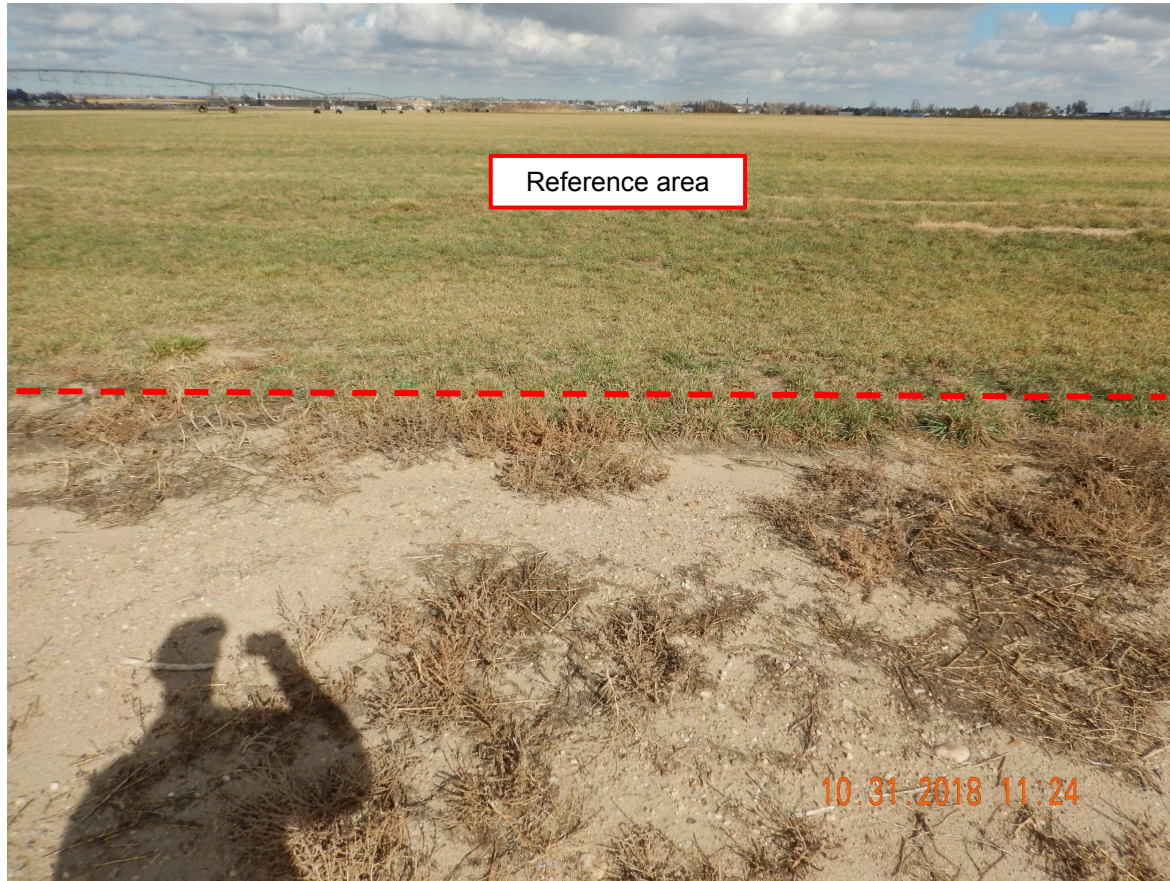
Photo 5. Photo taken from the northern tank battery location, facing North. See comments under Photo 3.
