Inspection Photos

Operator: WIEPKING-FULLERTON ENERGY LLC -
96340

Location ID: 443191

Inspection Doc. Number: 682504096
Lincoln County, CO

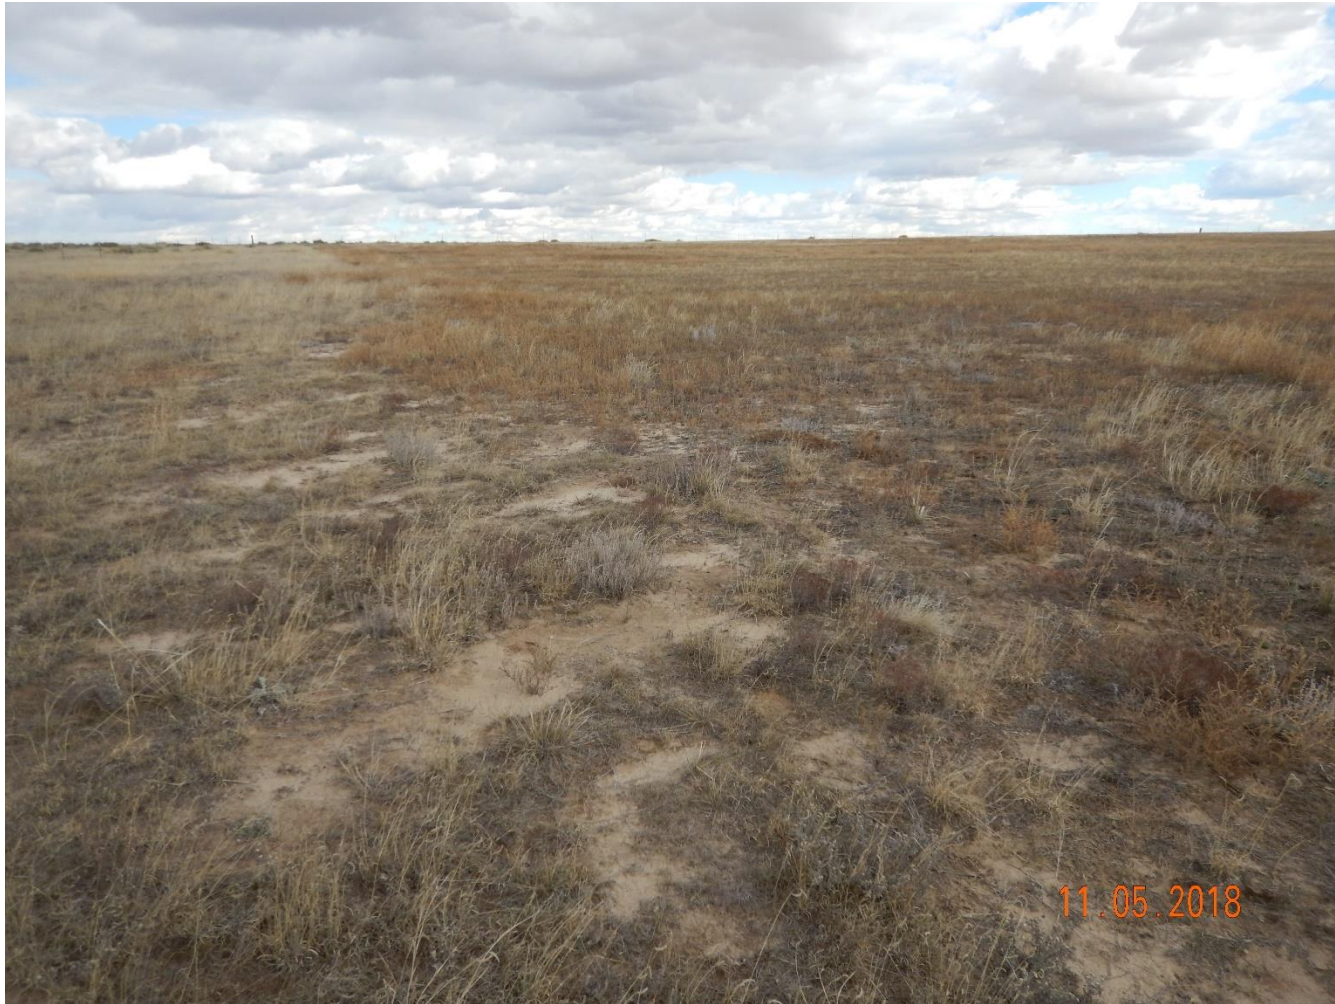
Photo 1: Photo taken from the northwest corner of the location, facing east. Photo shows overview of the reclamation area.

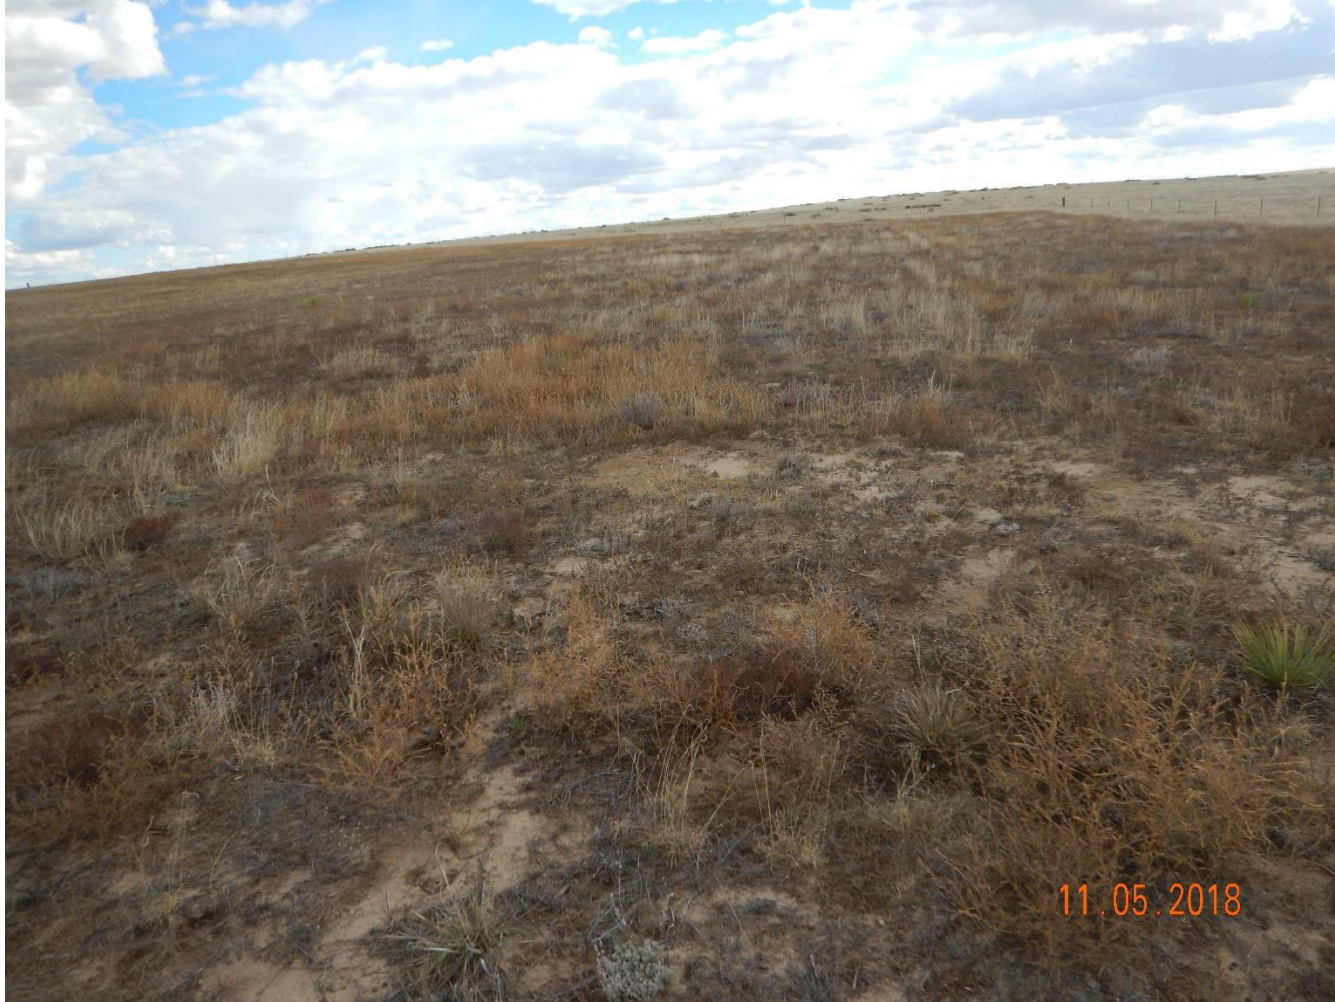
Photo 2: Photo taken from the northwest corner of the location, facing esouth. Photo shows overview of the reclamation area.

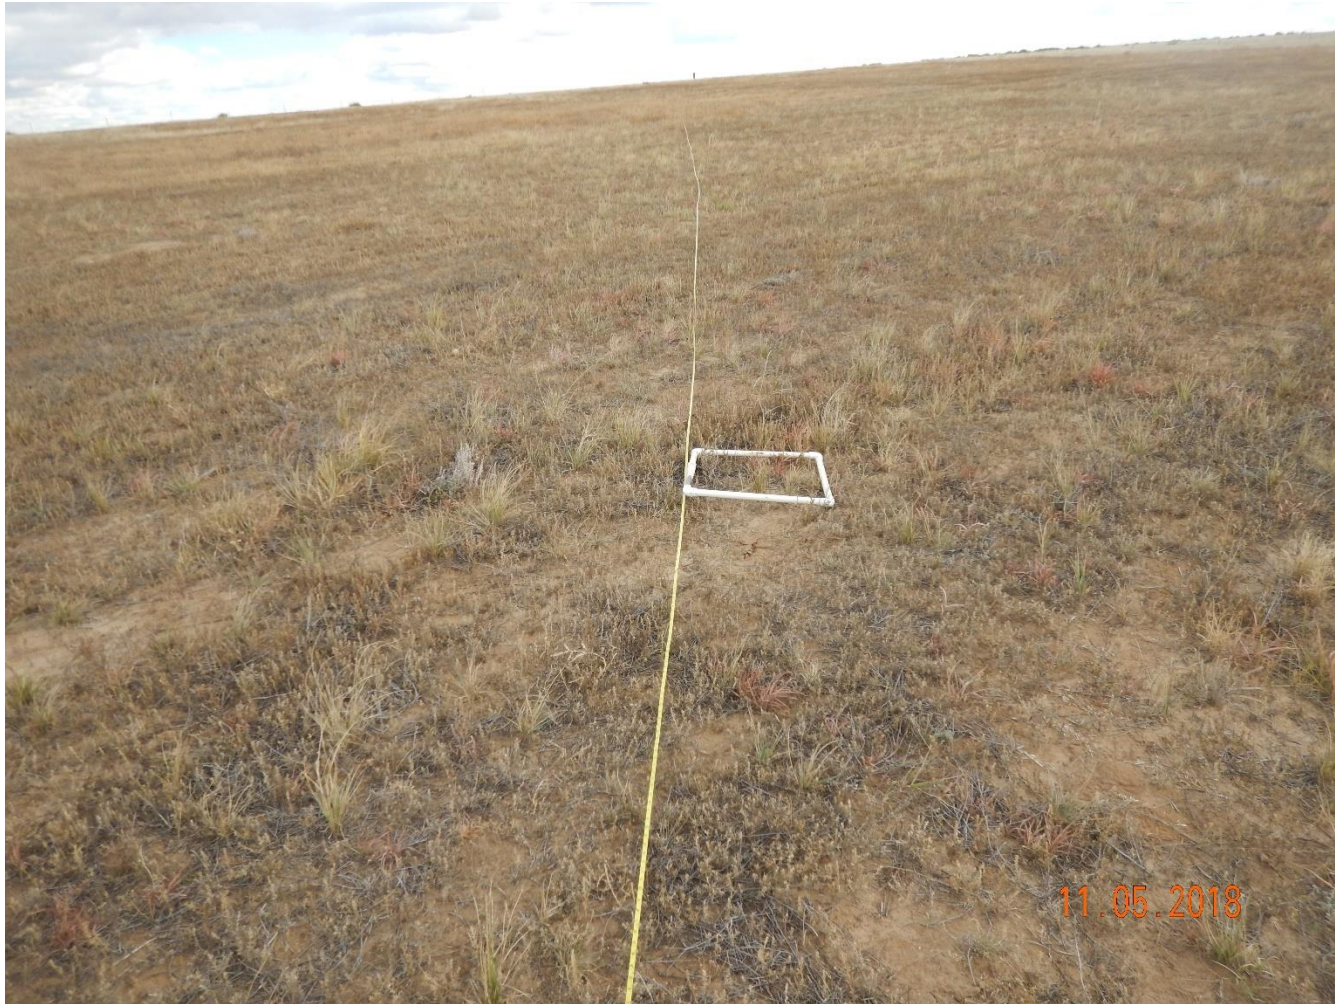
Photo 3: Photo taken from the location, facing southeast. Photo shows the “Germination Transect” line.

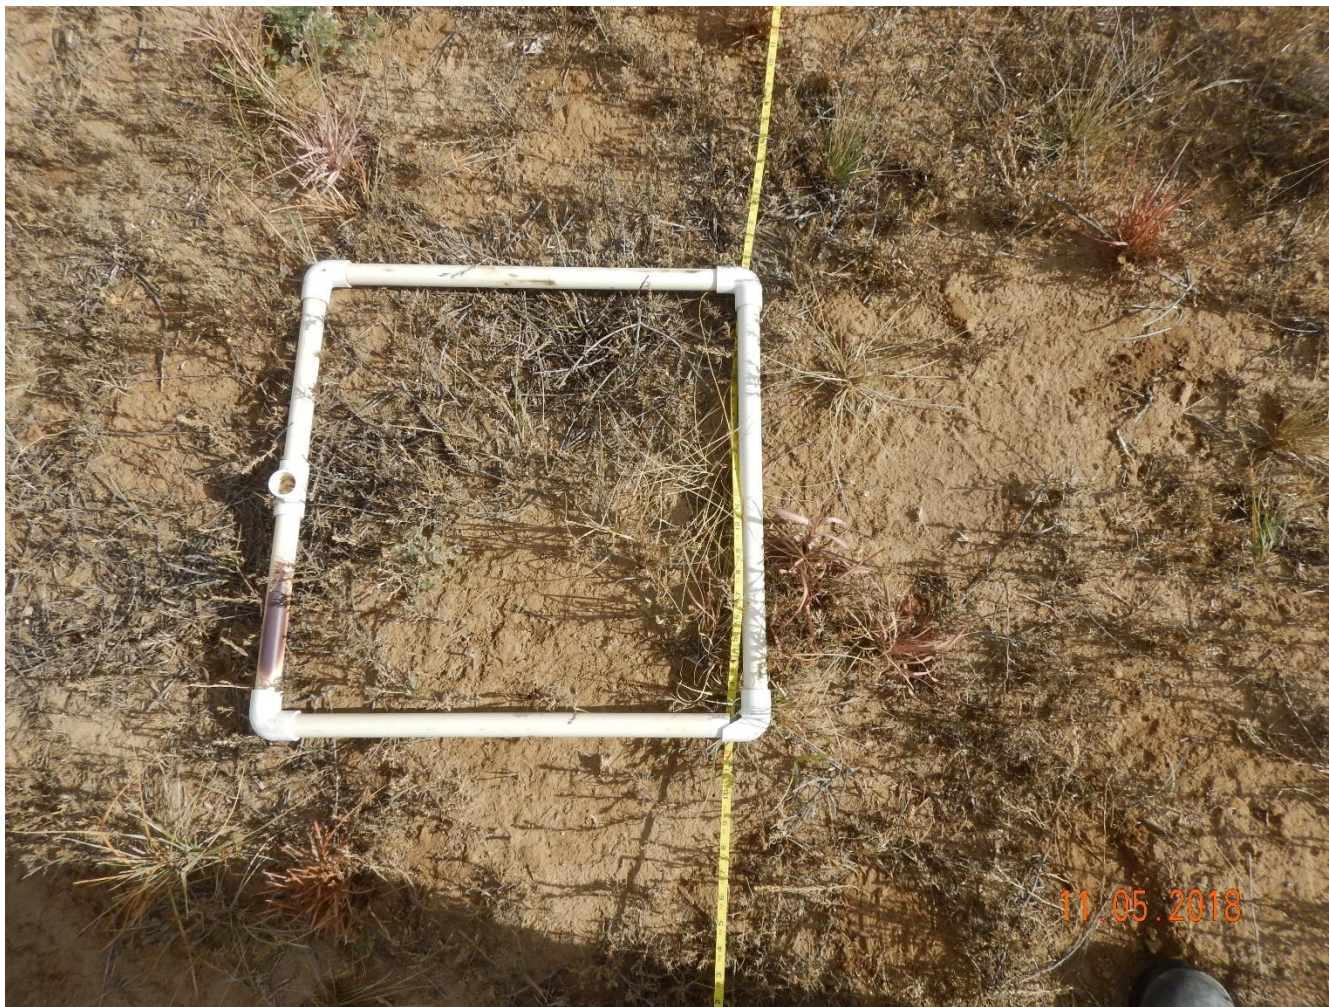
Photo 4: Photo taken from the 50th point of the transect. Photo shows vegetation over the reclamation area.

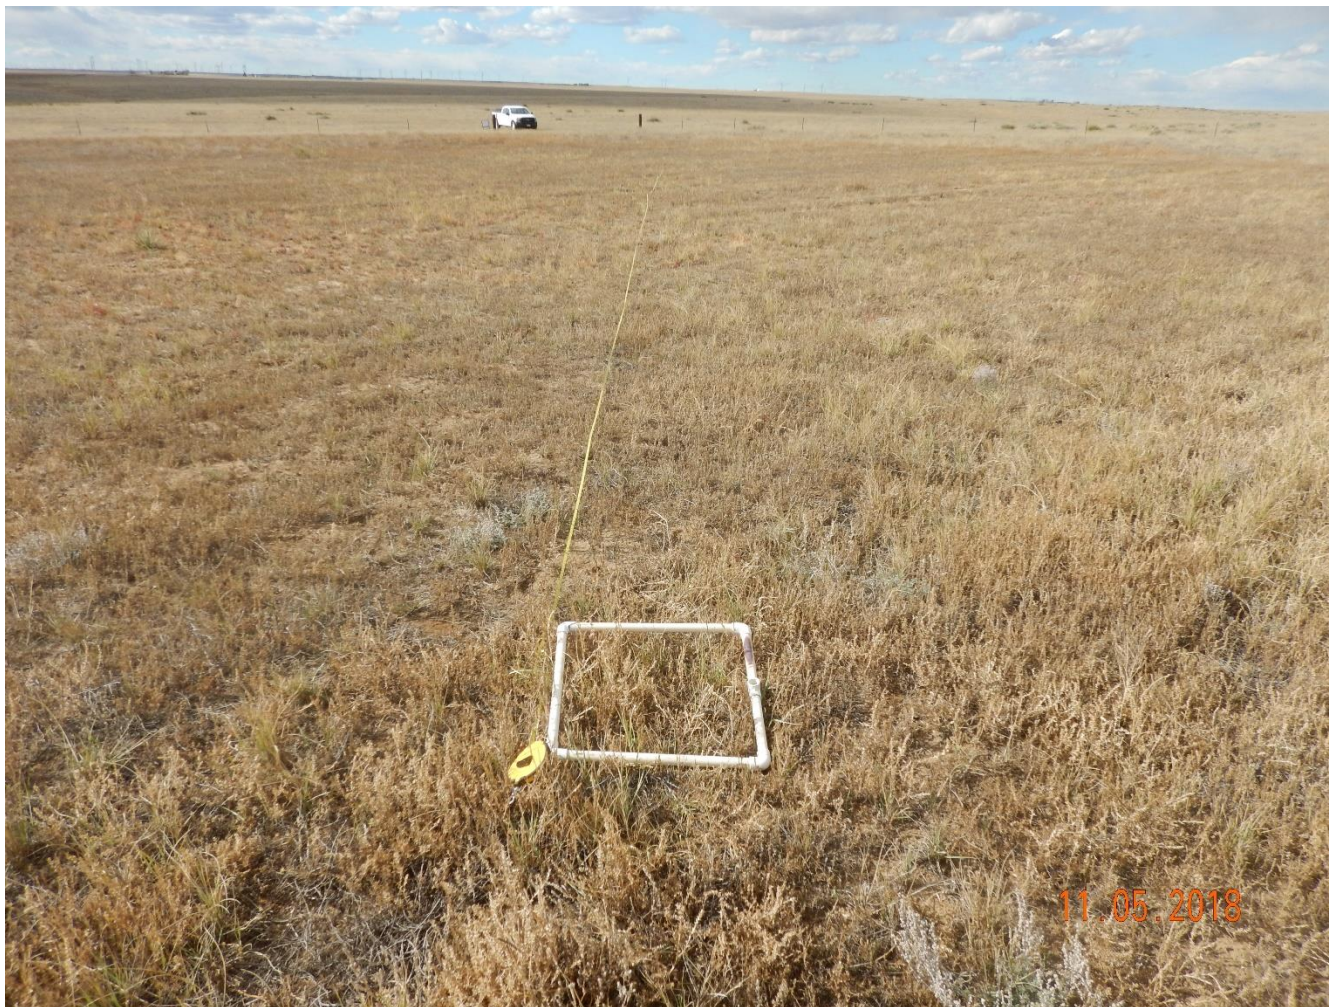
Photo 5: Photo taken from the 50th point of the transect, facing northwest. Photo shows vegetation over the reclamation area and transect line. Vegetation over the reclamation area remains predominantly undesirable weedy plant species such as Russian thistle.

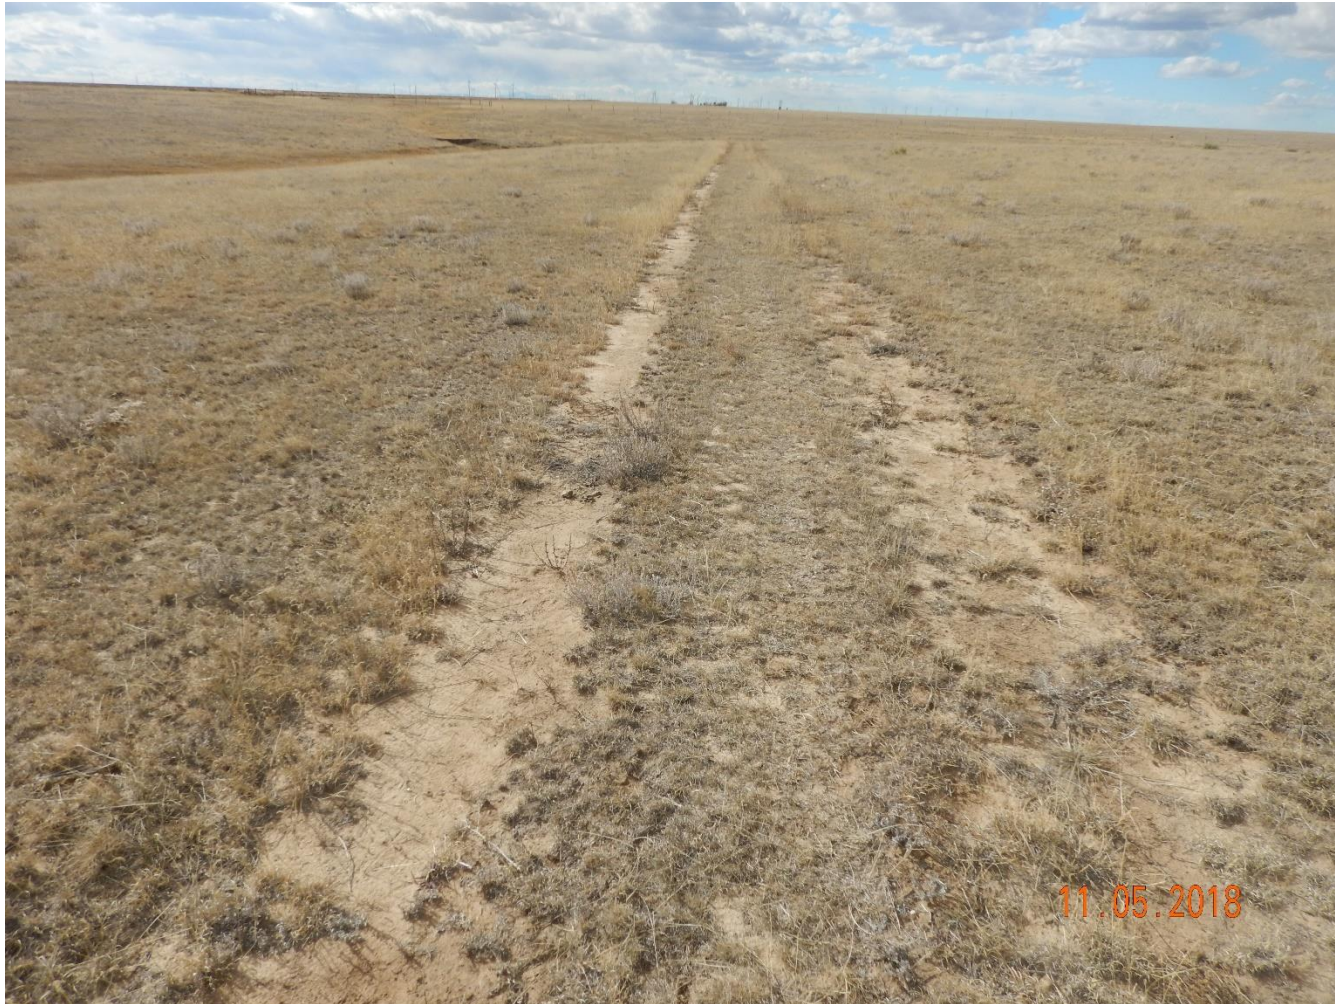
Photo 6: Photo taken from the southeast corner of the location, facing north. Photo shows reclamation activities appear to have been conducted on areas no longer reasonable needed for production activities.
