Final Reclamation Inspection

Operator: TOP OPERATING COMPANY - 39560

API: 05-123-08139

Inspection Photos
Location Name: SCHNEIDER #1
API: 05-123-08139

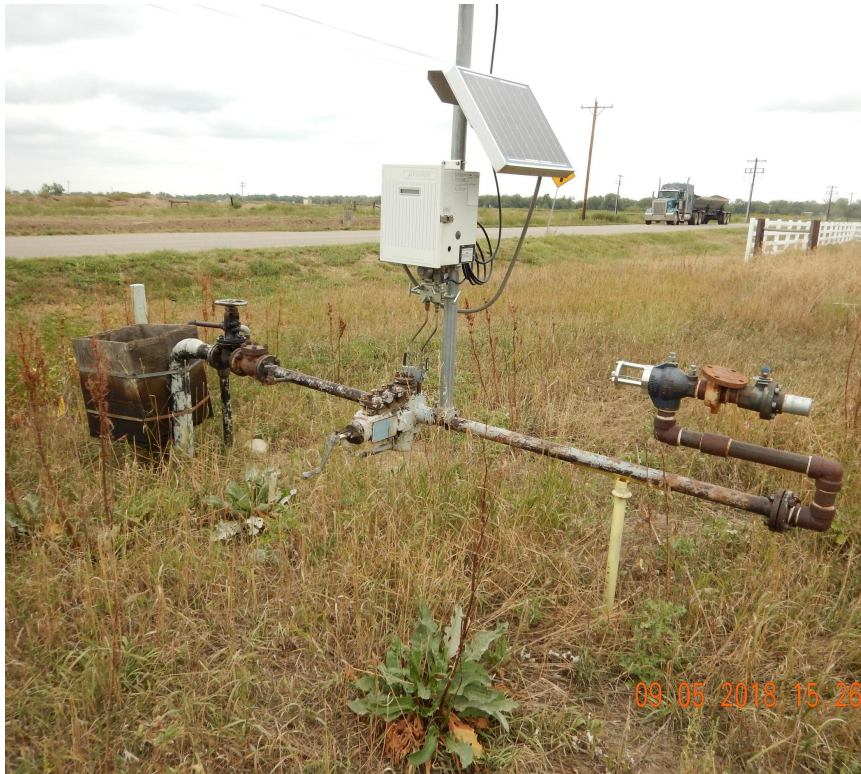
Photo 1. Photo taken from the eastern battery location on September 5, 2018. Photo illustrates the Operator failed to remove equipment after previous corrective actions were issued.

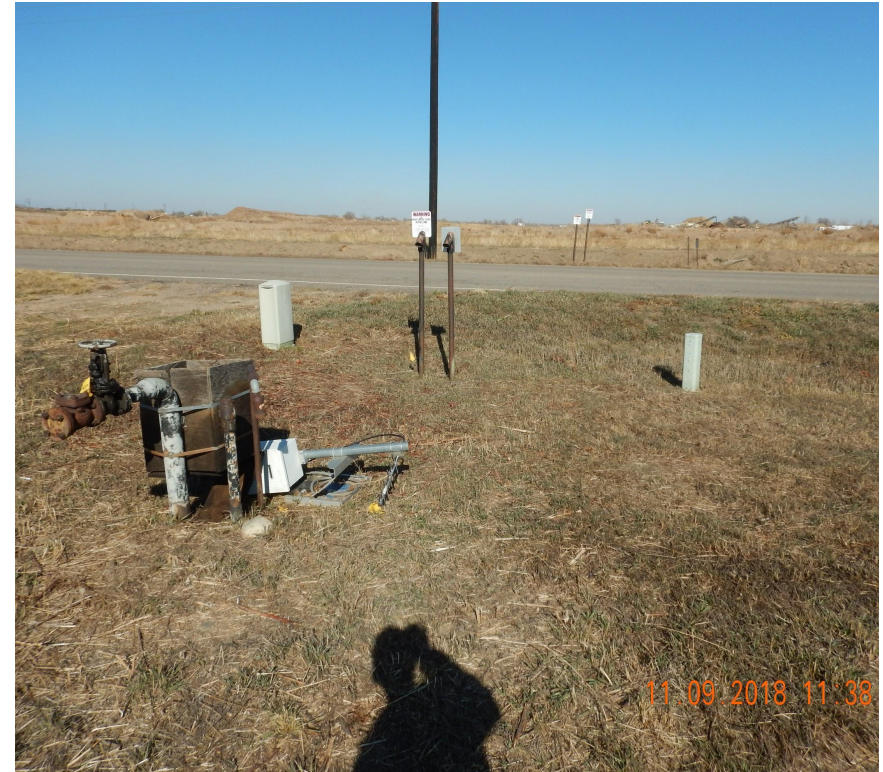
Photo 2. Photo taken from the eastern battery location on November 9, 2018. Photo illustrates the Operator is in process of removing equipment. Operator shall remove all equipment by February 28, 2019.

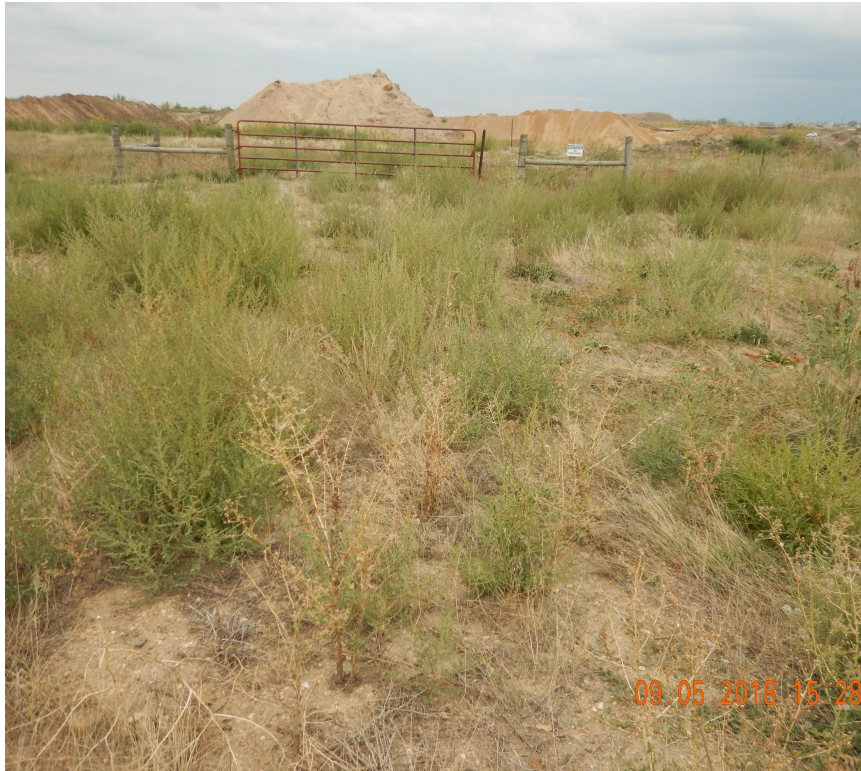
Photo 3. Photo taken from the battery location on September 5, 2018, facing South. Photo illustrates noxious thistles and undesirable weeds (Kochia and Russian thistle) were observed throughout the entire battery location.

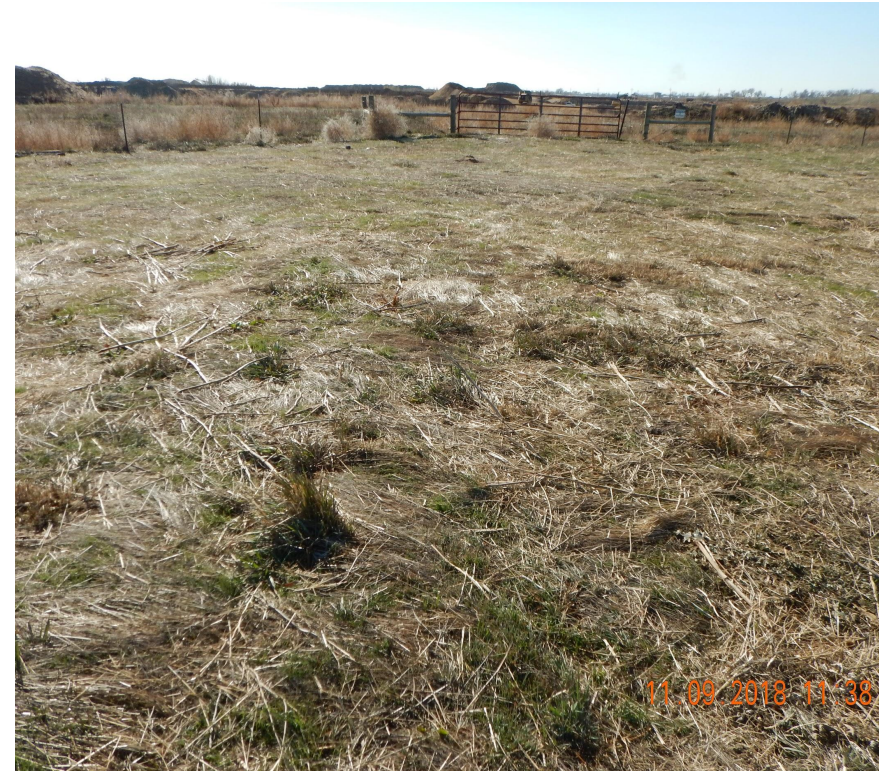
Photo 4. Photo taken from the battery location on November 9, 2018, facing South. Operator has mowed the entire battery location. Appears viable noxious thistle rosettes were still observed throughout portions of the battery location.

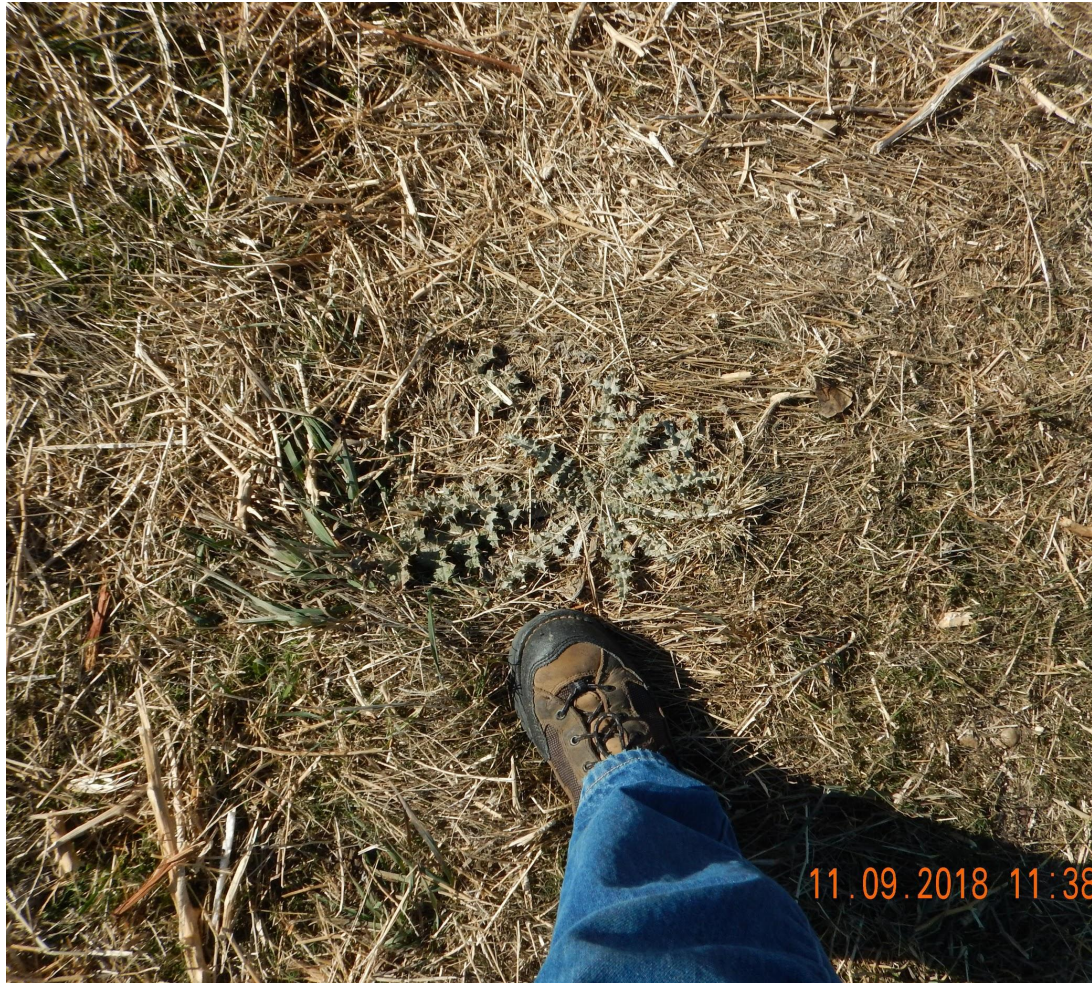
Photo 5. Photo taken from the battery location on November 9, 2018. Photo illustrates a viable Musk thistle rosette, a List B Colorado noxious weed. Operator shall continue to control and manage weeds and erosion until the Location has 2 consecutive growing seasons with no noxious weeds.
