Final Reclamation Inspection

Operator: NOBLE ENERGY INC- #100322

API: 05-123-25003

Inspection Photos
Location Name: WILMOTH C #5-20
API: 05-123-25003

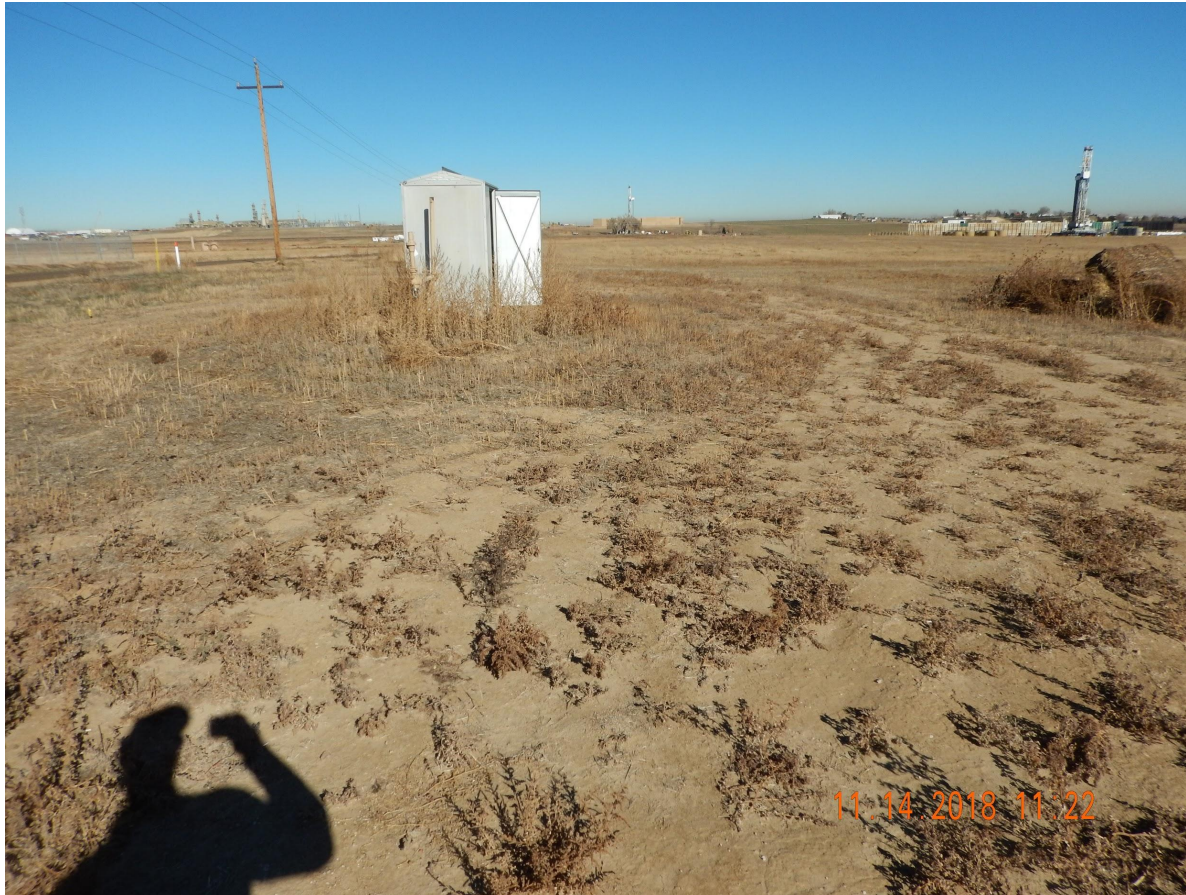
Photo 1. Photo taken from the offsite tank battery, facing North. Well was plugged and abandoned on 01/24/2017; this appears to be the last well plugged that used this offsite tank battery. Operator shall comply with Rule 1004 standards to remove all equipment and perform final reclamation activities. Another nearby PA location used this battery and already has a corrective action date- see FIR Doc. #682504032.

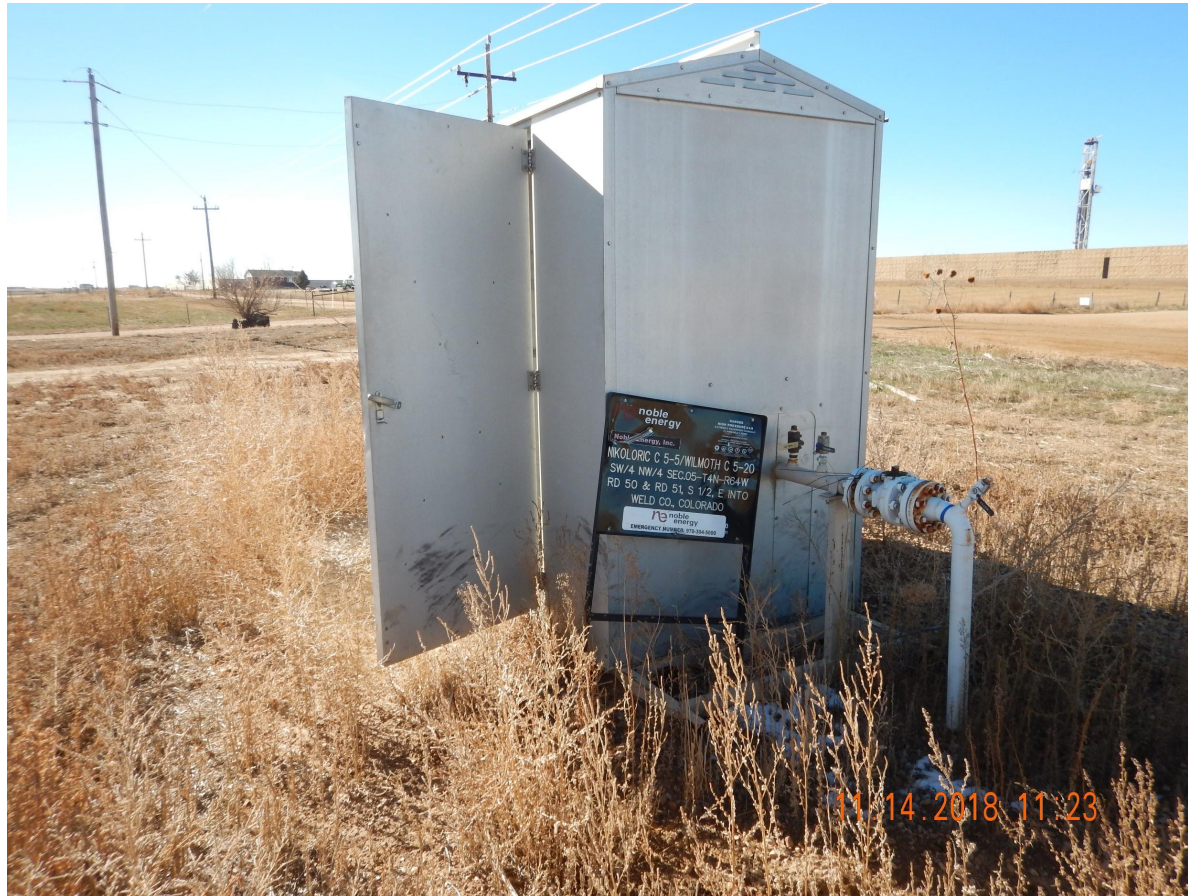
Photo 2. Close-up photo of the meter shed left at the tank battery, facing South.

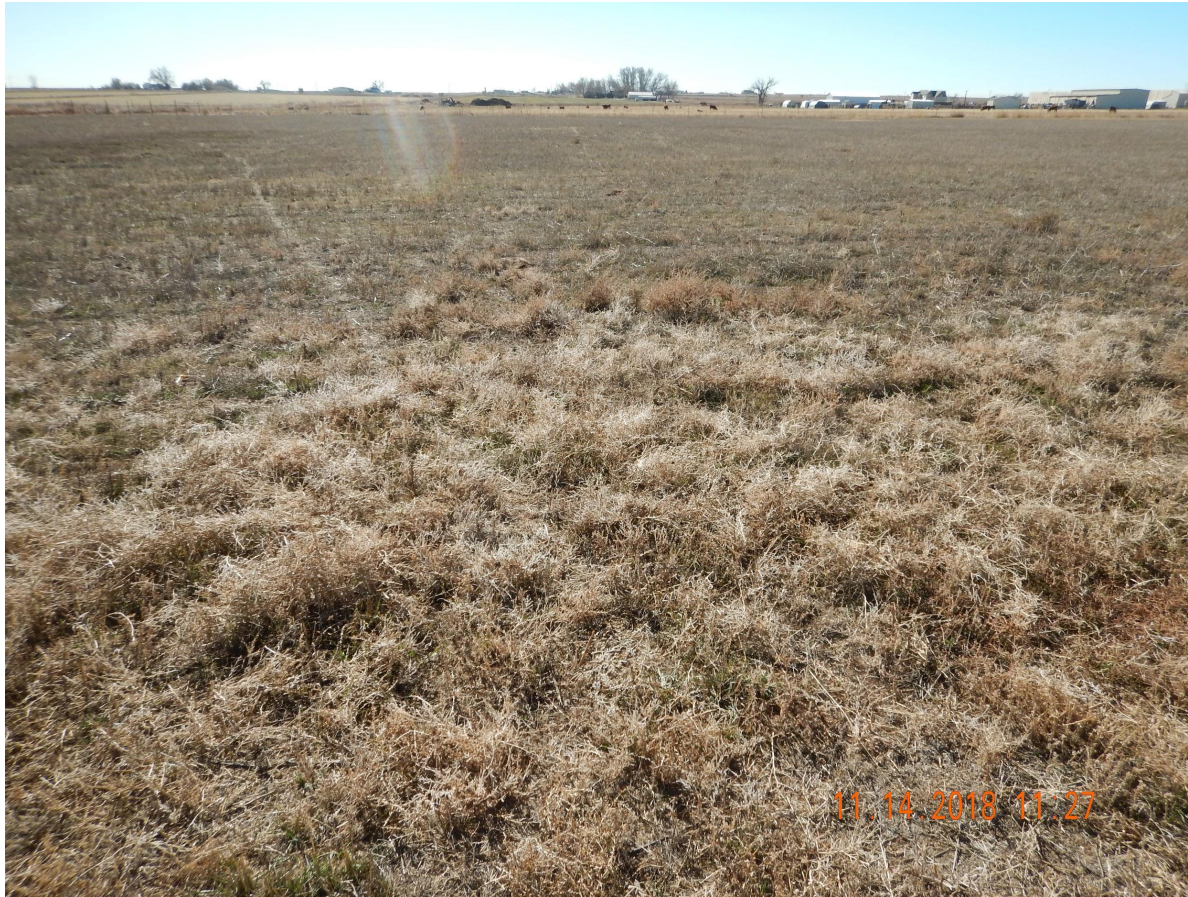
Photo 3. Photo taken north of the well location, facing South along the former access road. There was a lock gate with livestock so Staff did not proceed to the well location. Staff will conduct a follow-up inspection once the equipment has been removed from the tank battery and the location meets Rule 1004 vegetative standards.

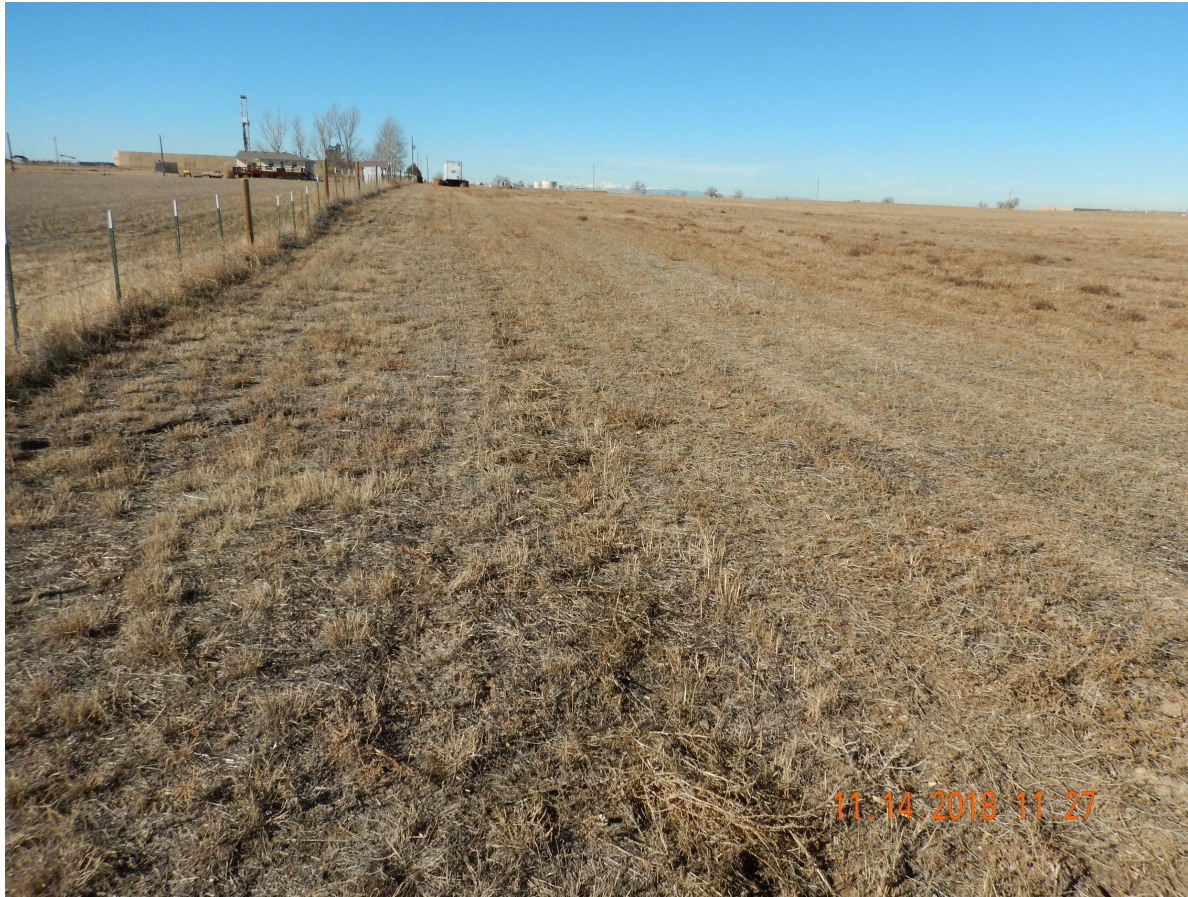
Photo 4. Photo taken from the previous photo location, facing West. Photo illustrates the former access road.
